D14 AQUATIC INSTRUMENT SYSTEM (AIS) SITE CHARACTERIZATION REPORT

Title: D14 AIS Site Characterization Report	Author: C. Bohall	Date: 03/29/2016
NEON Doc. #: NEON.DOC.001592		Revision: B

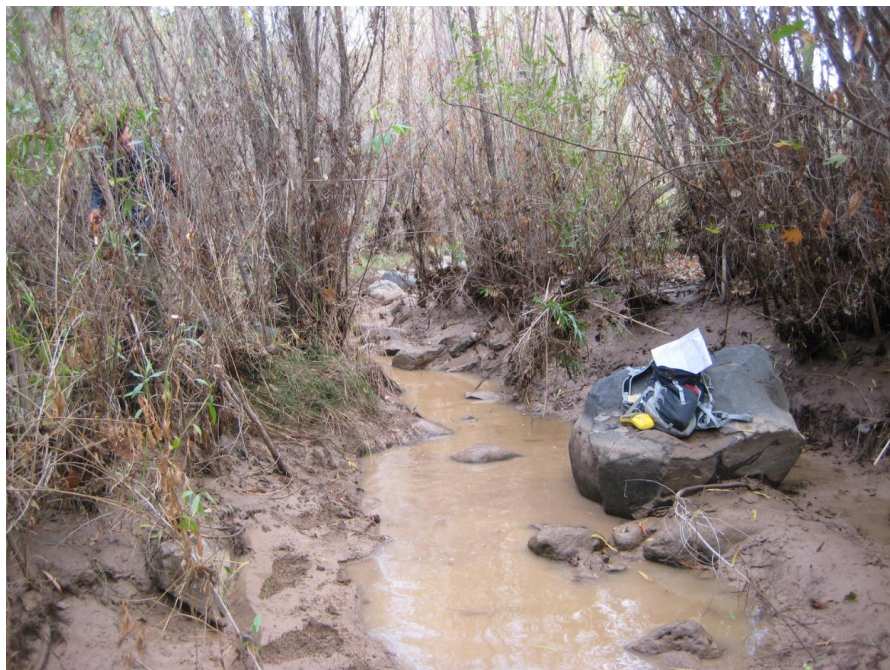
Figure 3 S1 location at D14 Sycamore Creek. Note that the benthic substrate consists of sand, thus channel features will likely evolve considerably over time, particularly following high flow events. Shown is the downstream direction. The main channel may be braided at times.

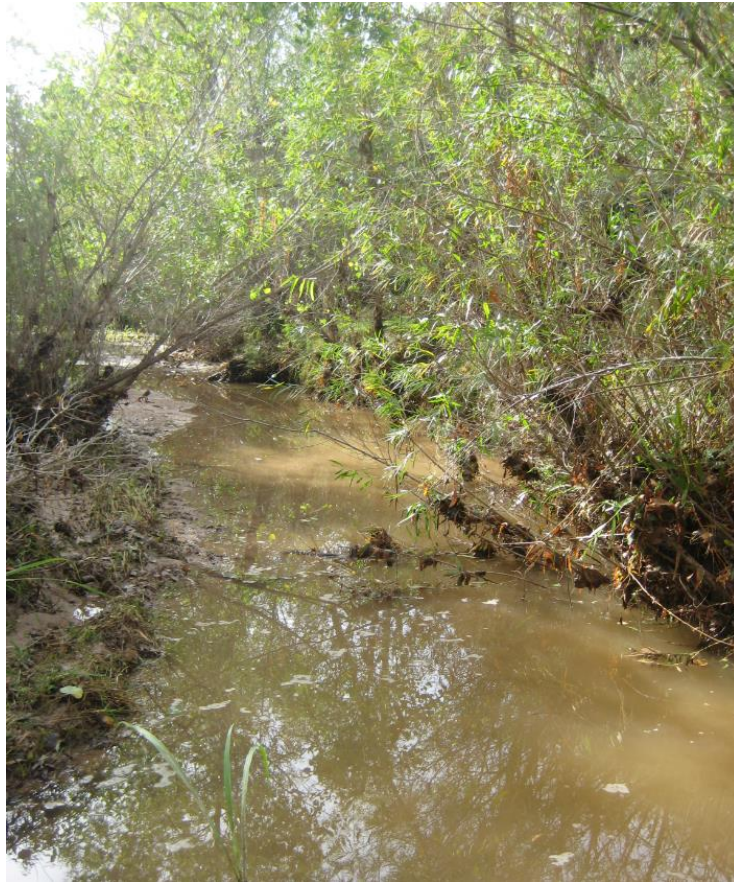
Figure 4 S2 Location at D14 Sycamore Creek. Shown is the downstream direction. Multiple active channels are very common in Sycamore Creek.

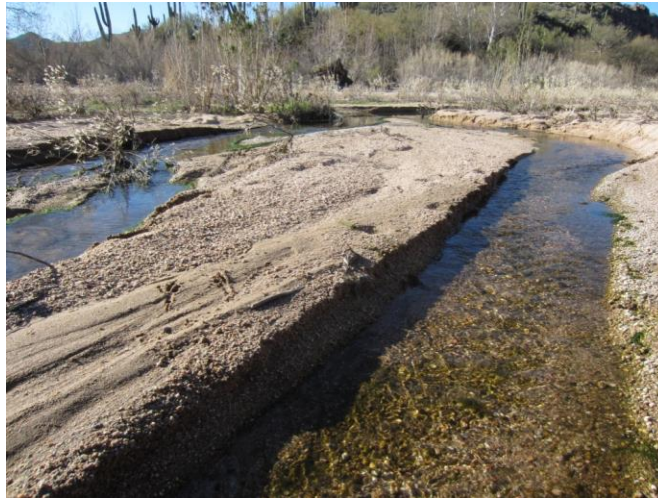
Figure 6 Much of the channel in Sycamore Creek consists entirely of sandy reaches, which will shift and evolve during high flow events.

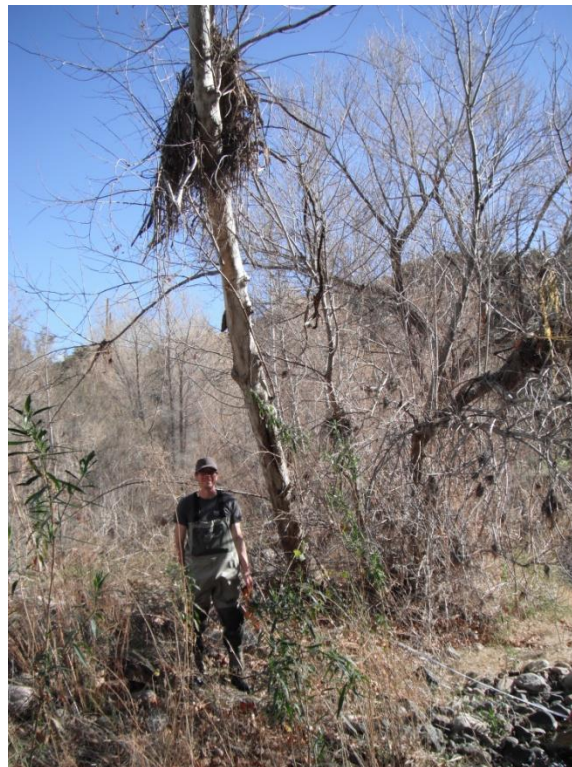
Figure 11 Very high intensity flood events occur in Sycamore Creek. Shown here is debris transported by a recent flood that remained in a riparian tree.

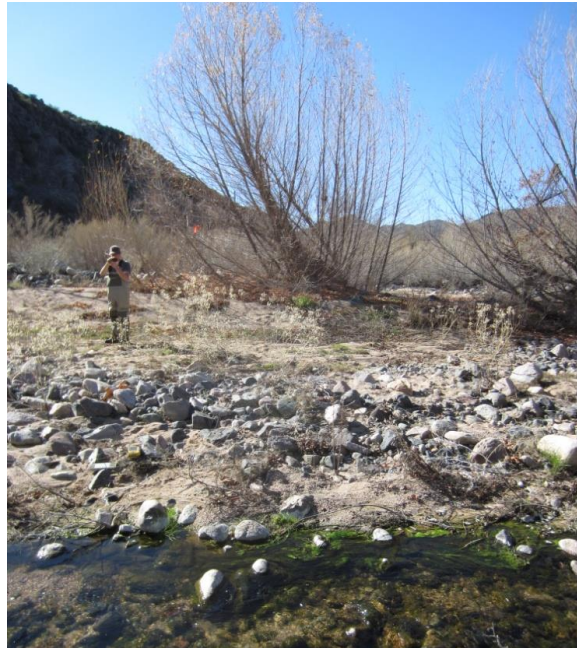
Figure 12 The true channel of Sycamore Creek is very large. Although riparian trees can grow within the channel as shown here, multiple side channels active only during high flow events are located behind these trees. The true channel is typically 50+ meters wide.

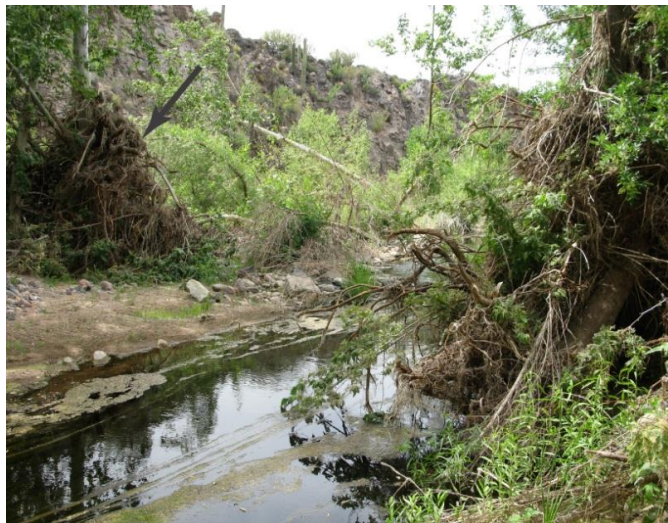
Figure 13 More evidence of high-intensity floods that occur in Sycamore Creek. **Floods of the magnitude that deposited the debris likely recur annually.**

- The most significant challenge at Sycamore Creek is the hydrologic regime of the stream. Extreme high flow events will very likely threaten sensors and any other *in situ* NEON infrastructure – **designs should take into account the likelihood (~every 5 years) of repeated high stream flow/debris flow events.**

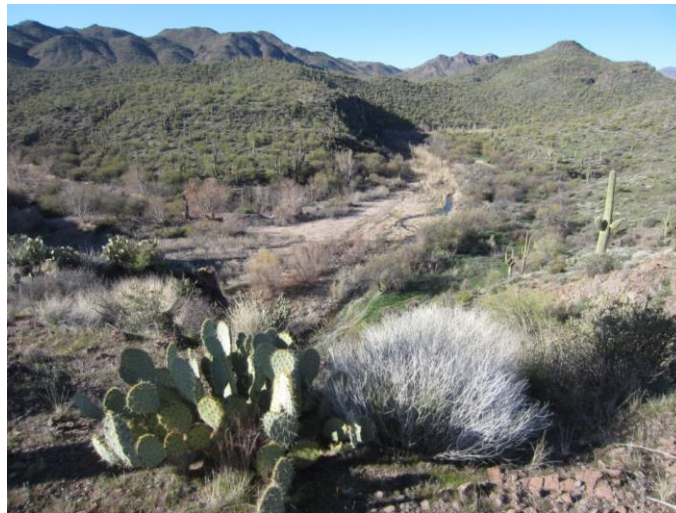
Figure 14 The vegetation of the Sycamore Creek basin consists of many plants hazardous to the touch- cactus and thorny shrubs. **Thus a path from the access road will need to be cleared to avoid contact with such vegetation.**

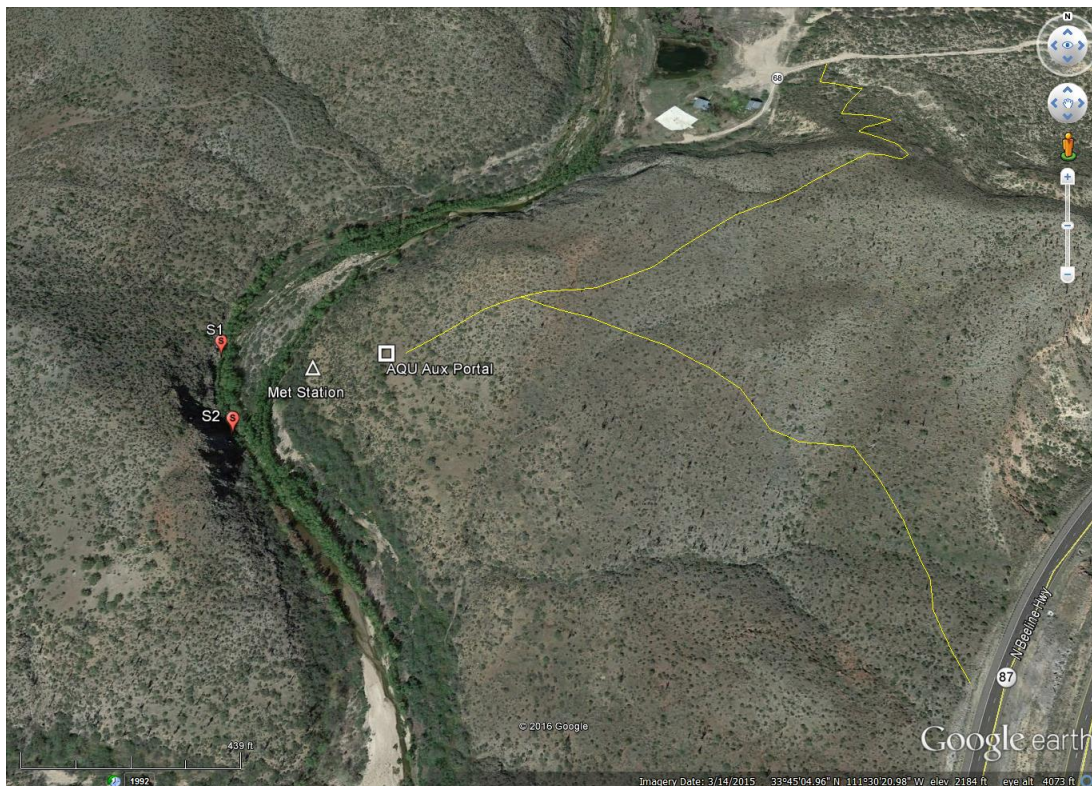
Figure 15 A new 600 m path from highway AZ 87 to the Sycamore Creek channel will need to be developed. The approximate route of this path is shown on the map above. However, the exact route is adjustable. An alternative route is shown from Forest Road 68.

Option 1. A ~600 m path cleared from AZ highway 87 to the stream channel. The approximate route (and areas in the near vicinity) shown in Figure 15 features a moderate gradient and should not require stairs or a ladder. A parking area and secure gate may be needed for site security.

- **A footpath from highway 87 to the Sycamore Creek channel will need to be constructed.** Either the existing pull-off area along the away could be used (which would require a relatively longer footpath) or a new area for vehicles to pull off could be developed.
- **A footpath along the left bank of Sycamore Creek will need to be developed to allow access to all sensor locations and NEON infrastructure.**

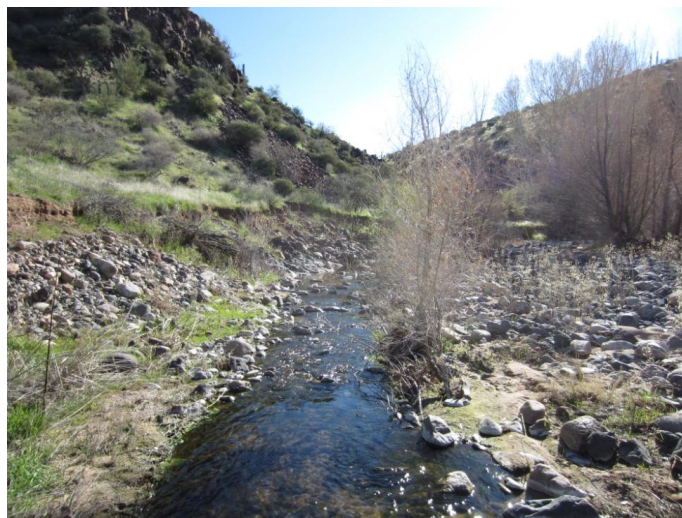
A flat, vegetated area located on the right bank near the S1 sensor appears suitable for installing sensor supporting equipment. However, the flat area very likely becomes inundated during high flow events. The valley slope (that does not flood) is located nearby. Only one nutrient addition station is required for Sycamore Creek (STR). Table 8 lists suggested coordinates for installing the STREON nutrient drip. However, any location may be selected so long as the nutrient addition station is deployed within 20 m of the STREON S1 sensor set. The nutrient addition station may need to be deployed on an elevated platform to prevent flood damage if deployed very near the channel.

Figure 17 STR S1 location at D14 Sycamore Creek (STR). A flat, vegetated area is located on the right bank and appears suitable for installing sensor supporting equipment. However, the flat area very likely becomes inundated during high flow events. The valley slope (that does not flood) is located nearby.

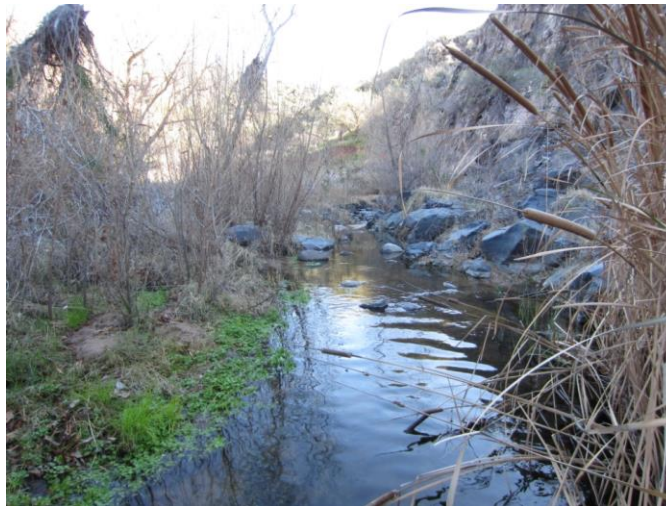
Figure 18 STR S2 location at D14 Sycamore Creek (STR), facing upstream. Note that the left bank is a bedrock outcrop and the beginning of a sheer cliff. Despite this feature, one may access the sensor location on foot (except during very high flows).

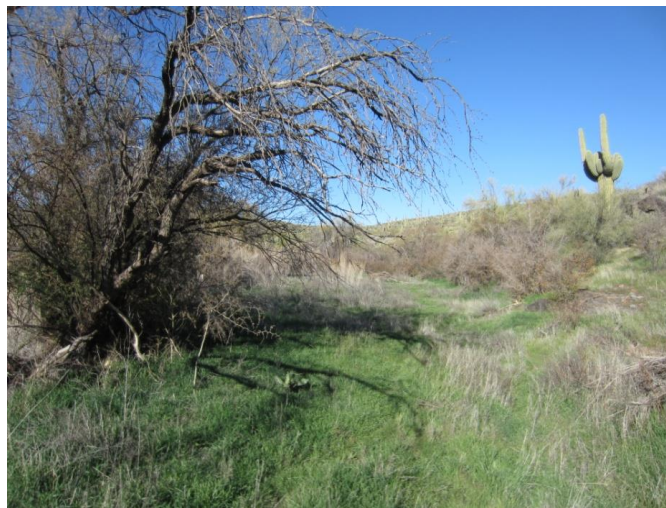
Figure 19 Meteorology station, STREON hut and STREON nutrient drip apparatus location at D14 Sycamore Creek (STR). A flat, grassy terrace immediately adjacent to the channel provides a suitable location for installing such facilities. **However, this terrace is very likely inundated during high flow events. Therefore, positioning infrastructure on the slope shown in the right-hand edge of this figure may prove the best option. Alternatively, facilities may be anchored and/or raised to help withstand high flow events.**

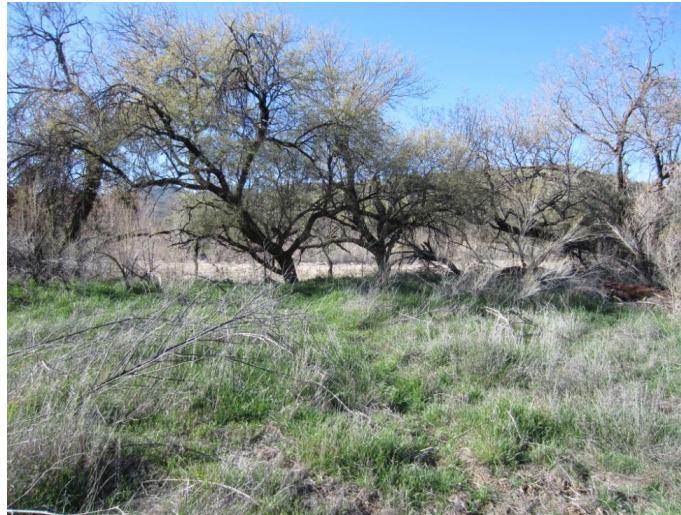
Figure 20 The flat, vegetated area in between the AQU and Sycamore Creek (STR) reaches appears for installing various NEON infrastructure, though the terrace likely floods during high flow events. However, the water velocity during such events is not likely very high (as suggested by the vegetation) and **a raised STREON hut on this terrace may prove to be the best option.**

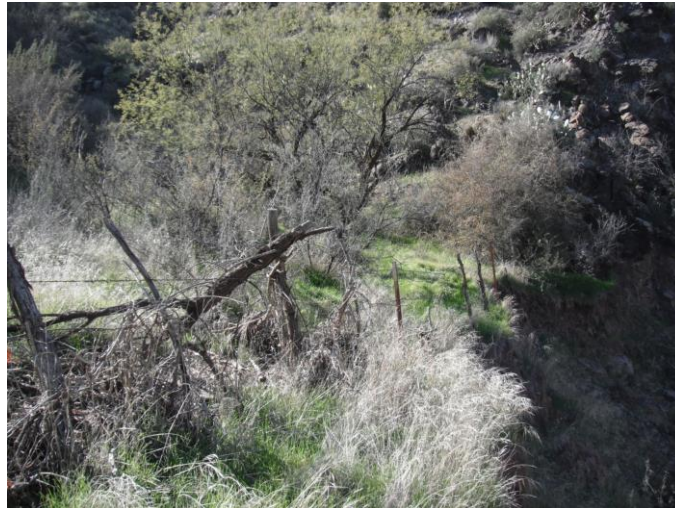
Figure 28 Old barbed wire fencing from defunct ranching operations may require removal during construction of access paths.
