<i>Title:</i> D08 AIS Site Characterization Report	<i>Author:</i> J Vance	<i>Date:</i> 06/03/2016
<i>NEON Doc. #:</i> NEON.DOC.001370		<i>Revision:</i> B

D08 AQUATIC INSTRUMENT SYSTEM (AIS) SITE CHARACTERIZATION REPORT

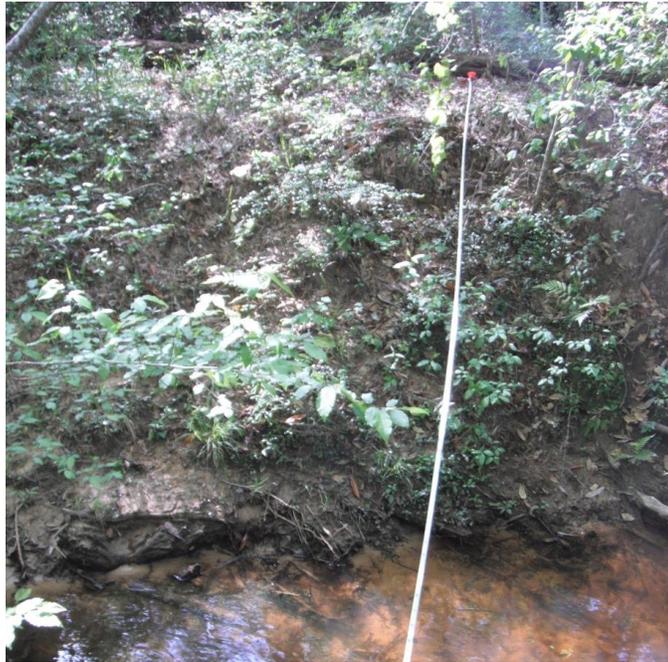
Figure 6. Mayfield Creek banks consist of packed sand stabilized by roots.

- Construction activities should take care to minimize disturbances to channel banks, which consist of packed sand stabilized by roots. Heavy equipment should remain away from the bank to prevent mass failure.
- Sensor installation and routine maintenance should not involve the removal or destruction of large woody debris dams in the channel of Mayfield Creek.
- Up to five species of venomous snakes are found in the Mayfield Creek vicinity. During site characterization in April 2012, multiple snakes were encountered hanging from riparian trees and adjacent to wetland areas. Personnel should conduct field operations with appropriate protective gear and an Emergency Action Plan.
- Use of Personal Flotation Devices (PFDs) may be required, depending on regional USGS regulations and standards for work in or near lakes, streams, or creeks.

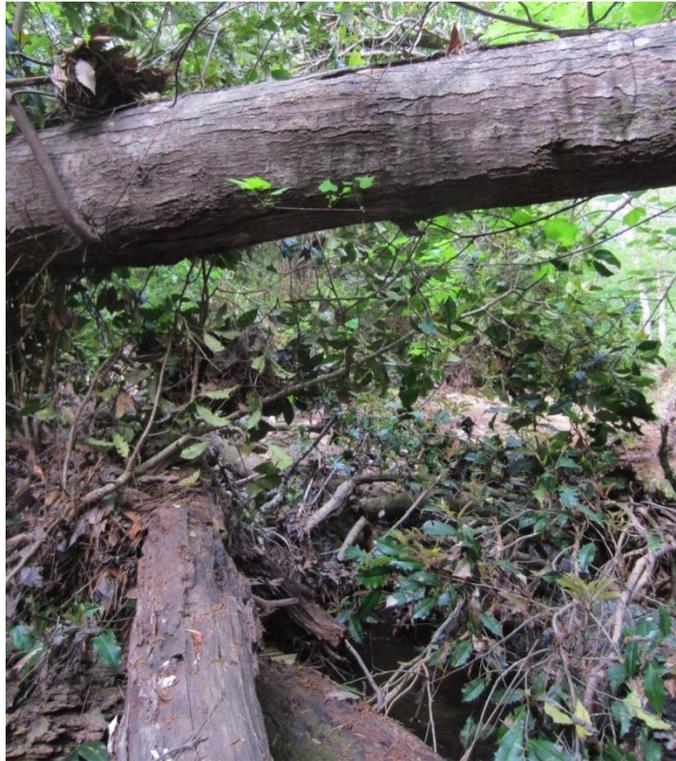
Figure 14. Large woody debris and associated leaf packs are common throughout the **Mayfield Creek** channel. These features are biologically important and should not be removed or disturbed during infrastructure installation operations.

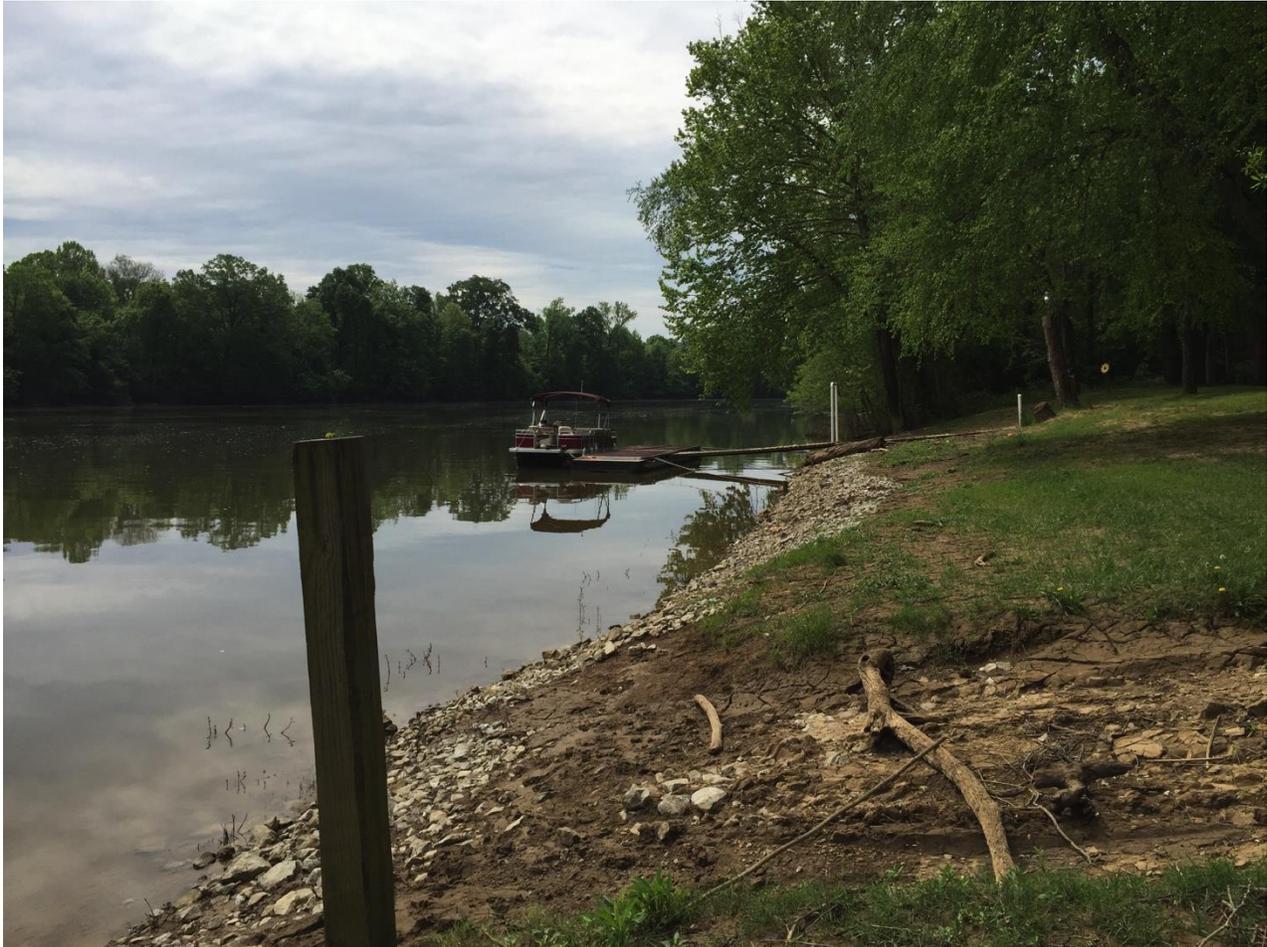
Figure 44. The substrate is mostly sand and silt. Rock and riprap have been added by private land owners to limit bank erosion.

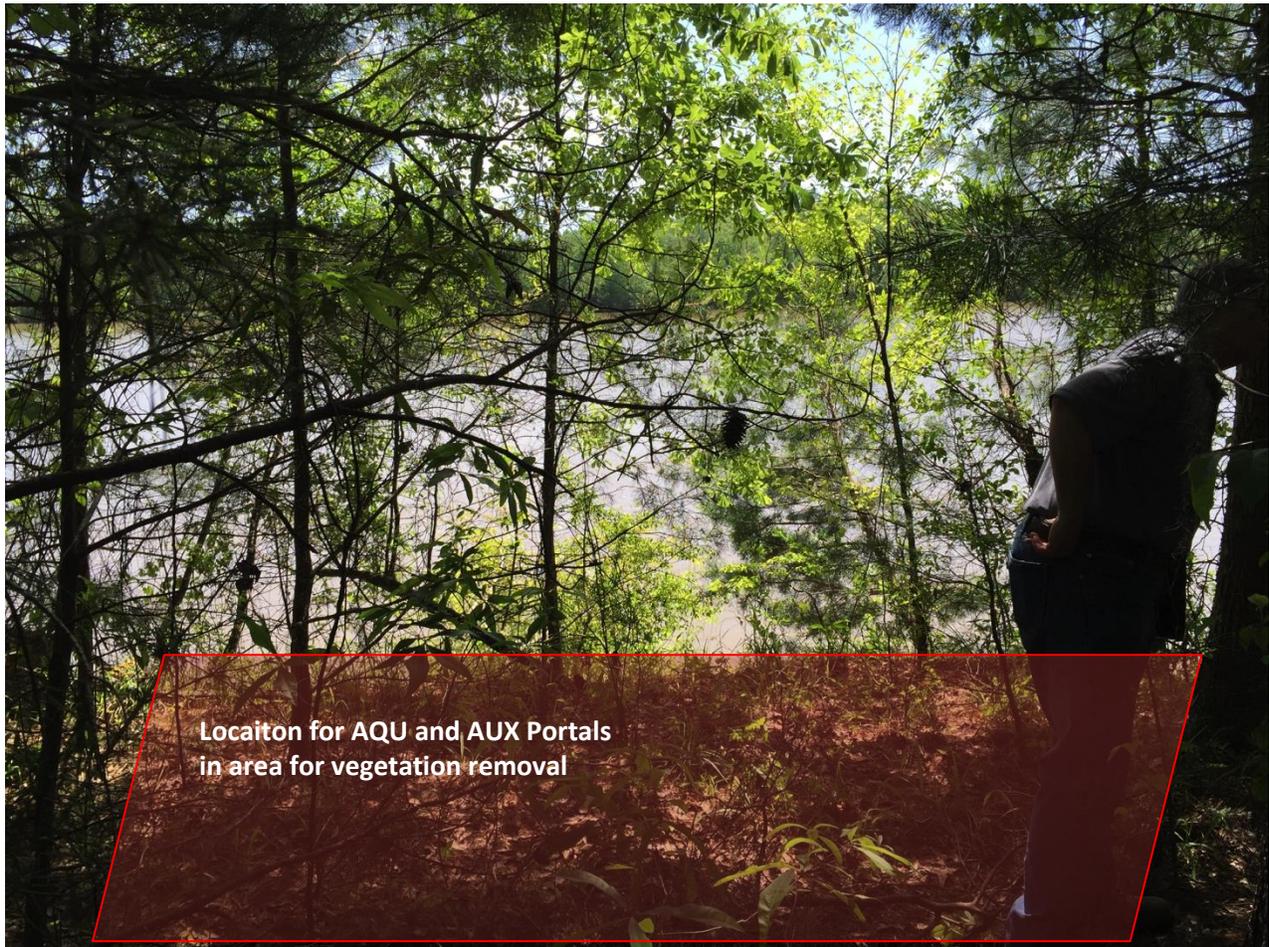
Figure 48. Picture showing the AQU and AUX Portal locations, with clearing area indicated by red box.

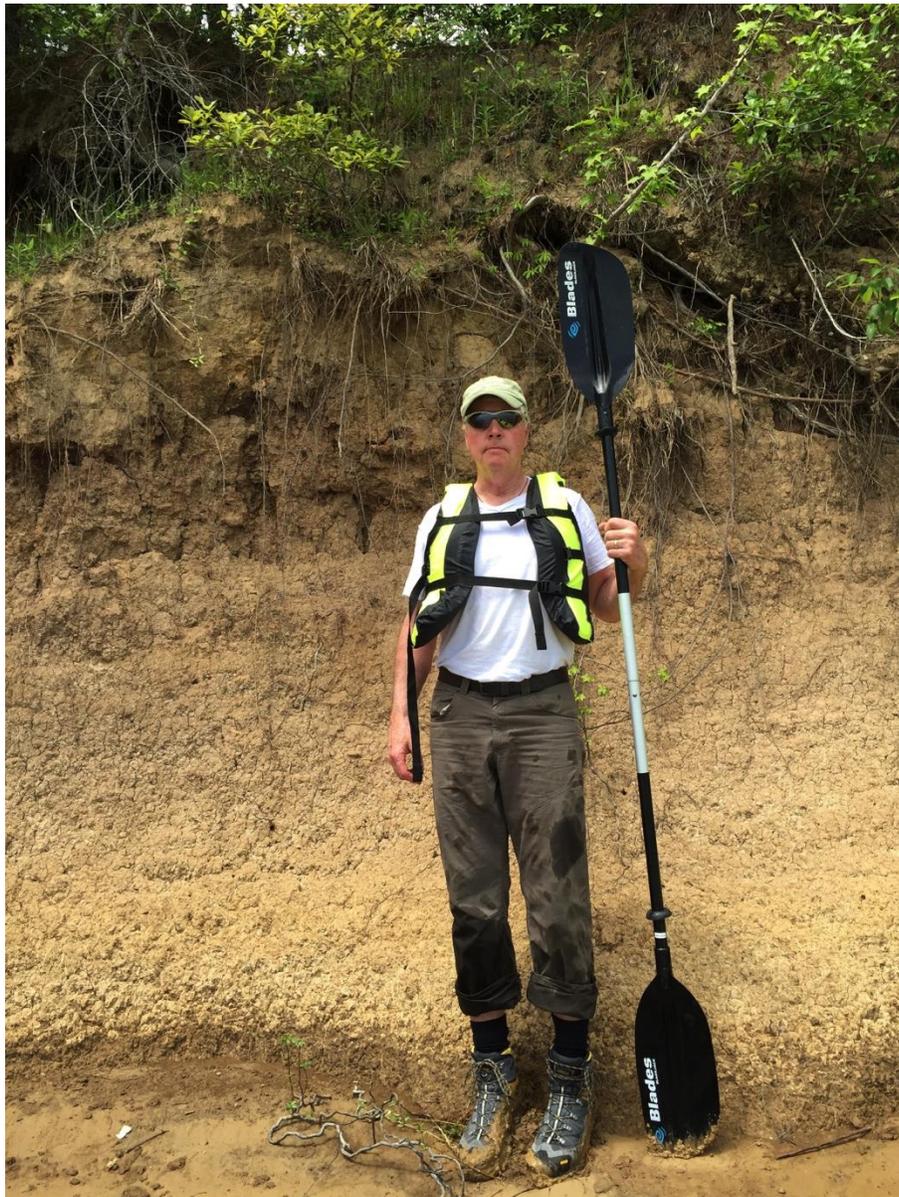
Figure 50. Picture of right bank under portal location with Dan as reference. Estimate height to portal location is approximately 5 m.

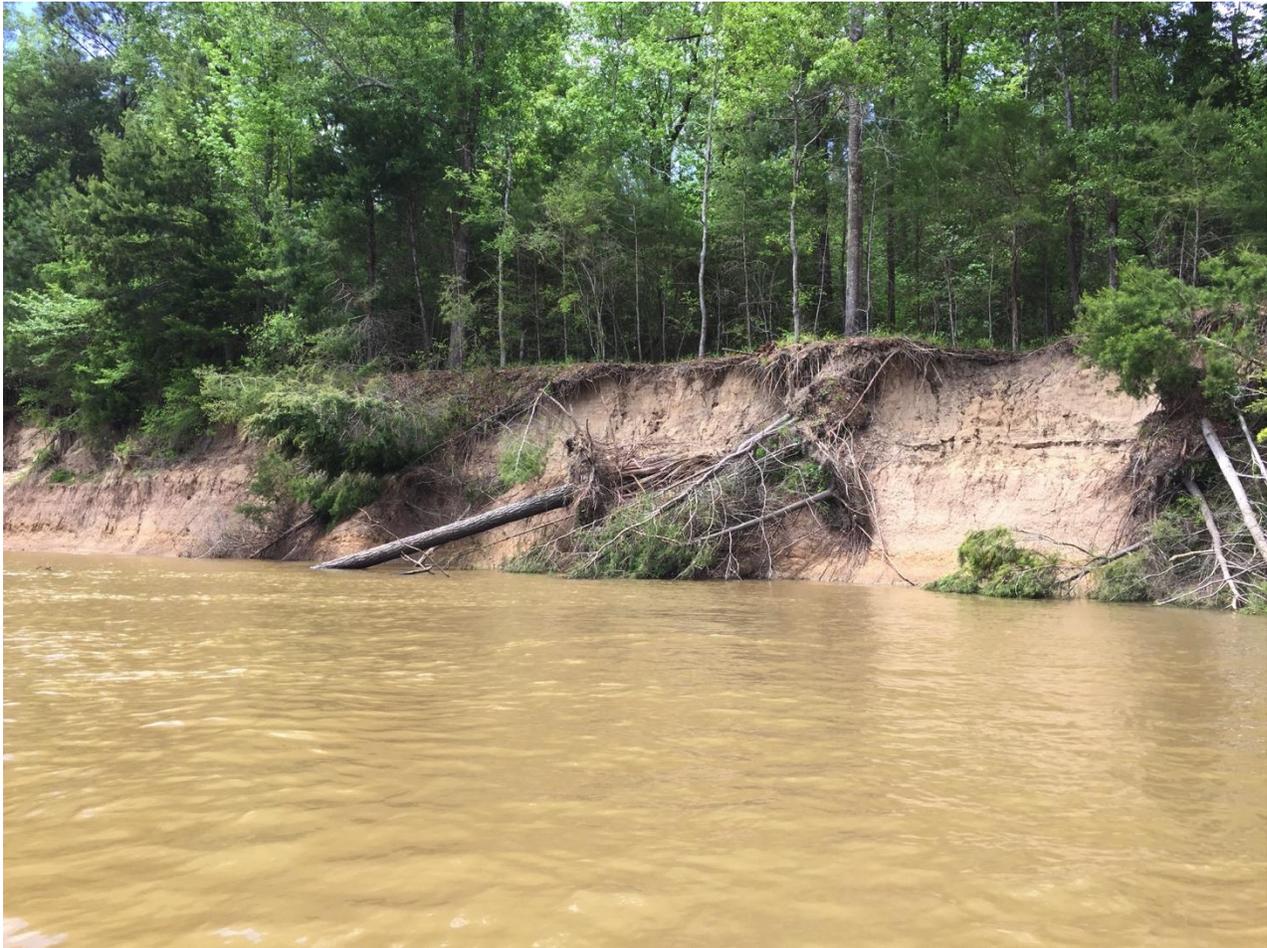
Figure 47 Photo of typical bank structure along reach. Steep eroding banks ranging 2-7 m in height.

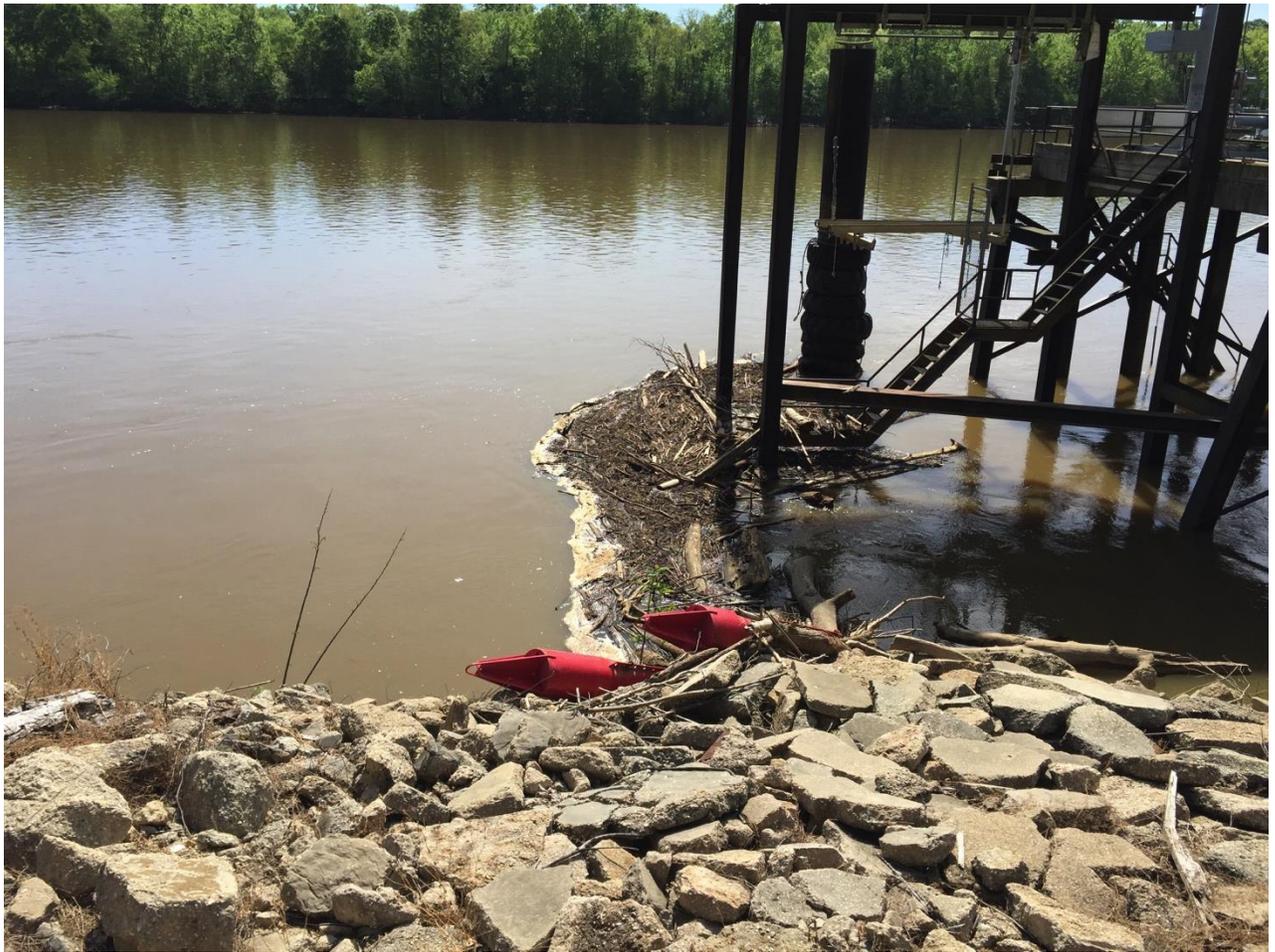
Figure 48 US Coast Guard buoys frequently wash up at the Hunt Refinery dock 500m downriver.

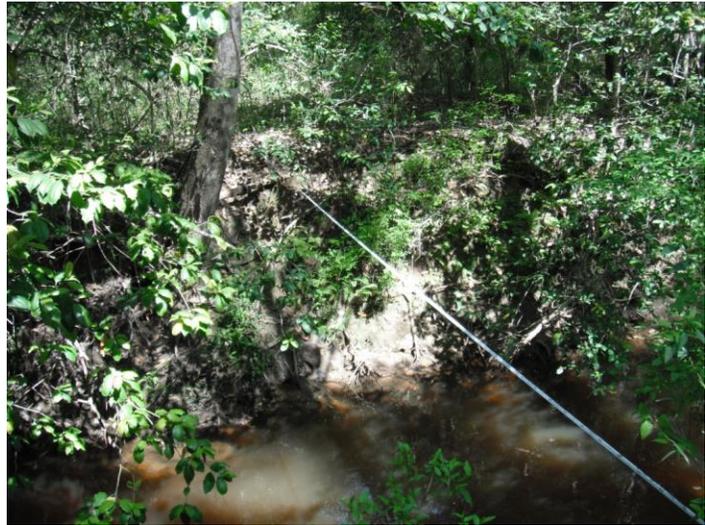
Figure 58 Typically, at least one bank steeply rises ~2 m from the channel to the floodplain. Shown here is the right bank of the Mayfield Creek (STR) S1 location.

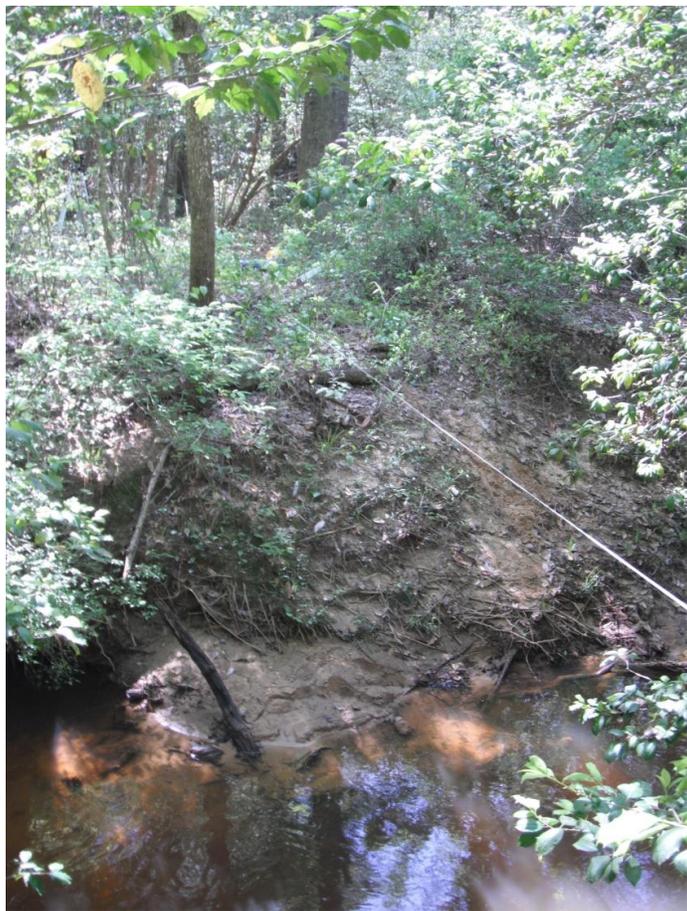
Figure 59 Some banks are more gently-sloping, though access to any sensor location should be facilitated by a small ladder or stairway. Shown here is the S2 sensor location.

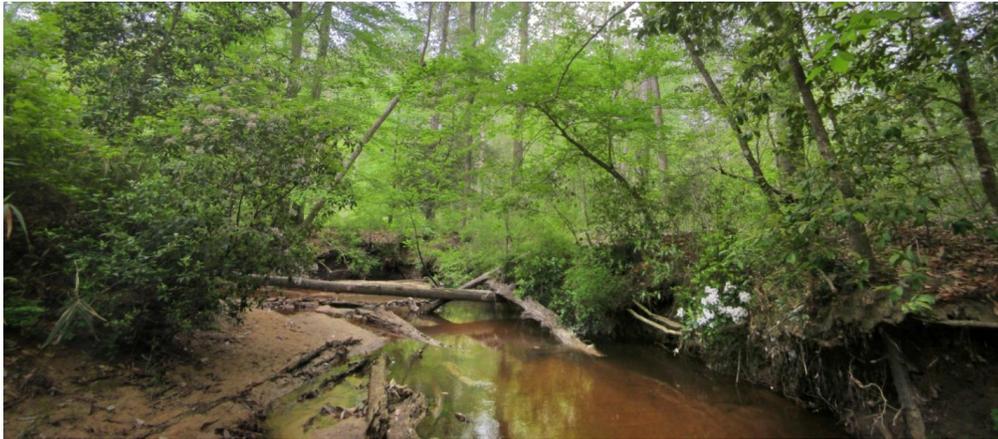
Figure 60 During moderate to large flood events, large woody debris that may pose a threat to sensor installations likely ensue.

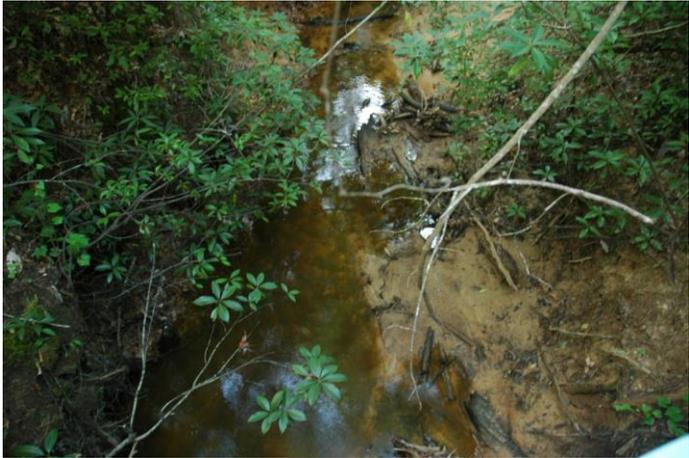
Figure 61 Though the banks and channel of Mayfield Creek (STR) consists of sand, under normal conditions the substrate is compacted and easy to traverse. However, after a large storm event, the substrate becomes relatively unconsolidated and wading the channel will prove difficult.
