<i>Title:</i> D12 AIS Site Characterization Report	<i>Author:</i> M. Fitzgerald	<i>Date:</i> 05/15/2014
<i>NEON Doc. #:</i> NEON.DOC.001669		<i>Revision:</i> A

D12 AQUATIC INSTRUMENT SYSTEM (AIS) SITE CHARACTERIZATION REPORT

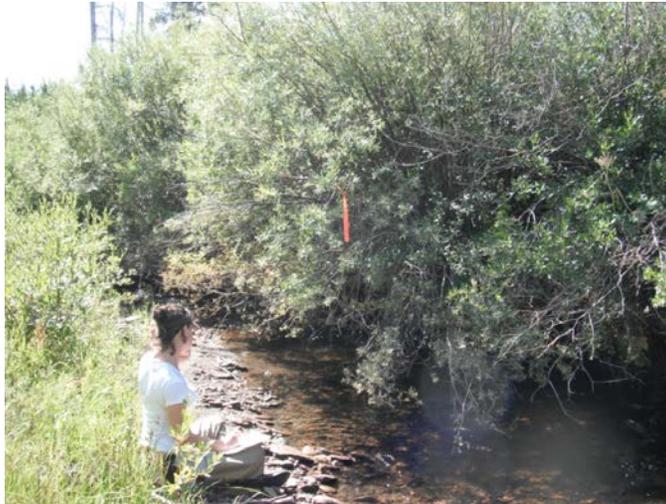
The S1 and S2 locations include pools, which may be used as installation areas for sensors thus reducing the potential for drying.

Figure 3 Photo of S1 Location at D12 Blacktail Deer Creek, looking upstream. A pool is present underneath the dense willow canopy on the left bank.

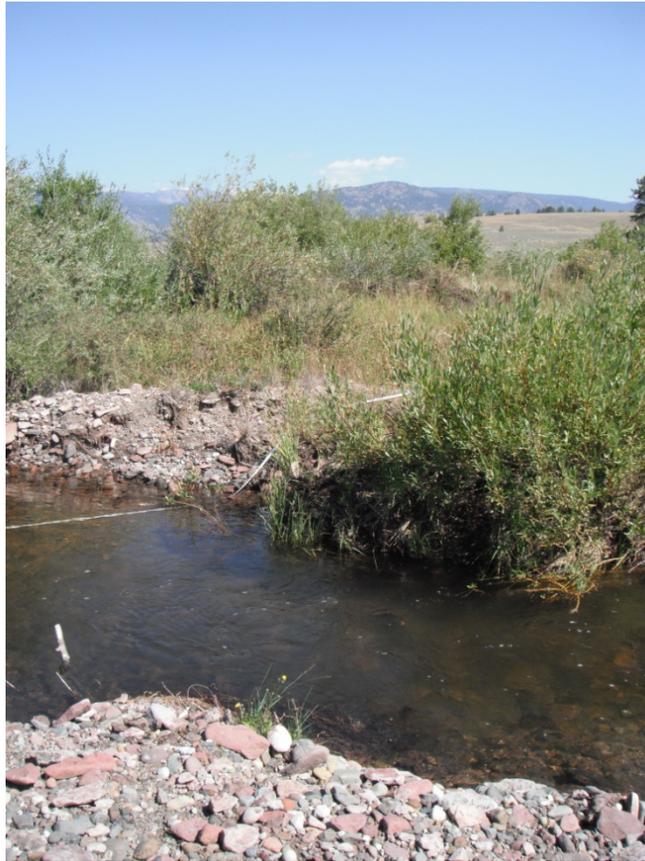
Figure 4 Photo of S2 Location at D12 Blacktail Deer Creek. This site contains a pool.

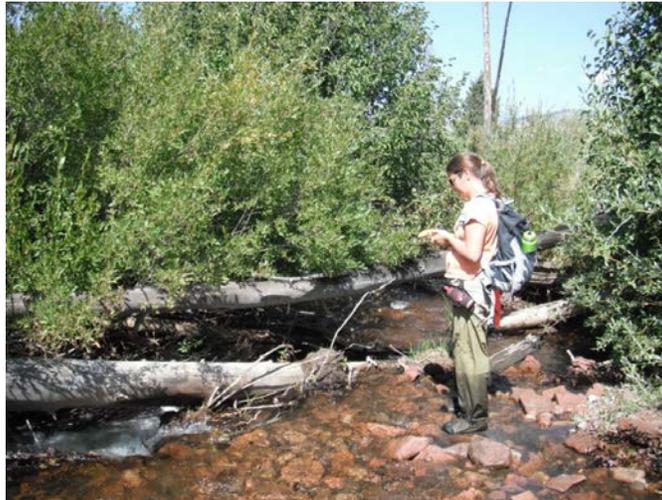
S1 is located downstream of an area where a former forest fire has affected the large vegetation. Dead tree trunks have fallen across the stream, and alter flow at some locations. The S1 location is chosen to be below this downfall, with enough area between the downfall and S1 to inject gas tracers.

Figure 6 Photo of injection site upstream of S1. S. Parker stands near downed trees from a historic forest fire.

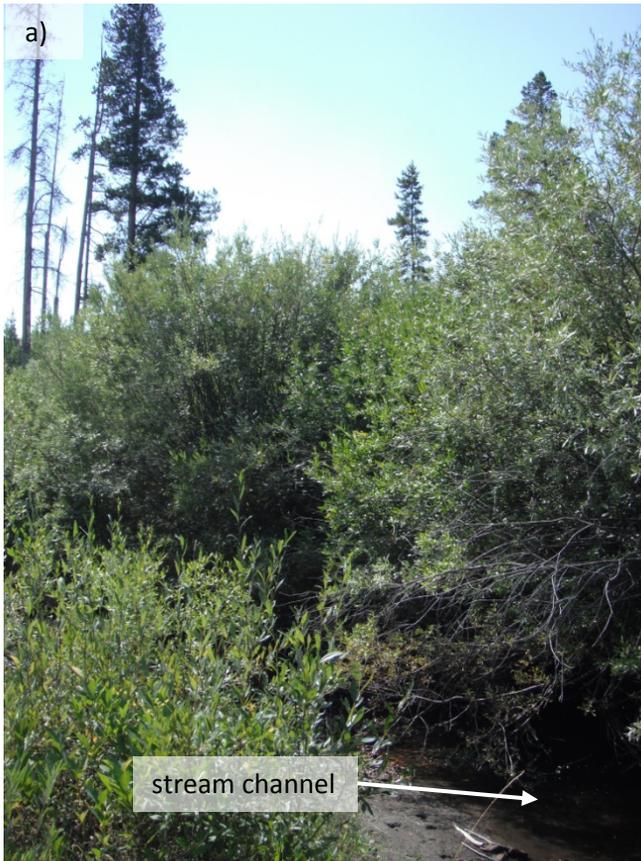
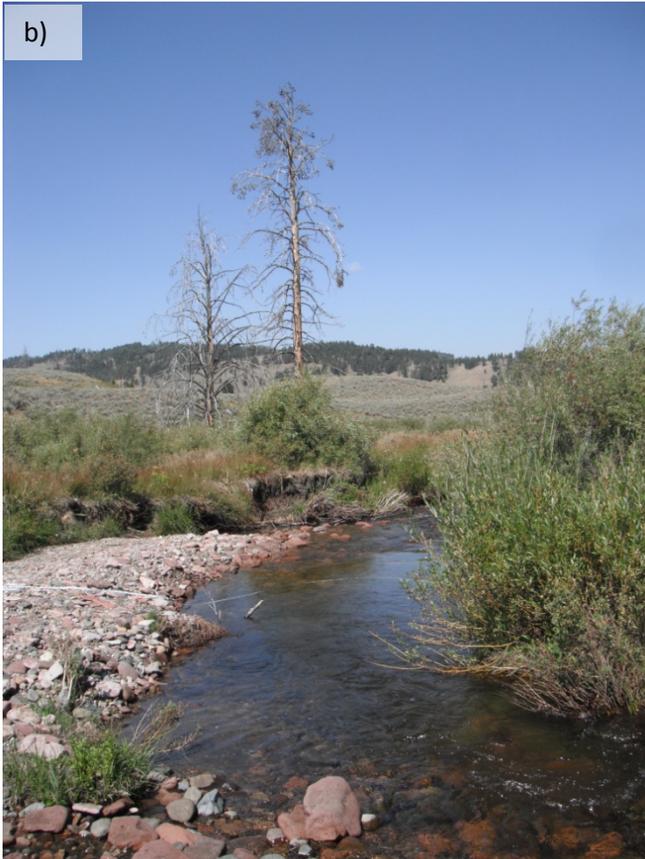
The riparian vegetation at Blacktail Deer Creek is composed primarily of willows. Willow shrubs are dense along the stream channel for the majority of the stream reach. The location for S2, however, is relatively open with some smaller willow shrubs along the bank. The upstream portion of the reach has some surrounding lodgepole pines that have been burned in a forest fire (not recent). Some of these trees have fallen across the stream, and obstruct flow in the channel. AQU has places all sensor locations downstream of these fallen trees. Understory vegetation also consists of willow, roses, and grasses.

Figure 8 The Riparian Canopy at D12 Blacktail Deer Creek. a) Upstream canopy near S1 is composed of thick willows overhanging the stream. b) Downstream canopy near S2 is sparse willow cover.

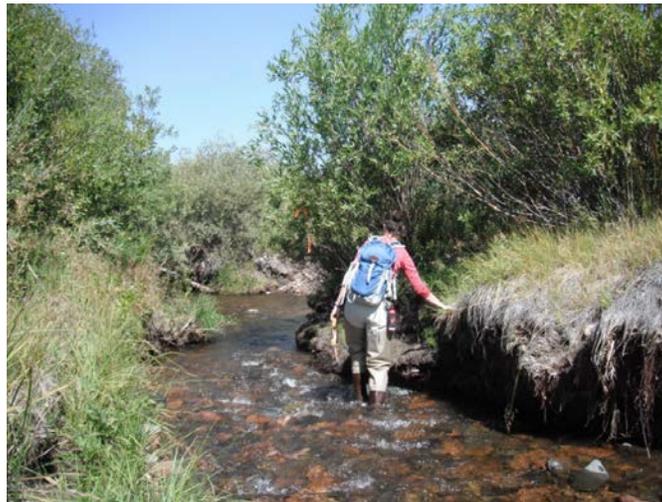
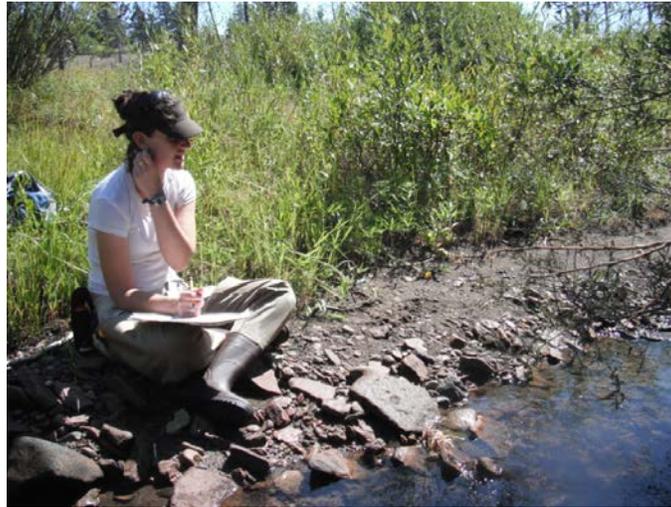
The stream bank at Blacktail Deer Creek varies along the AQU reach. Some areas show signs of erosion during floods (Fig. 10a) with high, cut banks. These areas are composed of organic matter and willow roots. In other sections of the reach, the banks are composed of cobble and gravel, and have a more gradual slope (Fig. 10b). At S1, the bank is composed of sand, cobble, and organic matter, with dense willow roots on the left bank. At S2, the bank is composed cobble, gravel, and fine organic matter.

Figure 10 a) K. Goodman walks by a portion of the stream where the bank has eroded due to flooding. b) K. Goodman sits on a bank composed of cobble and gravel. Photos taken in 2011.

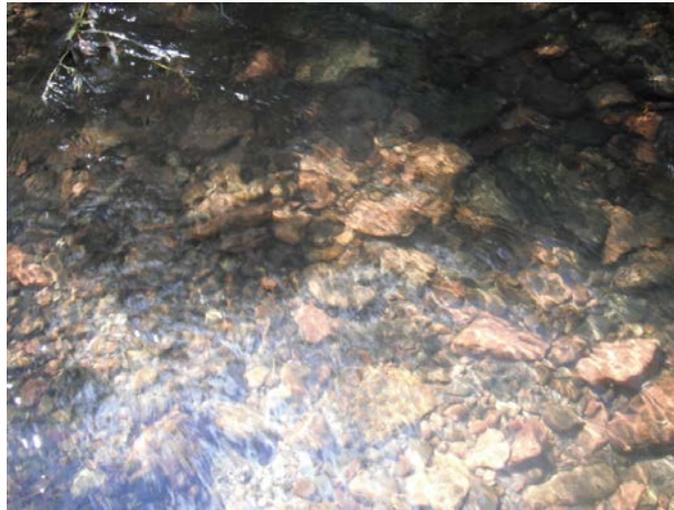
Figure 11 Typical Substrate in D12 Blacktail Deer Creek is composed mostly of cobbles, with some gravel.

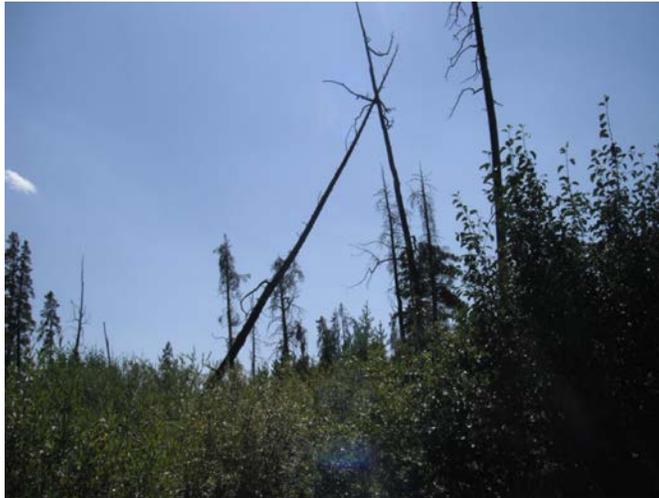
Figure 12 A past forest fire has burned several lodgepole pines near the upper end of the reach.

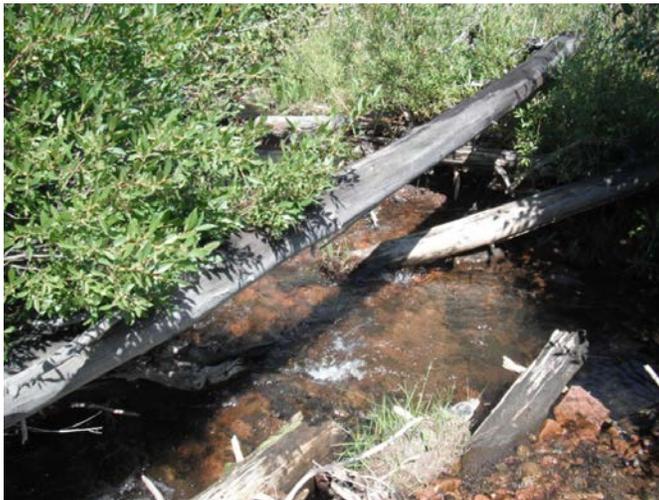
Figure 13 Deadfall in the stream channel as a result of past forest fires in the watershed. These trees may be swept downstream over time.

- Past forest fires in the upper watershed may eventually drop more dead trees into the stream channel, and trees that have already fallen in the stream channel may become mobile and wash downstream during future flood events.

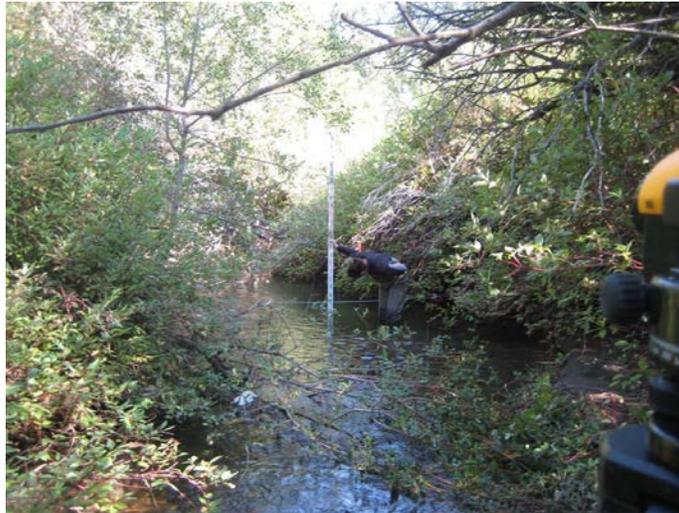
S1 is located in a pool downstream of the Goldenstein Lane bridge (Figure 17). It is accessible off of the Sourdough Trail on the left bank, however is well-hidden from the trail itself. The right bank appears to be the yard of a private landowner. Both banks are heavily covered with riparian vegetation.

Figure 17 Photo of S1 Location at D12 Bozeman Creek, looking downstream. K. Goodman holds the survey rod during the cross-sectional survey. Note the dense riparian vegetation on each side of the stream.

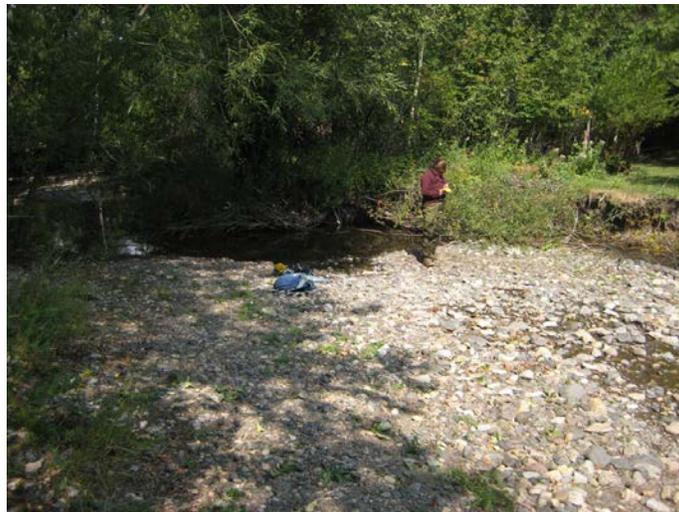
S2 is located in a pool directly off of the Sourdough Trail (Figure 18). There is easy public access to this location on the left bank. The right bank appears to be the yard of a private landowner, with a lawn that has been mowed all the way to the stream bank.

Figure 18 Photo of S2 Location at D12 Bozeman Creek. S. Parker collects GPS coordinates in the photo, the pool behind her is the S2 location.

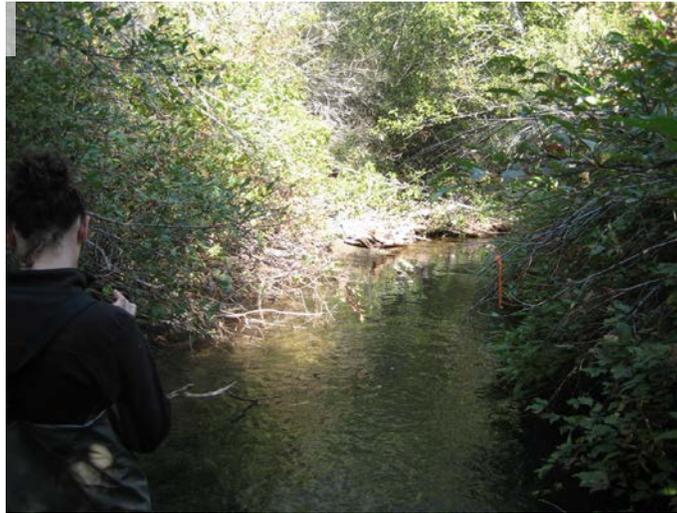
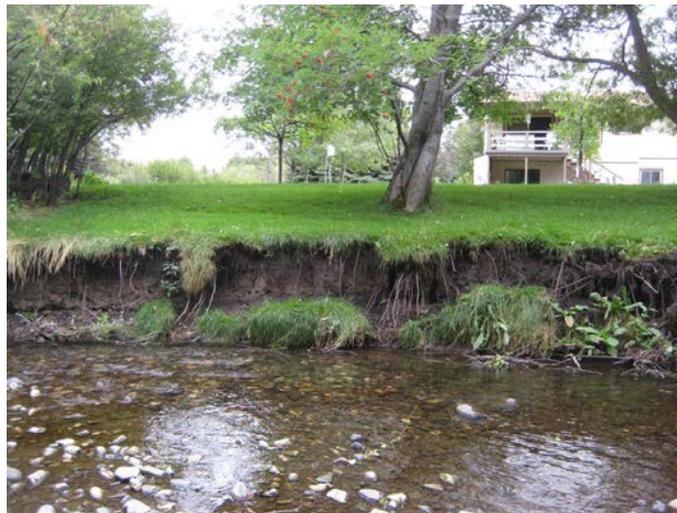
The vegetation at Bozeman Creek consists primarily of willows, cottonwoods, and alders. The brush is very dense in some locations (e.g., S1; Figure 21a). The understory vegetation consists of deciduous shrubs and berries. Large woody debris is abundant throughout the channel. In a few locations, landowners have mowed their lawns up to the stream bank (Figure 21b). The canopy cover at S1 and S2 are both approximately 30% closed.

Figure 21 The Riparian Canopy at D12 Bozeman Creek. a) The riparian canopy near S1 is very dense on both sides of the stream with willow and alder bushes. b) Private landowners have mown the lawn all the way to the streambank just upstream of S2.

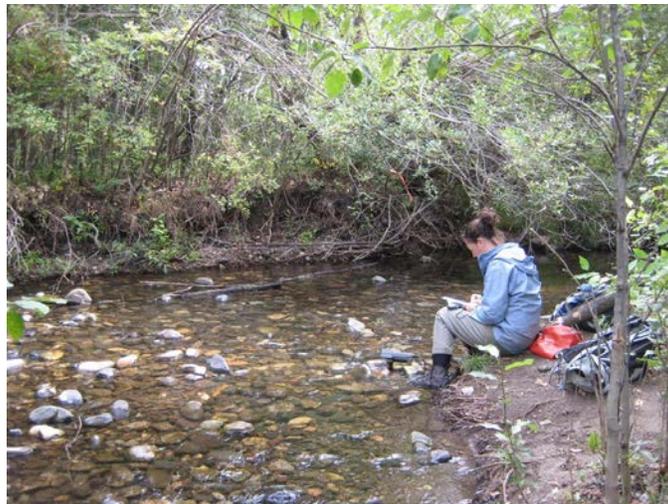
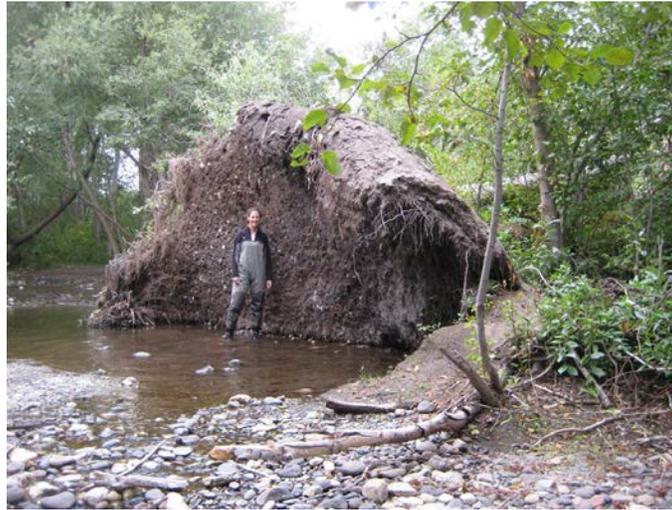
Figure 23 Bank erosion is highly likely along the Bozeman Creek AQU reach. a) A cut bank is visible across the stream from K. Goodman. b) Four large trees have overturned uprooting a large section of stream bank just upstream of the S1 location.

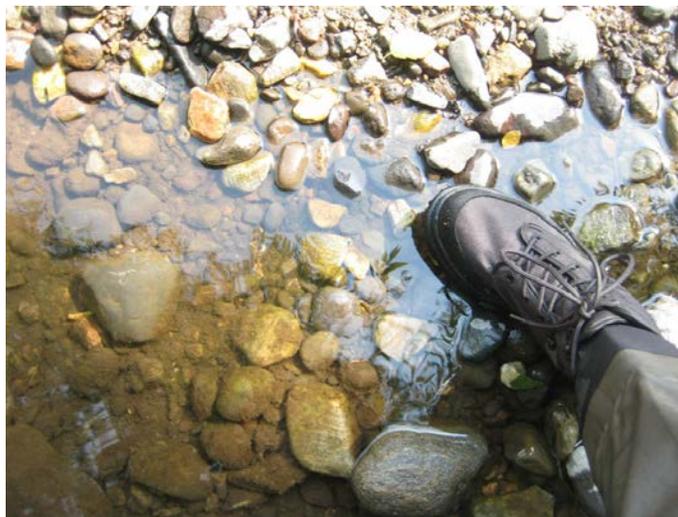
Figure 24 Typical substrate in D12 Bozeman Creek is cobble and pebble.

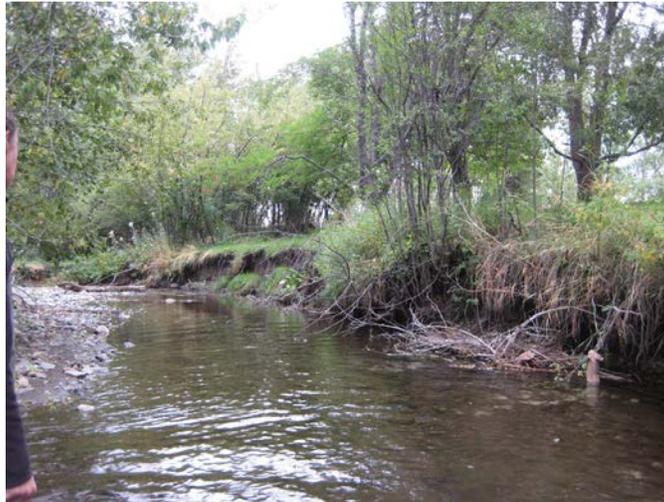
Figure 25 The right bank appears to be private property, and is eroding in several locations especially just upstream from S2 (photo).

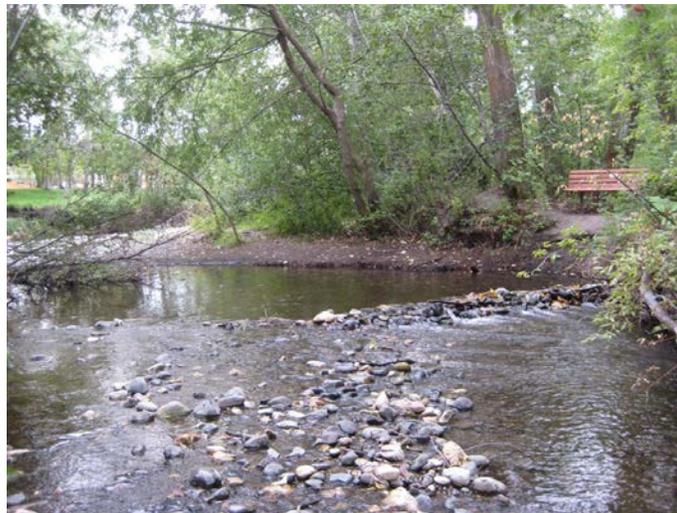
Figure 26 The Sourdough Trail runs along the left bank of the stream. In some locations, it is on the streambank (see trail and park bench in photo, at S2), in others there is a dense riparian buffer between the trail and the stream channel.

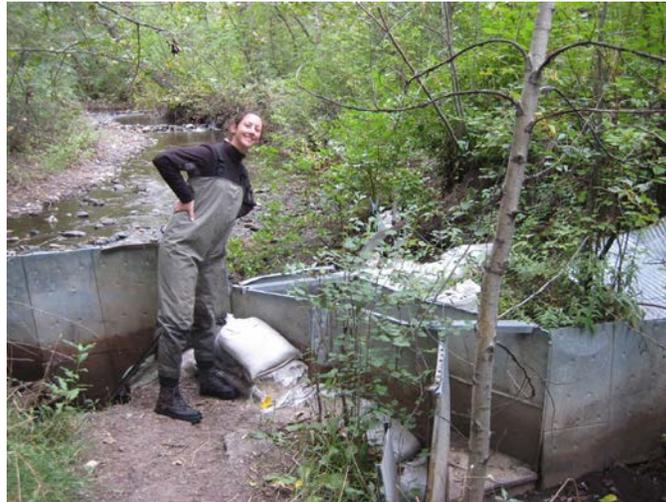
Figure 27 A metal diversion structure, likely for irrigation purposes, has been built downstream of S2.
