Domain 11 Aquatic Instrument System (AIS) Site Characterization Report

<i>Title:</i> Domain 11 AIS Site Characterization Report	<i>Author:</i> C. Bohall	<i>Date:</i> 04/28/2016
<i>NEON Doc. #:</i> NEON.DOC.002416		<i>Revision:</i> B

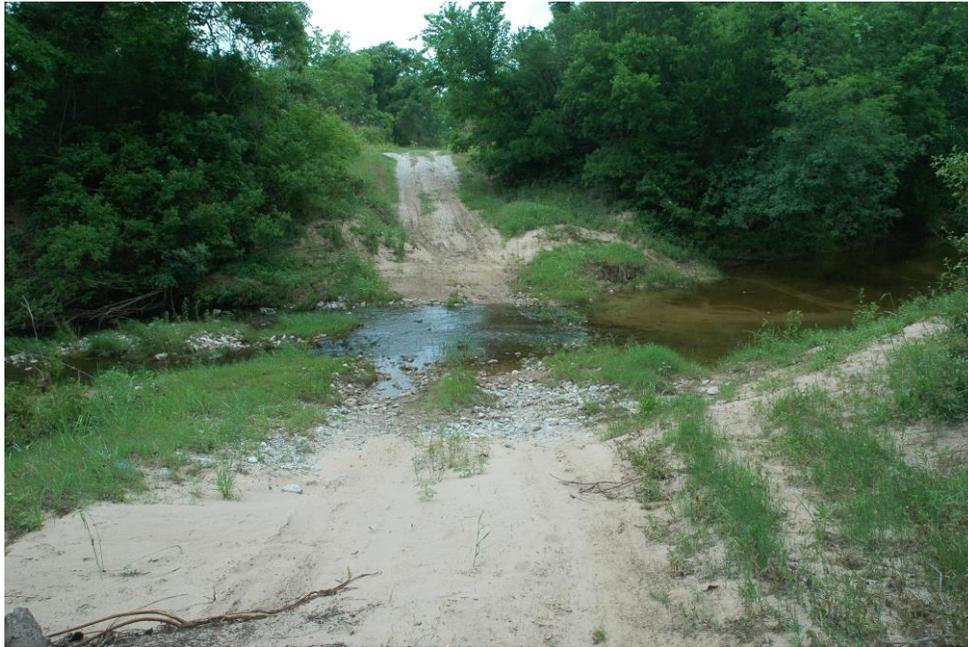
Figure 20 View of USFS road that passes through the creek where culvert is proposed to be installed.

Parking is available at the USFS gate (Figure 18). We propose to receive gate access keys from the USFS so that field techs may drive to within 130m of the met station and DFIR, which will be 260m directly south from S2. The USFS road entering the site passes directly through the creek approximately 420m downstream of the AQU reach (Figure 18 below). We request that a culvert be installed to allow continued access during period of moderate to high flow while minimizing damage to the ecosystem and road maintenance (Figure 19 below). The magnitude and frequency of the high flow events is unknown for this creek. In the absence of historical data for Pringle Creek, Big Sandy Creek is used as a proxy. Figure 21 below shows that while discharge is typically very low, 1 event on the order of 5-6000 cfs may be expected over the duration of the project (30 year core site); events on the order of 1500-3000 cfs can be expected on a 2-5 year frequency. There is high level of uncertainty associated with these estimates for Pringle Creek given both the lack of data and projected climate change. Therefore we anticipate the culvert to be built based on conservative estimates. Table 7 provides the coordinates for the location of the culvert to be installed.

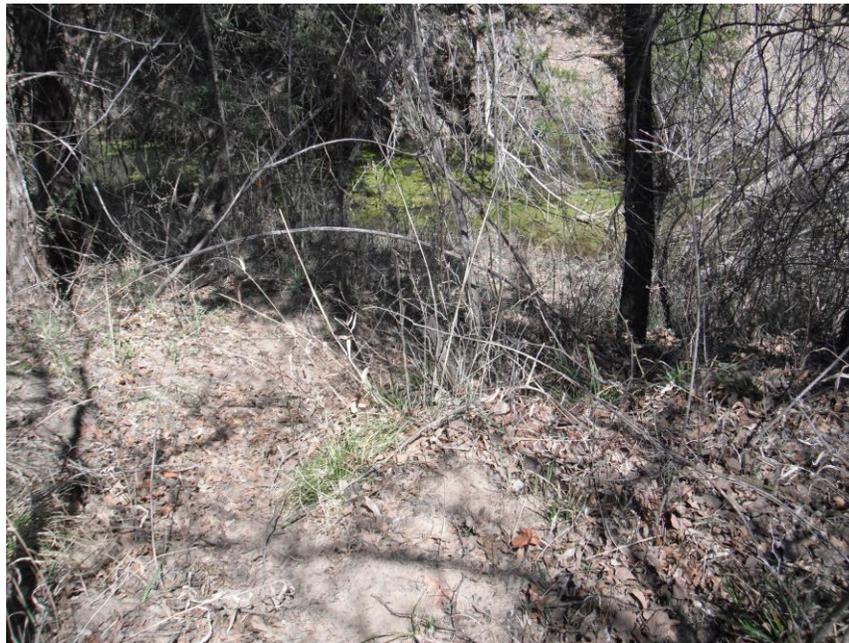
Figure 24 Location where pathway will need to be cut through riparian vegetation and stairs installed leading to S2.

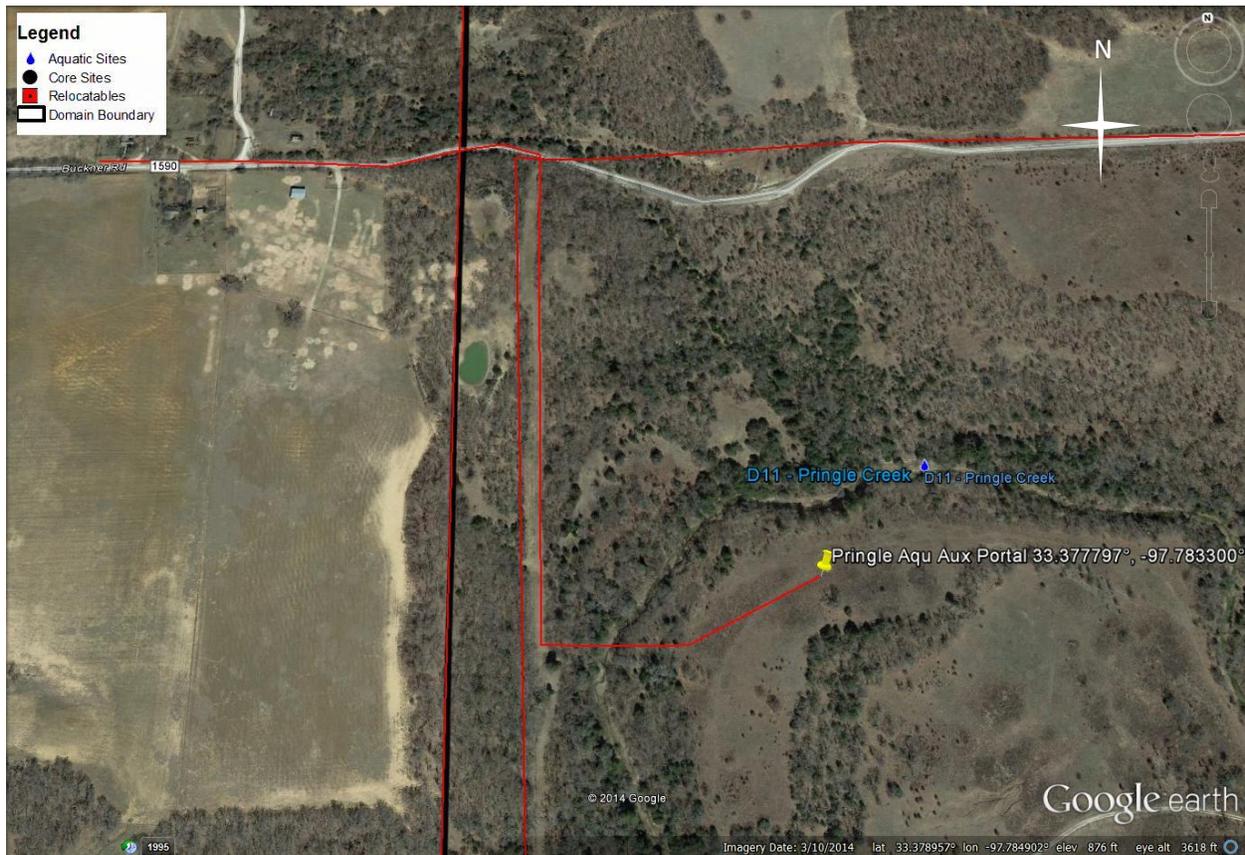
Figure 26 Pringle Creek site map showing potential power run as overhead lines along the path shown in red.

Line power may be run to site by extending existing overhead lines from nearby residential use. Figure shows a potential route (in yellow) for extending overhead lines. Pole may be installed and lines run down an existing cleared path that runs along the west boundary of the USFS land. Trees will need to be removed to pass the line power over the stream. Tree removal should be kept the minimum necessary.

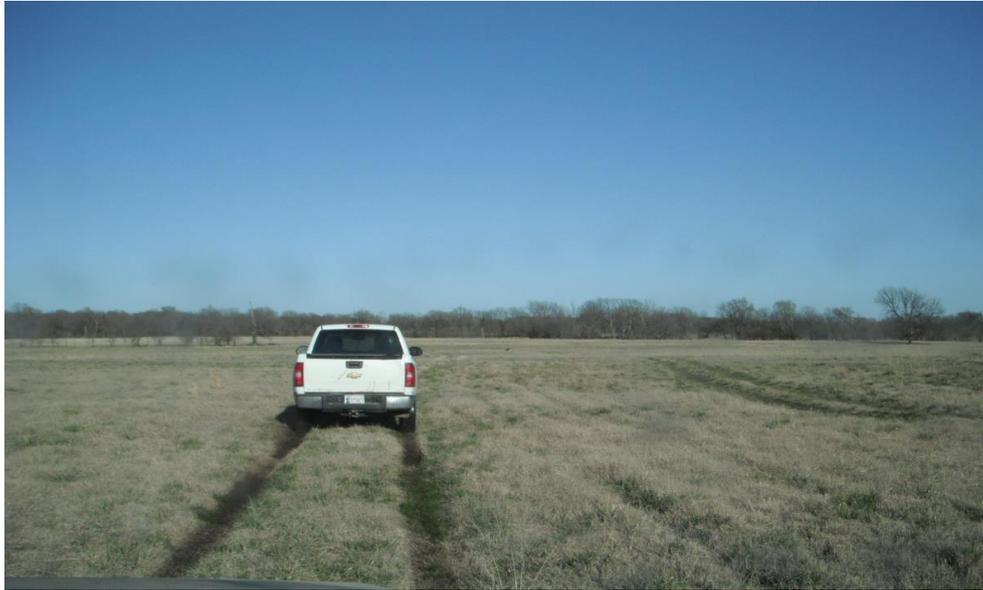
Figure 43 Vehicle access to Domain 11 Blue River.

to the ecosystem. Figure 43, below, shows the current two-track road. Table 18 gives coordinates for the start and end of the two-track and also the nearest power. The route of the proposed improved road should be laid out in coordination with the site host.

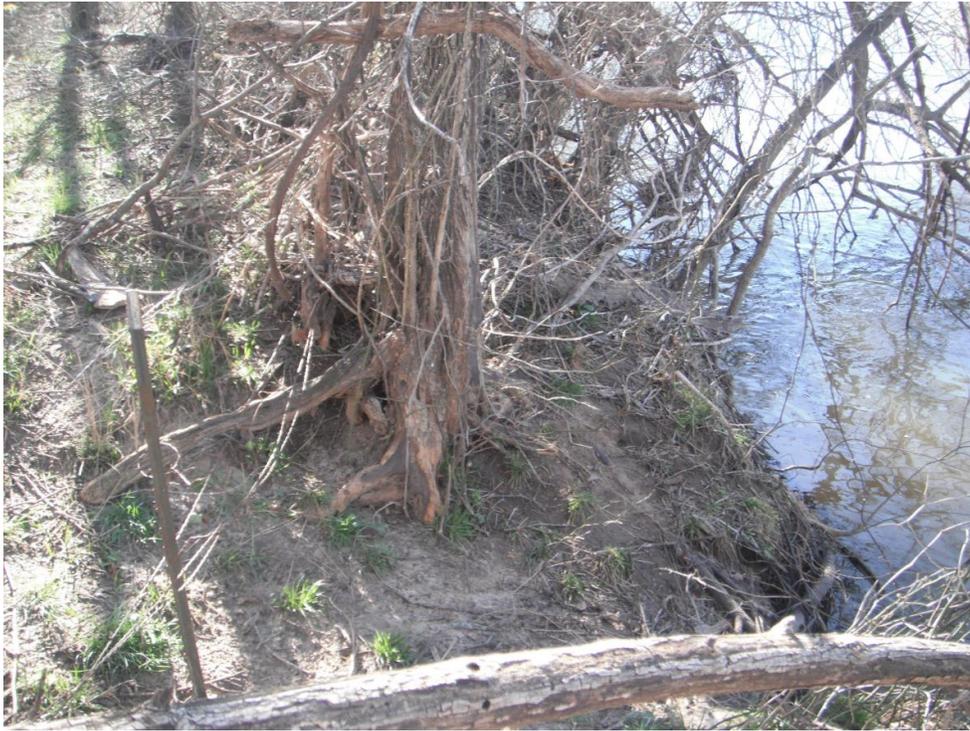
An old fence runs along sections of the eastern bank. It is suggested that portions of this fence be removed to allow access along both side of Blue River. The Nature Conservancy has periodic volunteer workdays and the possibility of requesting the removal of the fence would create a more natural riparian area as well as improved access.

Figure 44 Old fencing running along the right bank of Domain 11 Blue River.

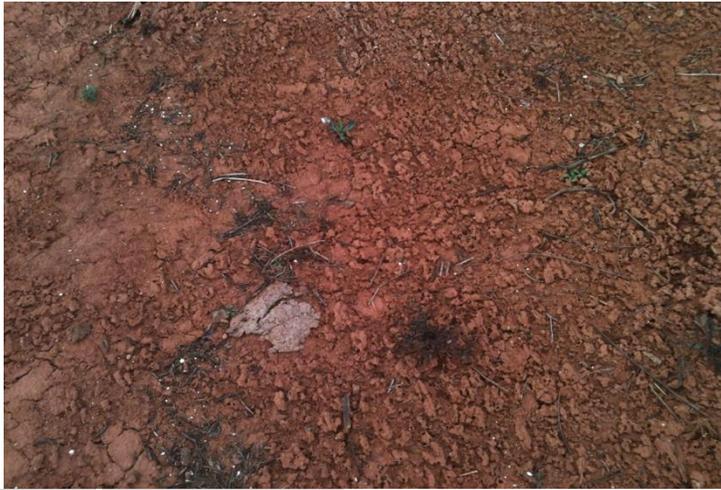
Figure 55 Substrate in Domain 11 South Pond Klemme consists mostly of silty clay sand with a high iron content producing a strong red color. The soils are highly erodible as witnessed by the large number of gullies in the area and with low tensile strength.

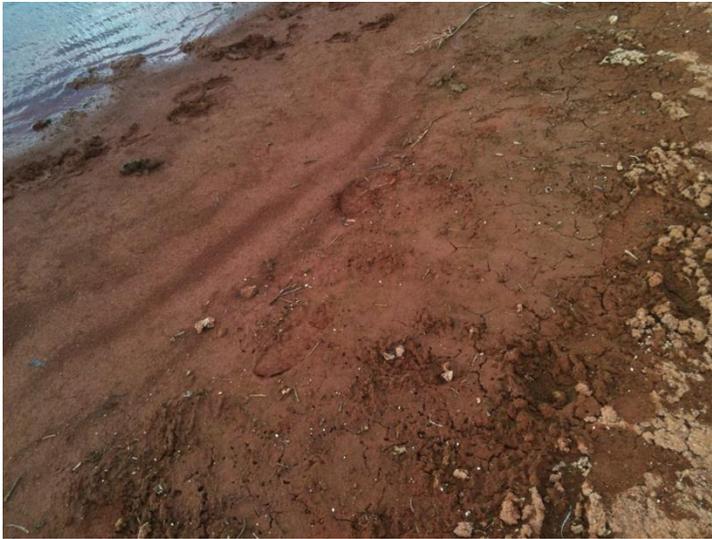
Figure 56 Example of substrate that is usually submerged. This substrate displays high wetting and drying cycles producing surface crusting at Domain 11 South Pond Klemme.
