<i>Title:</i> D07 AIS Site Characterization Report	<i>Author:</i> J. Vance	<i>Date:</i> 05/26/2015
<i>NEON Doc. #:</i> NEON.DOC.001372		<i>Revision:</i> B

D07 AQUATIC INSTRUMENT SYSTEM (AIS) SITE CHARACTERIZATION REPORT

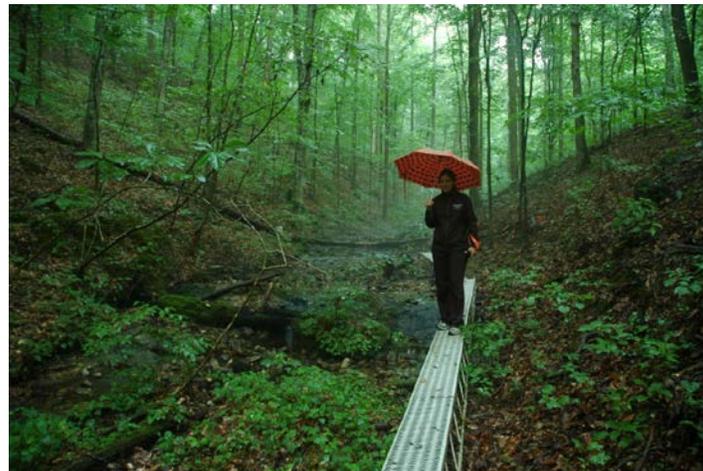
Figure 7 The Riparian Canopy at D07 Walker Branch – AQU is dense hardwood. Kirsten Ruiz is walking on the moveable boardwalk that is currently in the upper West Branch (property of ORNL).

There are existing walkways (e.g. boardwalks) at the site that NEON can use in upper West Walker Branch to facilitate sampling activities. The boardwalks are small and moveable, allowing for shifting of the boardwalk as necessary due to water conditions at the site. Some broken and corroding boardwalks should be removed.

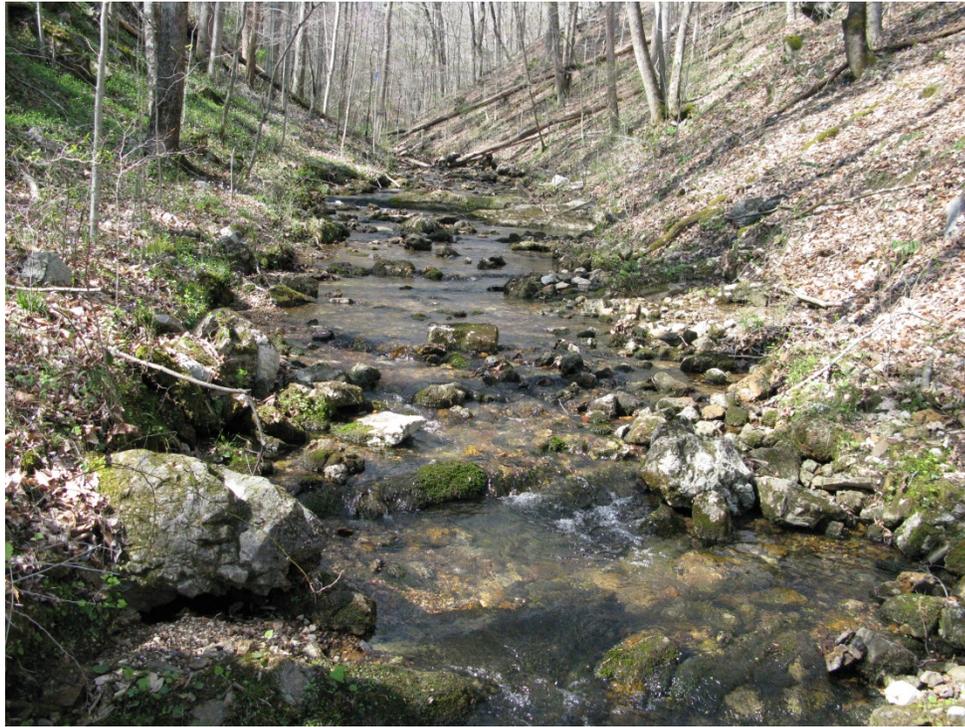
Figure 9 Picture of steep stream banks typical in the AQU and STREON sensor reaches.

Stairs to the sensors sets in both the AQU and STREON reaches will be needed for both safety and to control erosion during maintenance and sampling activities. Stairs shall be added near S1, the nutrient addition station (between S2 and STR S1) and at STR S2. These three locations will allow for safe access across the main Walker Branch reach.

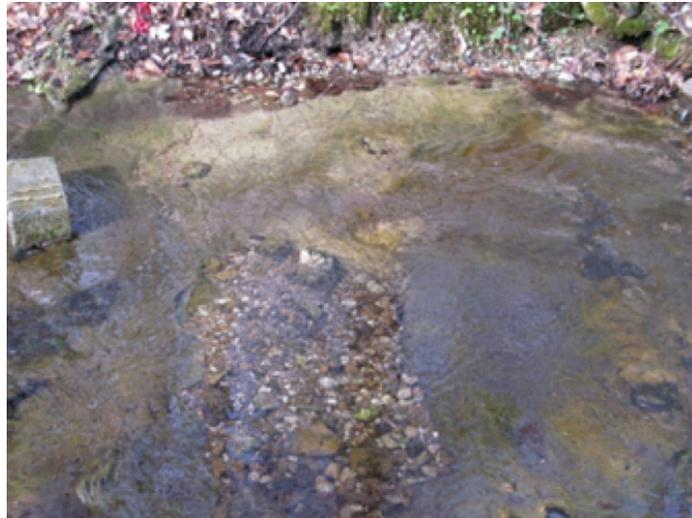
Figure 10 Typical Substrate in D07 Walker Branch – AQU are mostly bedrock and some cobble. Bedrock is the dominant substrate in AQU reach and may make installations tricky

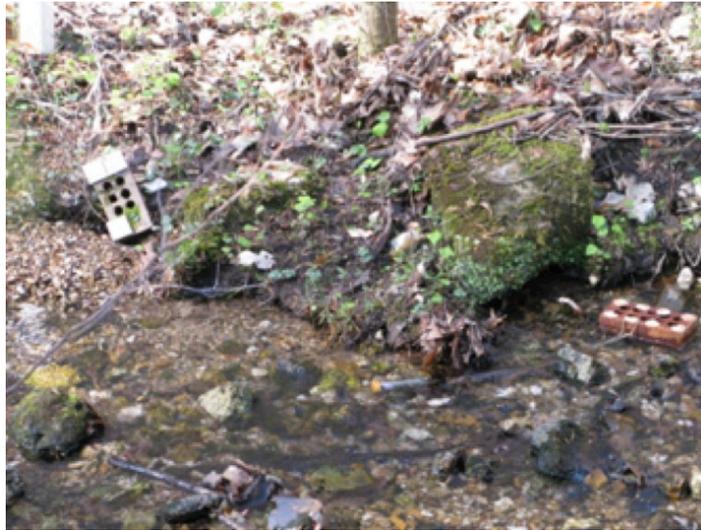
Figure 13 Lots of old research equipment in and around stream.

There is a large amount of “science trash” in upper West Walker Branch that should be removed at the time of deployment. These efforts will need to be coordinate with faculty at ORNL to understand what is no longer in use. There are plastic garbage and laundry tubs that are broken and deteriorating- at some points in the stream. In addition there are metal items which will provide ongoing contamination to our trace metal sampling. For example there is a small 1 x 4’ metal weir at the top of the reach.

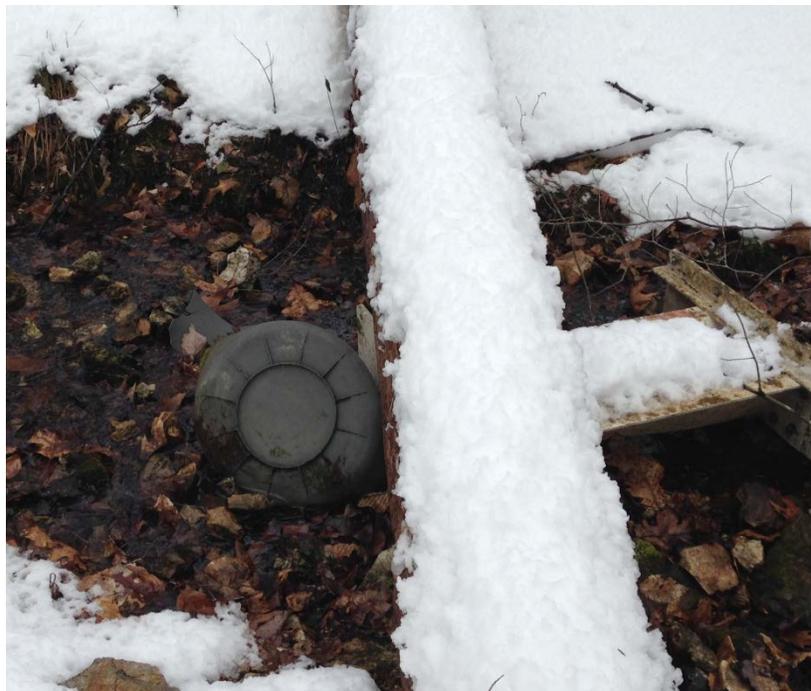
Figure 14 Additional science trash in upper West Walker Branch.

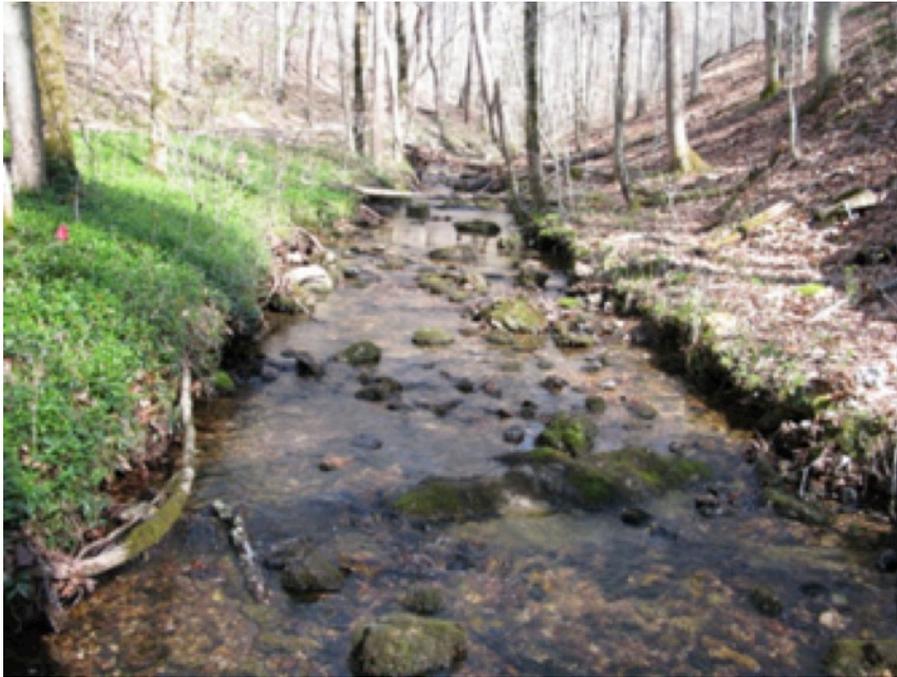
Figure 38 Typical flows, extremely shallow water depth.

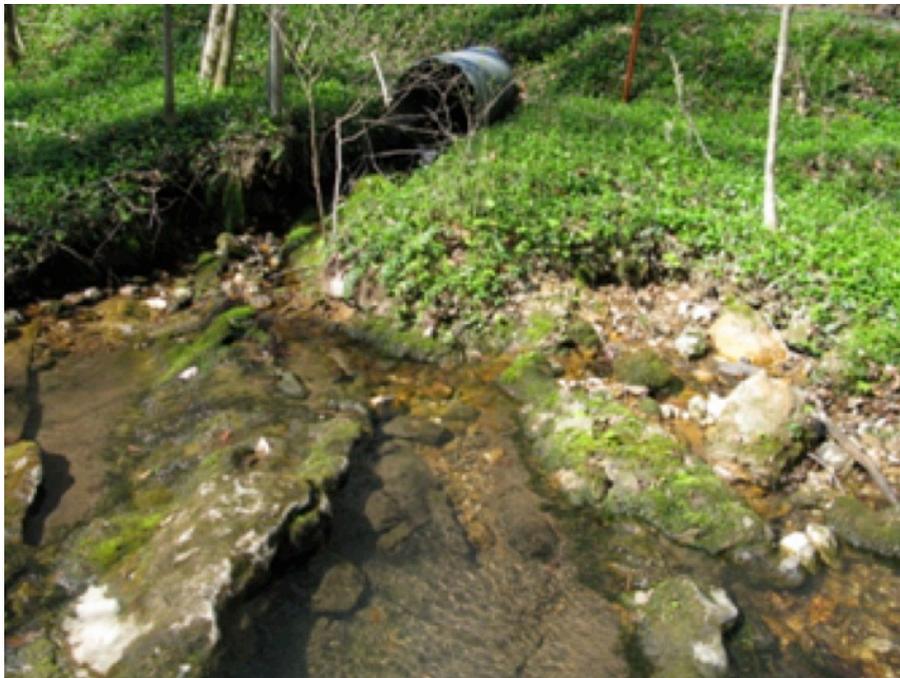
Figure 39 Intermittently flowing culvert between Aquatic and STREON reaches.

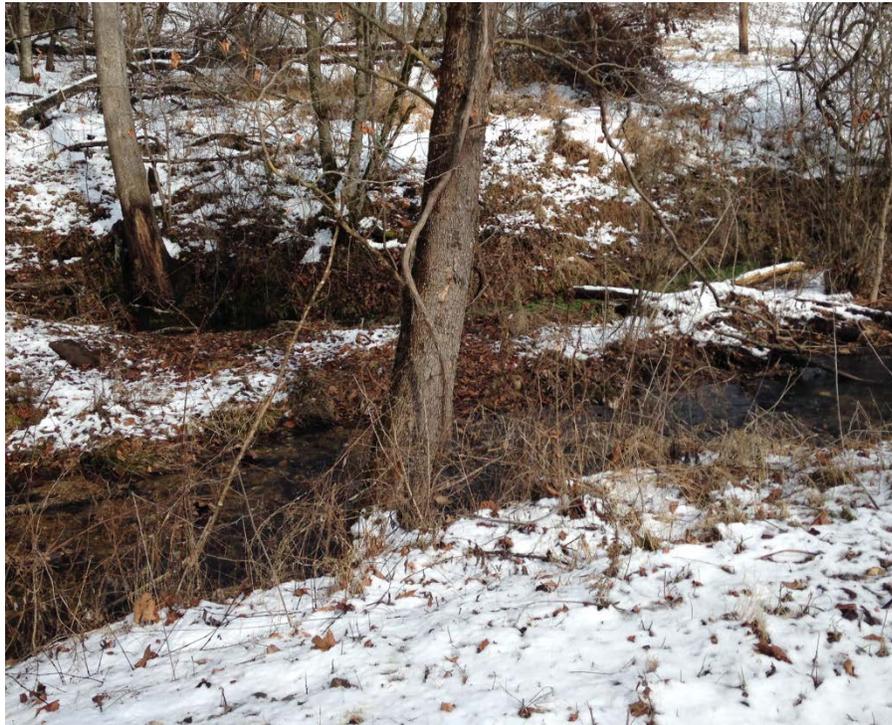
groundwater spring that significantly changes the common hydrology and aquatic vegetation and habitat diversity. No measurements should be made below this spring, shown in Figure 3

Figure 41 Spring feeding into the lower STREON reach has impact on aquatic biology.
