D18 Aquatic Instrument System (AIS) Site Characterization Report

<i>Title:</i> D18 AIS Site Characterization Report	<i>Author:</i> S. Parker	<i>Date:</i> 02/09/2015
<i>NEON Doc. #:</i> NEON.DOC.001671		<i>Revision:</i> A

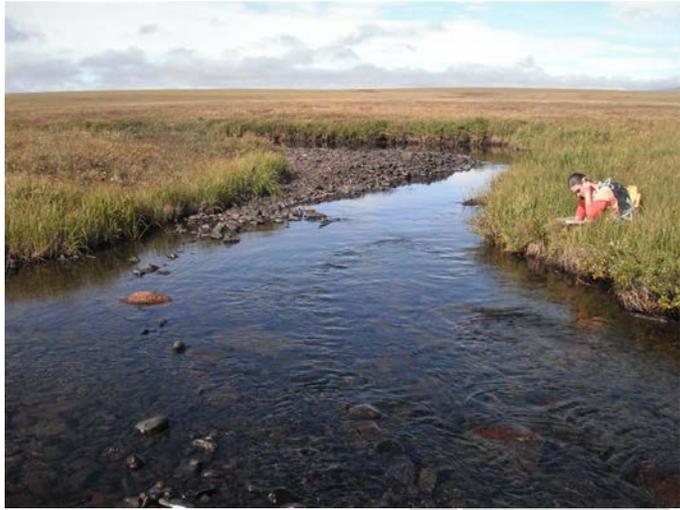
Figure 3. Photo of S1 Location at D18 Oksrukuyik Creek

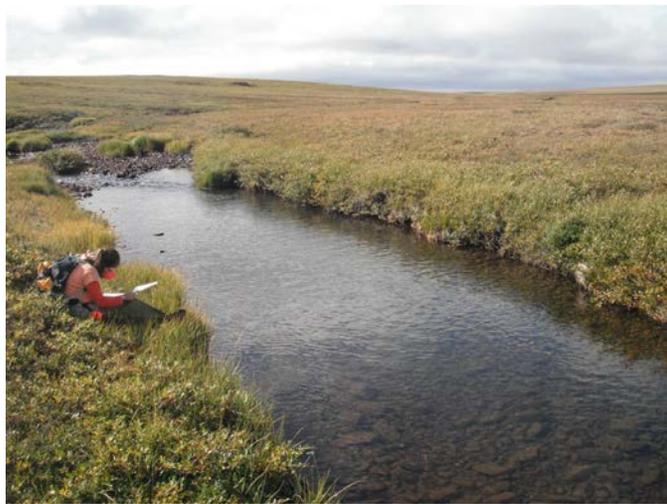
The discharge sensor should be located at S2.

Figure 4. Photo of S2 Location at D18 Oksrukuyik Creek.

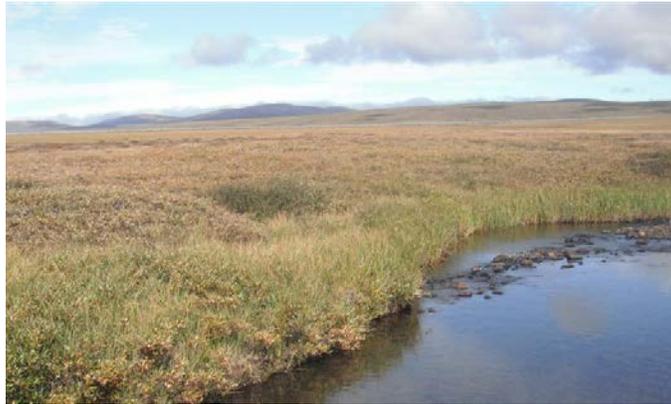
Figure 5. Photo of Met Station Location at D18 Oksrukuyik Creek

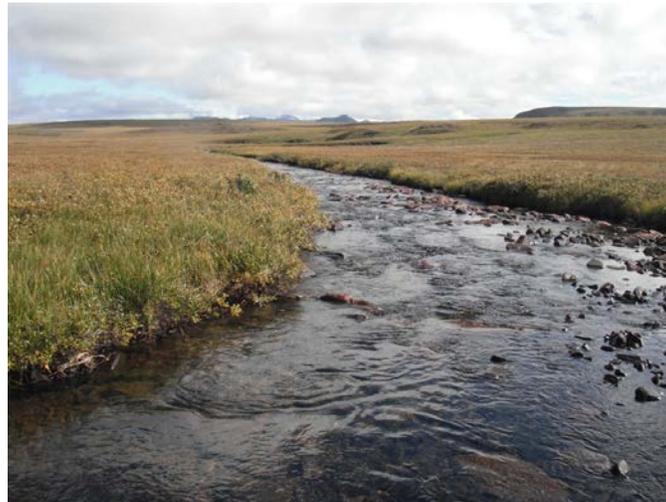
Figure 6. Sensors have been placed in shallow pools or deep runs, however riffles also occur throughout the reach.

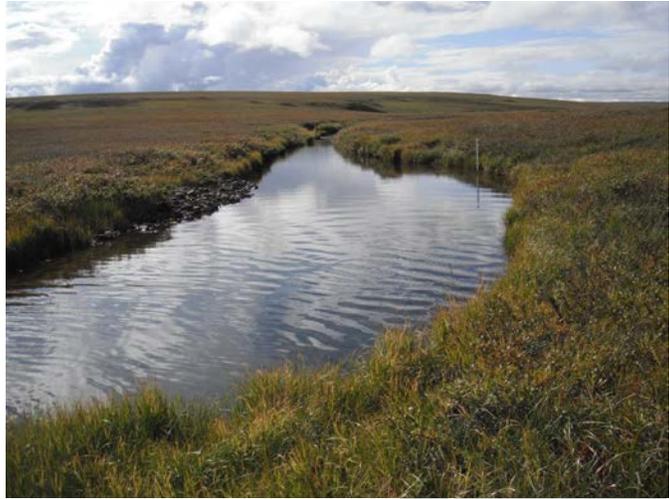
Oks Creek flows through a tundra ecosystem. Riparian vegetation consists of willows, dwarf birch, and some sedges. There is no overhanging vegetation along the AQU reach.

Figure 8. The riparian canopy at D18 Oksrukuyik Creek

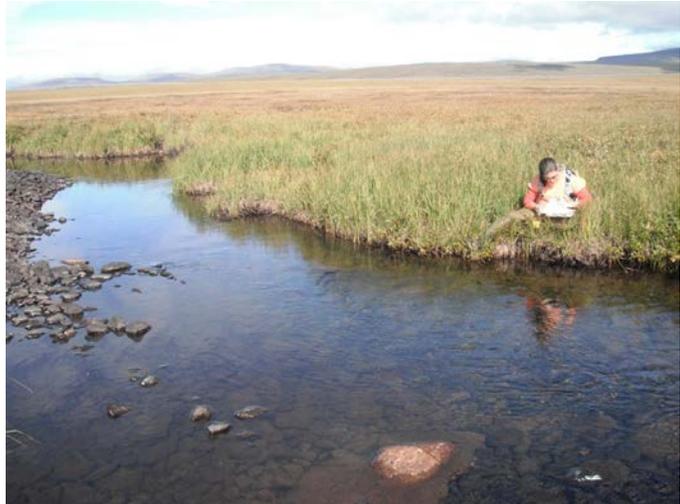
Morphology Type	S1	S2
RB* angle	160°	150°

LB* angle	160°	90°
Maximum water height	0.86 m	1.28 m
Bankfull width	5.8 m	5.9 m
Substrate composition	30% boulder, 70% cobble	15% boulder, 10% pebble, 75% cobble

Figure 10. The left bank at S1 is typical of bank morphology along the reach.

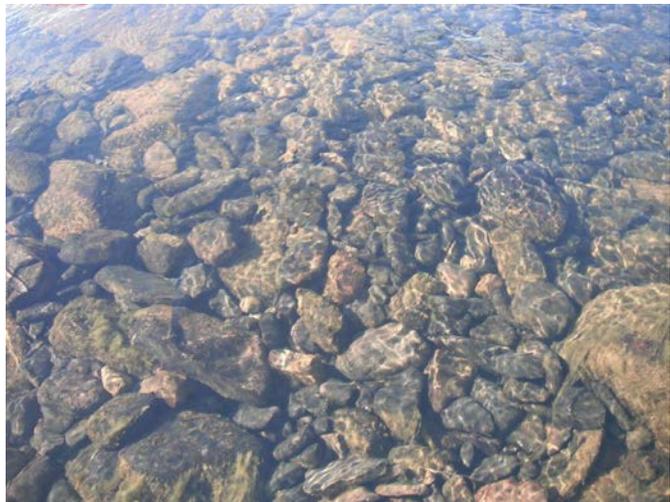
Figure 11. Typical substrate in D18 Oksrukuyik Creek is mostly cobble mixed with boulder.

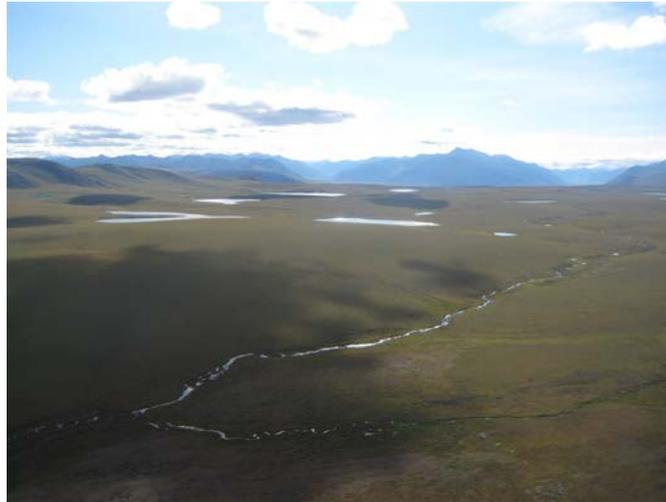
Figure 12. Oks Creek upstream of the AQU reach, looking southeast toward the Brooks Range. Note lakes in the headwaters.

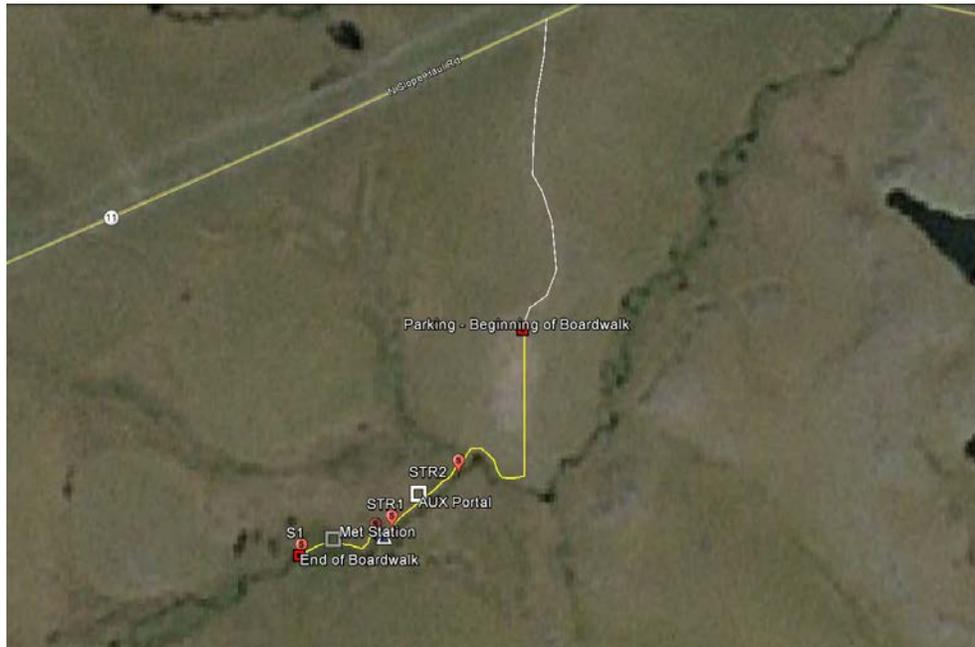
The length of the boardwalk from the parking area to ST S2 and continuing to the upper AQU S1 is approximately 1.2 km and will be constructed over sloping tundra and some boggy ground near the stream bank.

Figure 13. Google Earth image of boardwalk (yellow) starting at the parking area, extending along the northern streambank to S1.

Boardwalks are needed at D18 Oksrukuyik Creek for Science purposes from the parking area at the Material Site to the stream and along the stream bank from AQU S1 (most upstream point) to ST S2 (most downstream point).

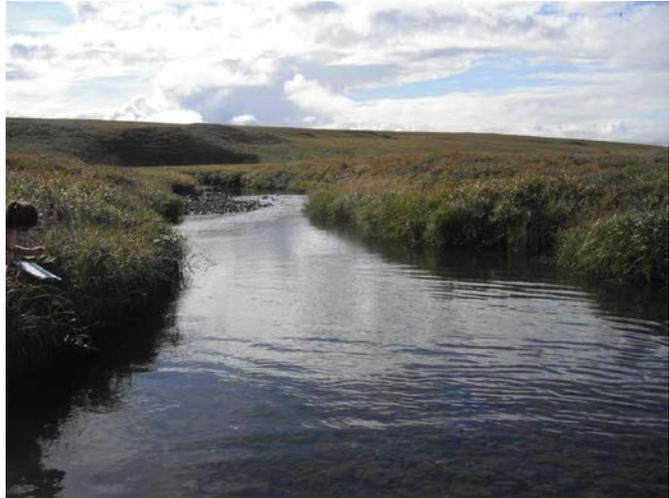
LB* angle	100°	170°
Maximum water height	1.7 m	1.63 m
Bankfull width	7.3 m	10.0 m
Substrate composition	70% cobble, 10% boulder, 20% pebble/gravel	15% boulder, 20% pebble, 65% cobble

Figure 22. Photo (looking upstream) of banks at STREON S2. Banks are similar at STREON S1.

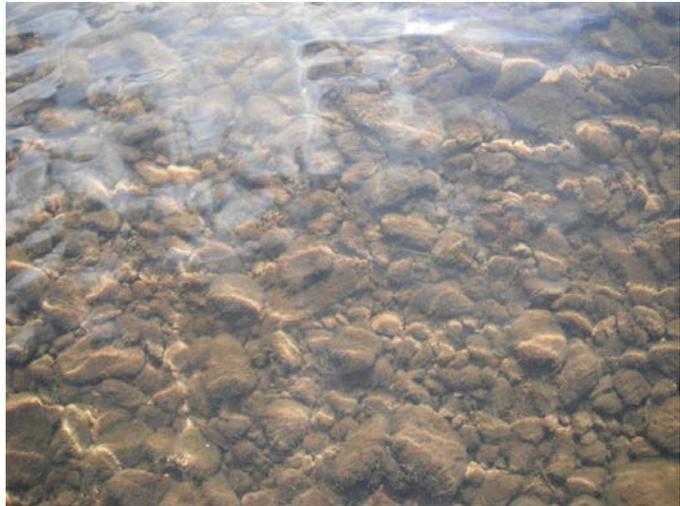
Figure 23. Typical substrate in D18 Oksrukuyik Creek (STREON) (STREON) is mostly composed of cobble and pebble.

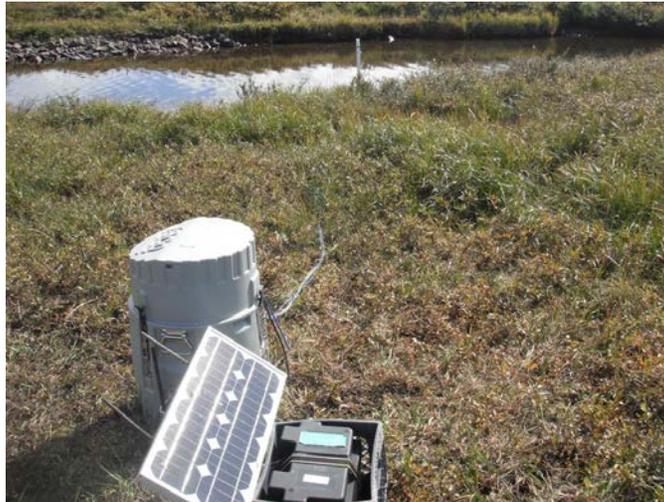
Figure 24. Equipment installed by researchers on the Arctic LTER Streams project near the ST S1 location.

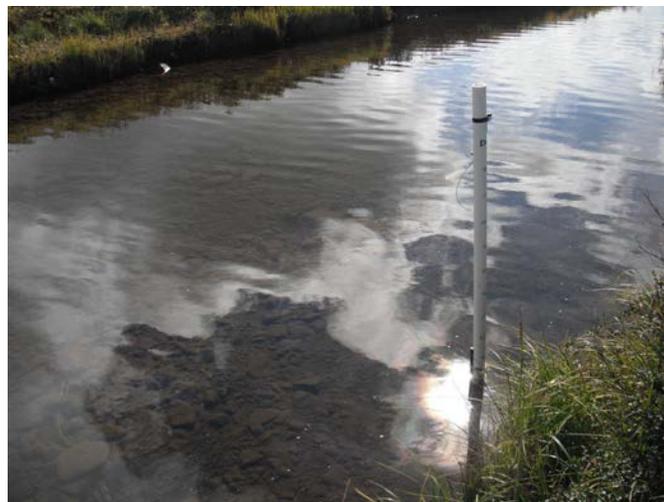
Figure 25. Arctic LTER research equipment, including auto-sampler tubing and a staff gauge in the stream near ST S1.

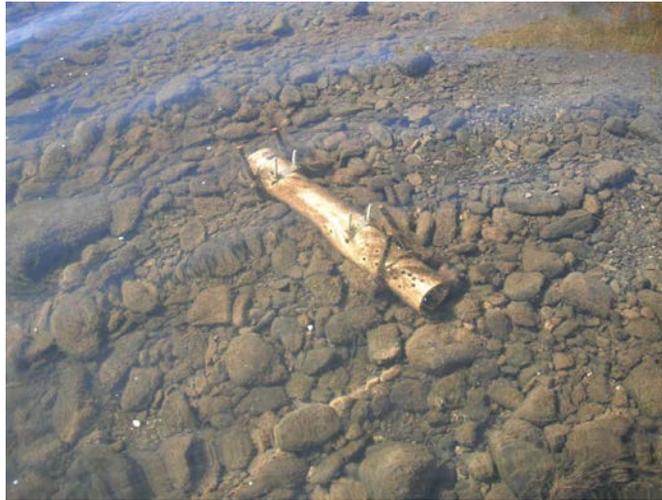
Figure 26. Arctic LTER research equipment containing the electronic fish tracker in the stream bottom at ST S1.

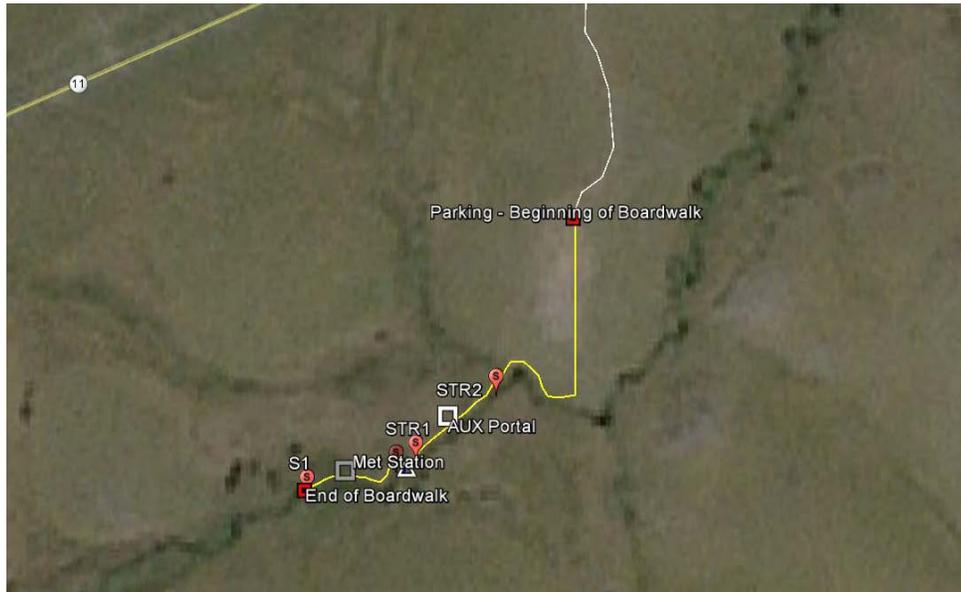
The length of the boardwalk from the parking area to STREON S2 and continuing to the upper AQU S1 is approximately 1.2 km and will be constructed over sloping tundra and some boggy ground near the stream bank.

Figure 28. Image showing pathway for boardwalk (yellow line) needed for access at Oksurkuyik Creek.

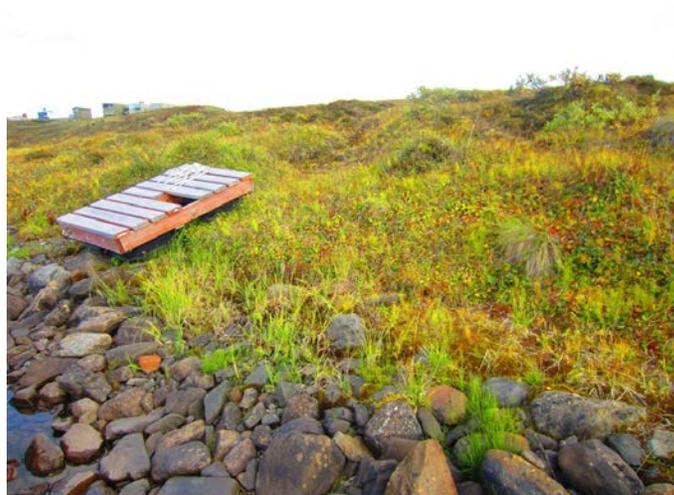
Toolik Lake is located within a tundra ecosystem. Riparian vegetation consists of willows, blueberry, dwarf birch, and some sedges. There is little to no overhanging vegetation around the lake as the shrubs are typically <1 m tall.

Figure 34. The Riparian Canopy at D18 Toolik Lake.

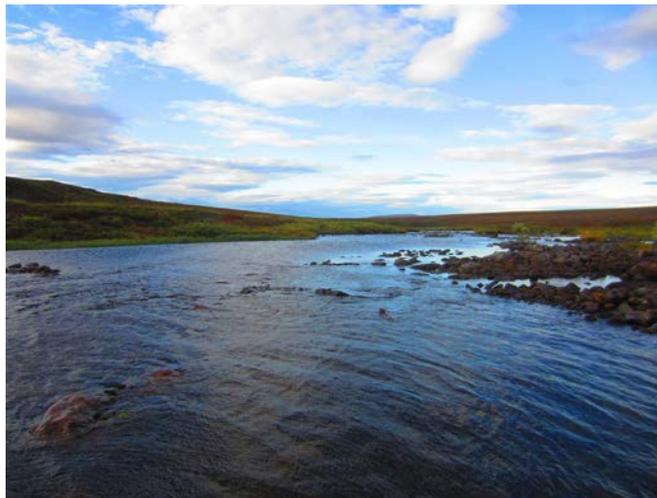
Figure 36. Typical Substrate in D18 Toolik Lake is mostly cobble nearshore, and silt in the deeper areas of the lake. Boulder may be scattered throughout the lake. Bank material is peat and tundra.

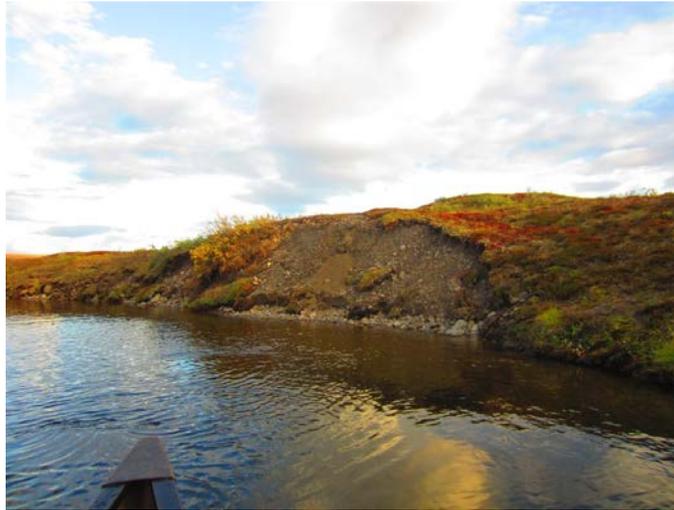
Figure 37. This slump was observed in 2012 on the lake bank on the south side of Toolik Lake.

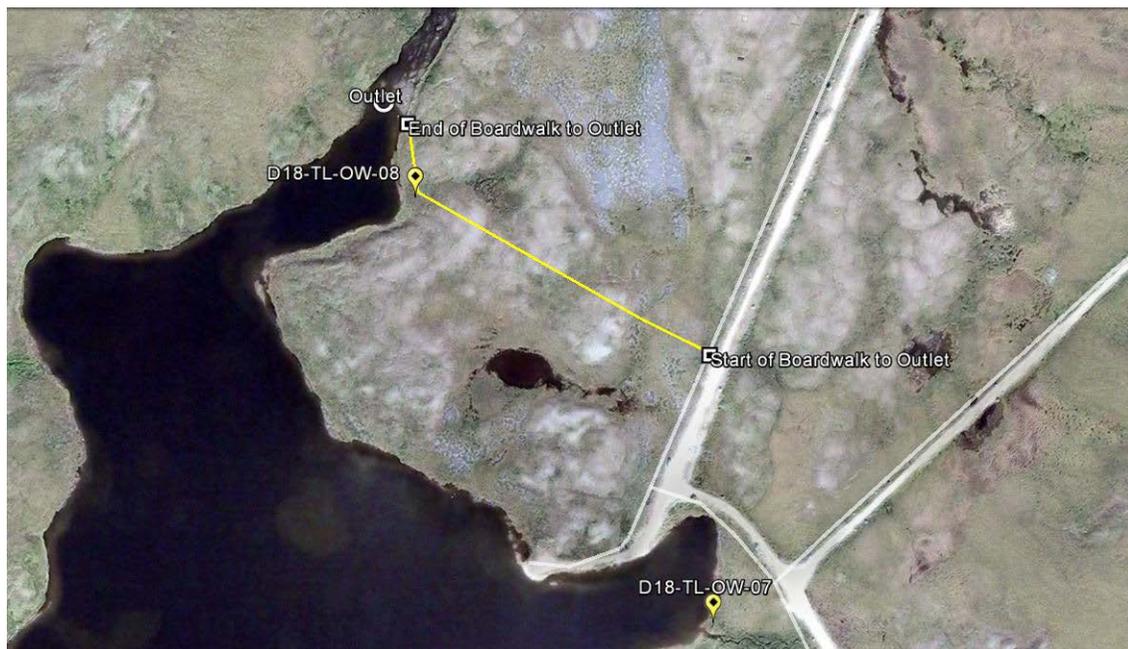
Figure 40. Image of boardwalk path (yellow line) required for access to Outlet; to include access to GWW 08.

A simple above grade boardwalk may need to be installed from the dirt road to the Outlet location at Toolik lake in order to minimize damage to local vegetation.
