| <i>Title:</i> D16 AIS Site Characterization Report | <i>Author:</i> R. Utz | <i>Date:</i> 08/28/2015 |
| <i>NEON Doc. #:</i> NEON.DOC.001856 | | <i>Revision:</i> B |

## D16 AQUATIC INSTRUMENT SYSTEM (AIS) SITE CHARACTERIZATION REPORT

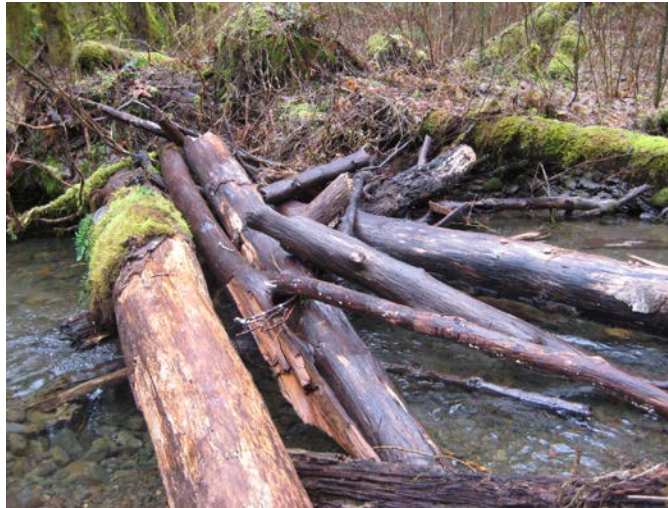
**Figure 11** Fallen trees in Martha Creek occasionally cause large obstructions in the channel and on the stream bank.

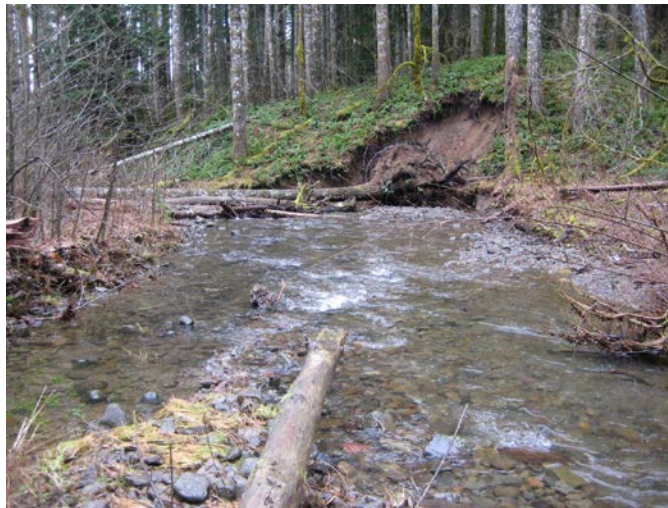
**Figure 12** Occasionally, no riparian floodplain is present where a steep slope abuts against the channel in Martha Creek and shows signs of erosion. Shown here is the right bank between S1 and S2.

An unimproved footpath through native vegetation along Martha Creek will be necessary to provide access to both sensors and locations within the sensor reach. Such a footpath should be located upslope from the active channel to ensure high flows do not inundate the path and prevent damages to riparian vegetation. Because the sensors are spaced approximately 490 m apart, a footpath of this length will be necessary.

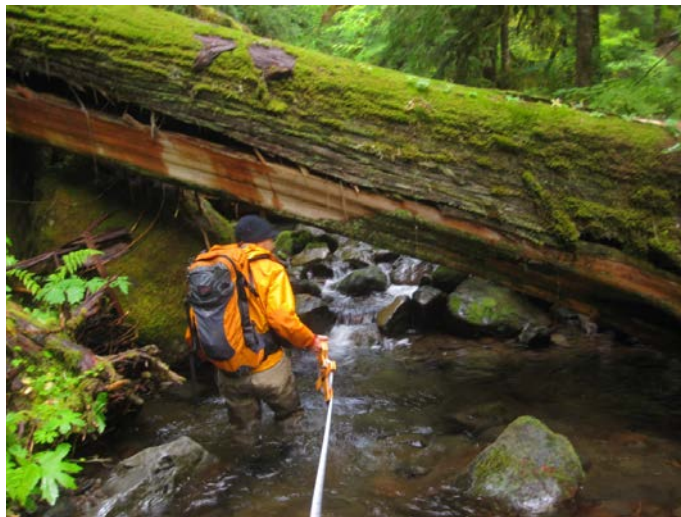
**Figure 23** Large woody debris falls can be quite sizable and capable of restricting access in the stream and along the channel.

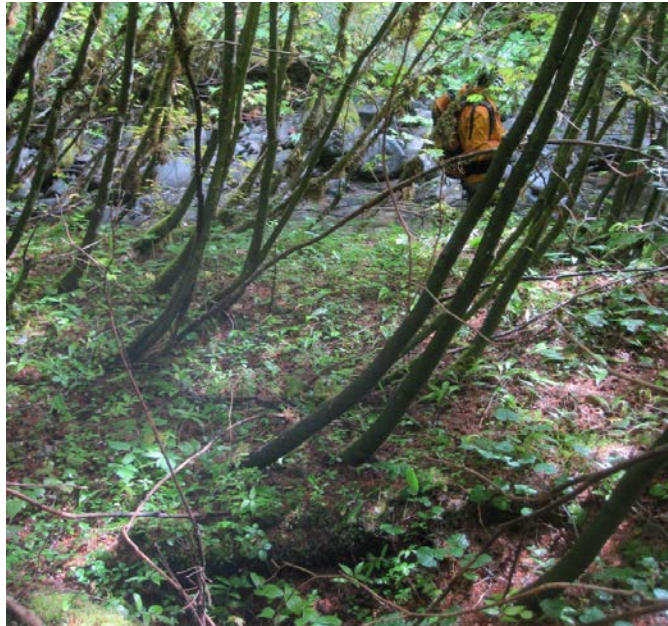
**Figure 24** Thick stands of vine maple and large fallen conifer logs can render mobility along the banks of McRae Creek difficult without a footpath.

- Road 325 provides direct vehicular access to **McRae Creek**. Four-wheel drive will not be necessary to traverse this road except when unplowed snow complicates driving conditions.
- Footpaths will need to be developed, either along the entire sensor reach or through a series of short routes from Road 325 to the sensor locations.

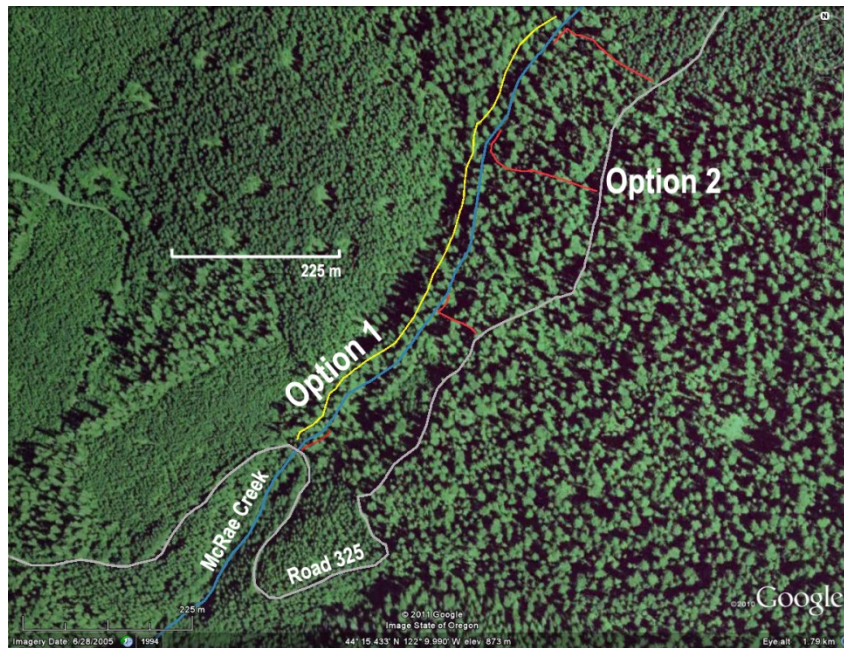
Potentially hazardous high flows in the winter and spring demand an access route that does not involve stream crossings. Two options exist for providing access to McRae Creek (Figure 31):

**Figure 27** Two options exist to provide access at McRae Creek. 1) A path could be constructed along the length of the stream from the intersection with Road 325 (shown in yellow) and 2) a series of short paths could be constructed from Road 325 to the sensor set

- 1) *Option 1*- A footpath could be constructed immediately adjacent to the floodplain from the point where Road 325 crosses McRae to the uppermost sensor location (approximately 670 m upstream). Such a path could be constructed on either side of McRae Creek, but whichever side is chosen will become the bank where all sensors and gears are placed, as high flows will disallow safe stream crossing during winter and spring.
- 2) *Option 2*- A series of footpaths from Road 325 to the sensor locations could be constructed. This option would require four such paths or one to each sensor and sampling location, with the lowermost one originating where the road crosses the stream. Adopting this option would

require all sensors and gear to be placed on the east side of the stream, as high flows will disallow safe stream crossing during winter and spring

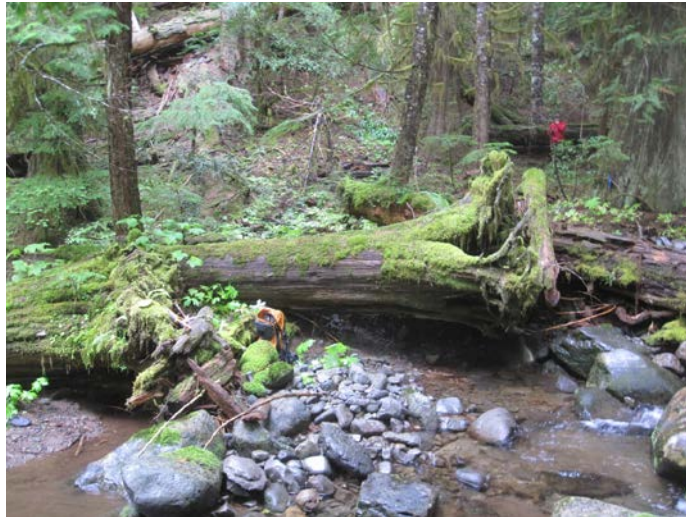
**Figure 38** Very large pieces of woody debris are common along McRae Creek STREON.

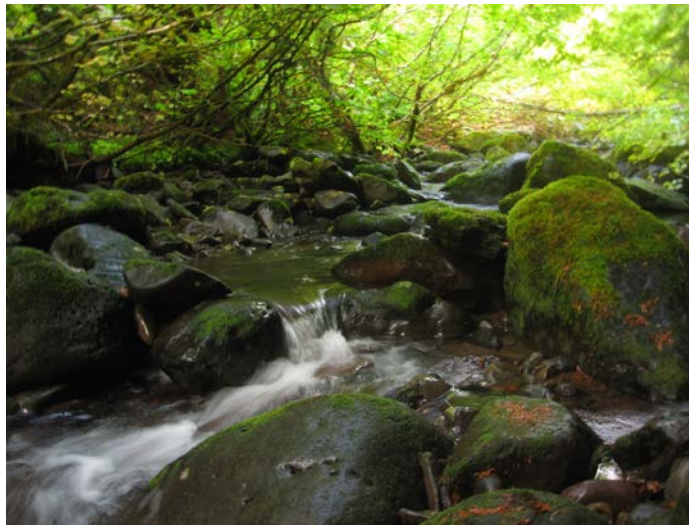
**Figure 39** In some places, riparian ground cover such as vine maple cover the entire width of the wetted channel.

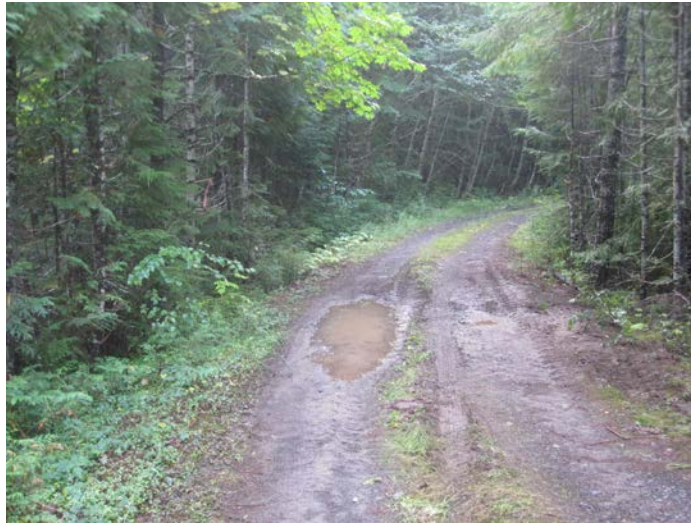
**Figure 40** The access road (325) to McRae Creek STREON is well-maintained enough for 2-wheel drive vehicles, except during hazardous winter conditions.
