Title: Domain 06 AIS Site Characterization Report	Author: C. Bohall, M. Fitzgerald	Date: 02/29/2016
NEON Doc. #: NEON.DOC.001858		Revision: B

Domain 06 Aquatic Instrument System (AIS) Site Characterization Report

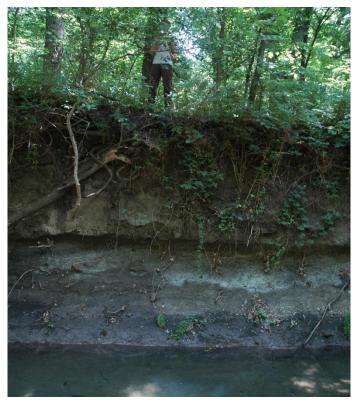
Figure 14 Example of a high, incised embankment in Kings Creek. Shown is the right bank of the S1 sensor station

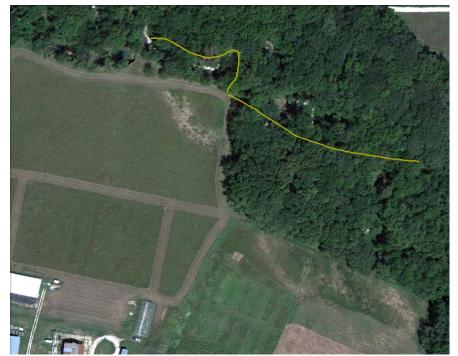
Figure 18 Approximate locations of the footpaths to be constructed to access sensors. Shown are paths to both the AQU and STREON reach sensors

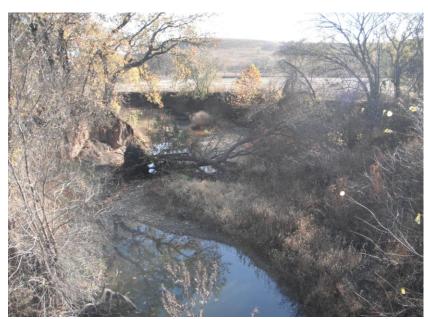
The riparian area adjacent to the McDiffett Creek consists of steep banks lined with a forest buffer and is located within a historically farmed field with regular crop rotation. Grasses, woody shrubs, and larger timber are present in the riparian zone. A mix of small woody species, small herbaceous, and some invasive vetch are present within the channel. Observations were made in November. Growing season updates will be more accurate.

Figure 25 Riparian vegetation, incised banks, and surrounding crop fields at D06 McDiffett Creek

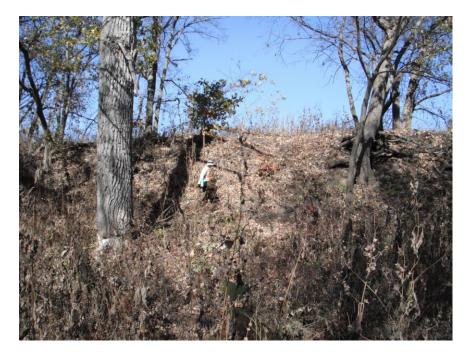
Figure 27 Steep incised banks will require developed access, such as stairs, to prevent erosion

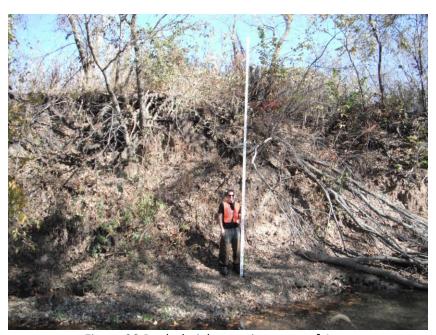
Figure 28 Banks heights are in excess of 4 meters

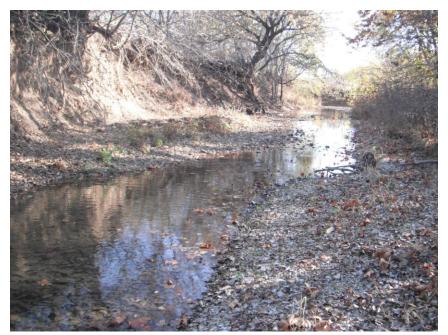
Figure 30 Bank angles are flat and then vertical. The flat portion is around 10 meters

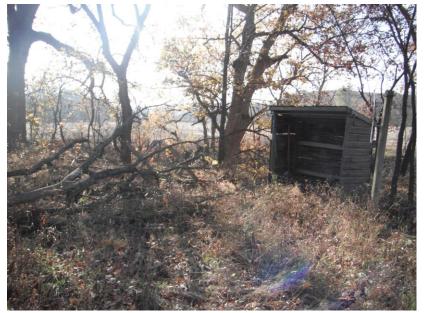
Figure 32 Campsite "improvements" found near the upper end of the aquatic reach.

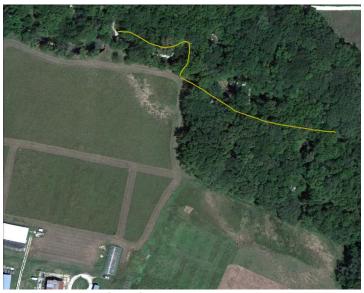
Figure 68 Approximate location of the footpaths to be constructed to access sensors. Shown are paths to both the AQU and STREON reach sensors.

Footpaths through the riparian gallery forest from the parking area or edge of field to the sensor and sampling locations will be required. The approximate location of the footpath is shown in Figure 68 (showing footpaths to both the AQU and STREON reach).
