Title: D05 AIS Site Characterization Report	Author: C. Bohall	Date: 07/20/2016
NEON Doc. #: NEON.DOC.002067		Revision: C

D05 AQUATIC INSTRUMENT SYSTEM (AIS) SITE CHARACTERIZATION REPORT

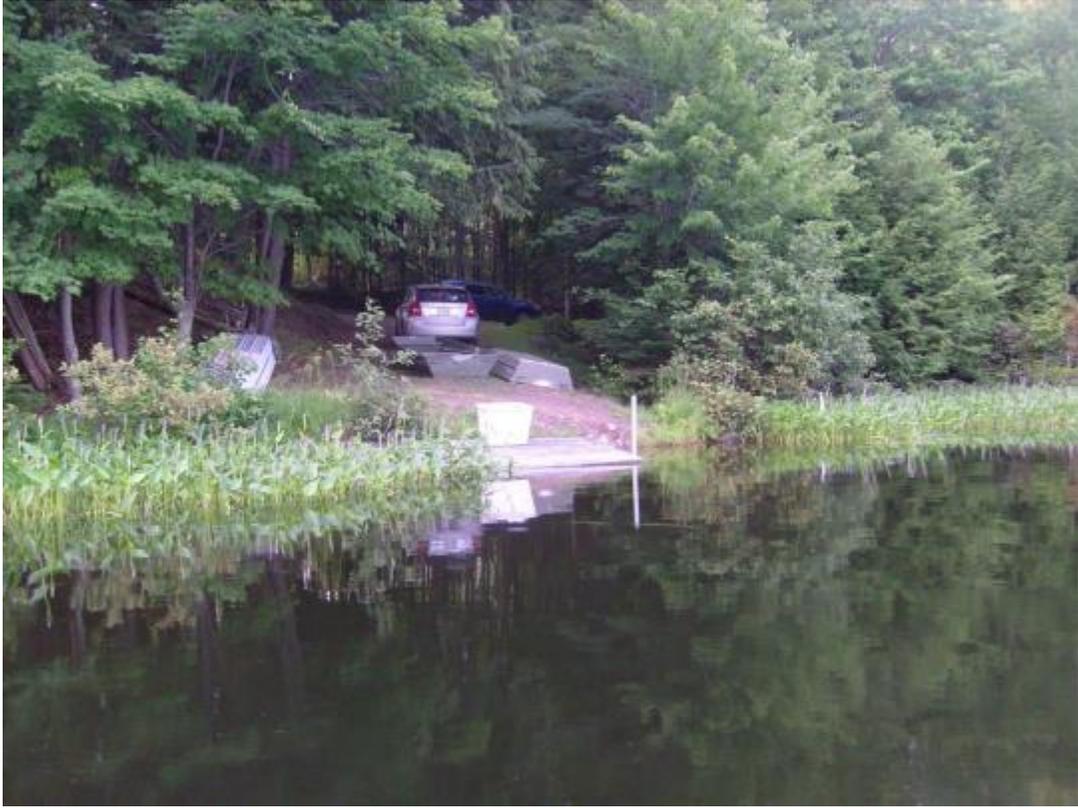
Crampton Lake has a boat launch next to an existing dock which is shown in Figure 3. This dock is currently too narrow to support a trailer wide enough to deploy the buoy. Therefore either the boat launch will need to be widened or a separate deployment strategy will need to be pursued. This responsibility and decision will be made by SI&V with consult from SCI and FOPS.

Figure 3 Photo of lake access at D05 Crampton Lake

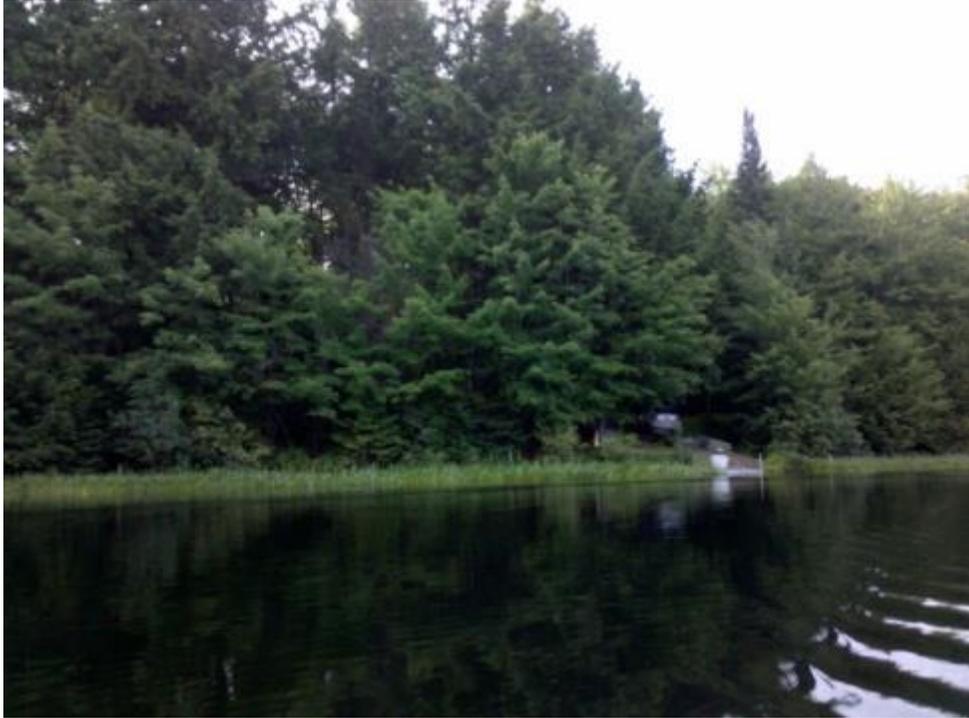
Figure 5 Photo of Bank Angle and Vegetation at D05 Crampton Lake

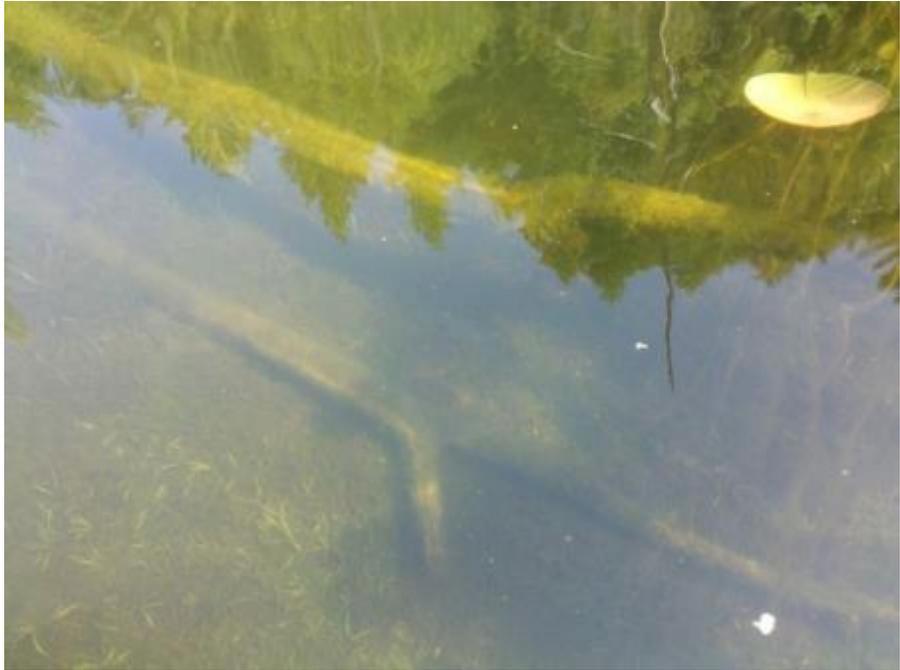
Figure 14 Typical large woody debris in littoral areas in D05 Crampton Lake

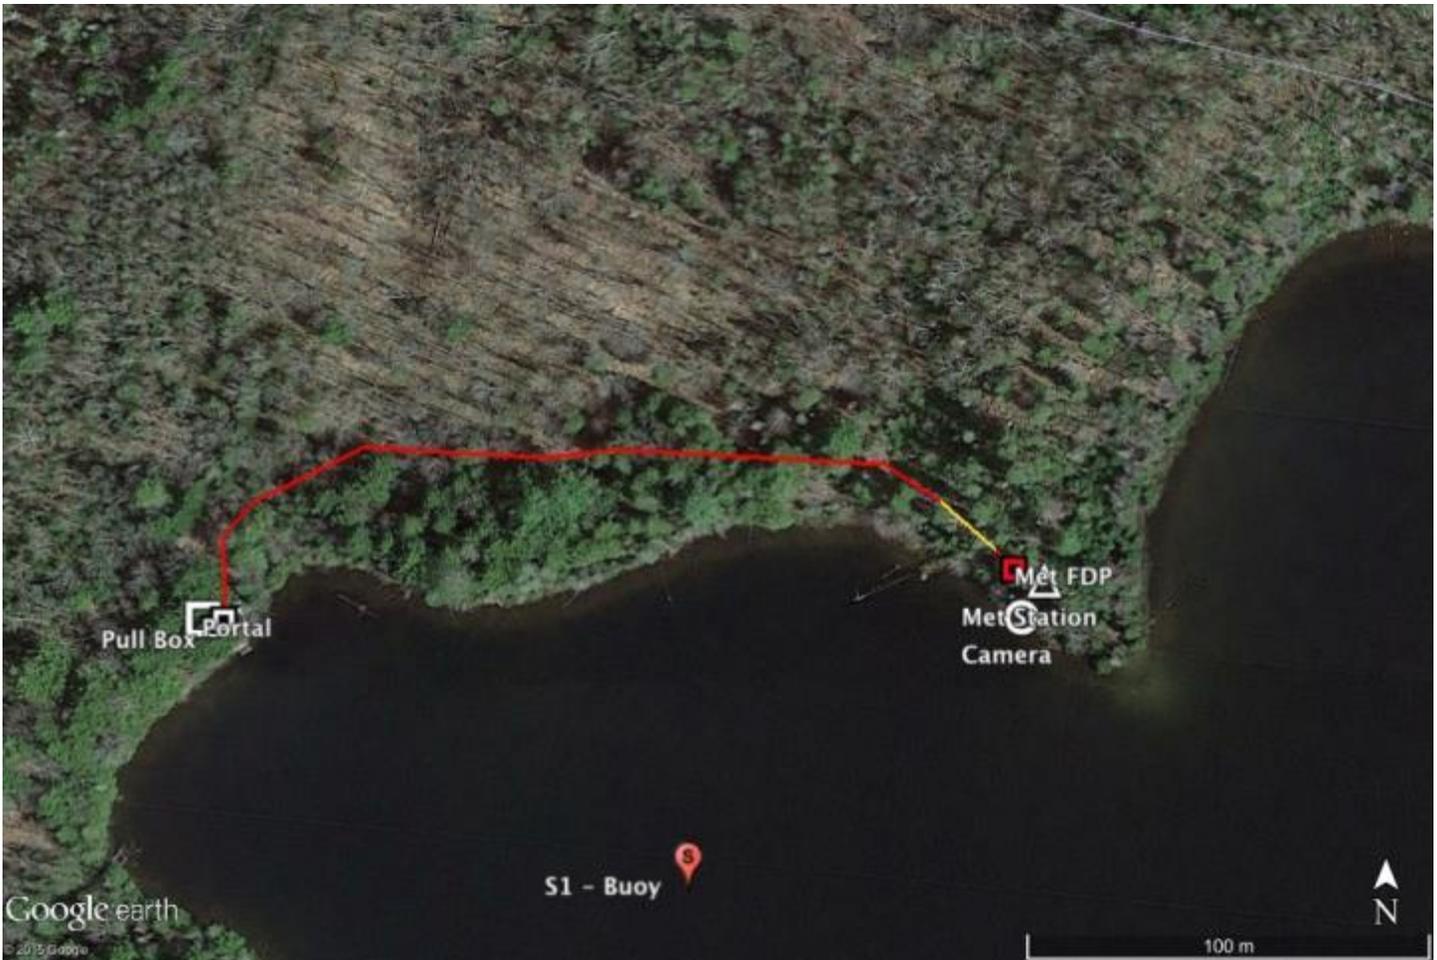
An unimproved access pathway will be needed from the portal to the met station on the northern peninsula. An length of approximately 18m of the trail may require excavation of approximately 1m we the trail path transverses a steep slope approaching the met station location. This area is illustrated in yellow on the map in Figure 15.

Figure 15 Map of Access Pathway needed from boat launch and portal area to met station and camera. The portion of the trail in yellow may require excavation to address safety concerns due to the ground slope.

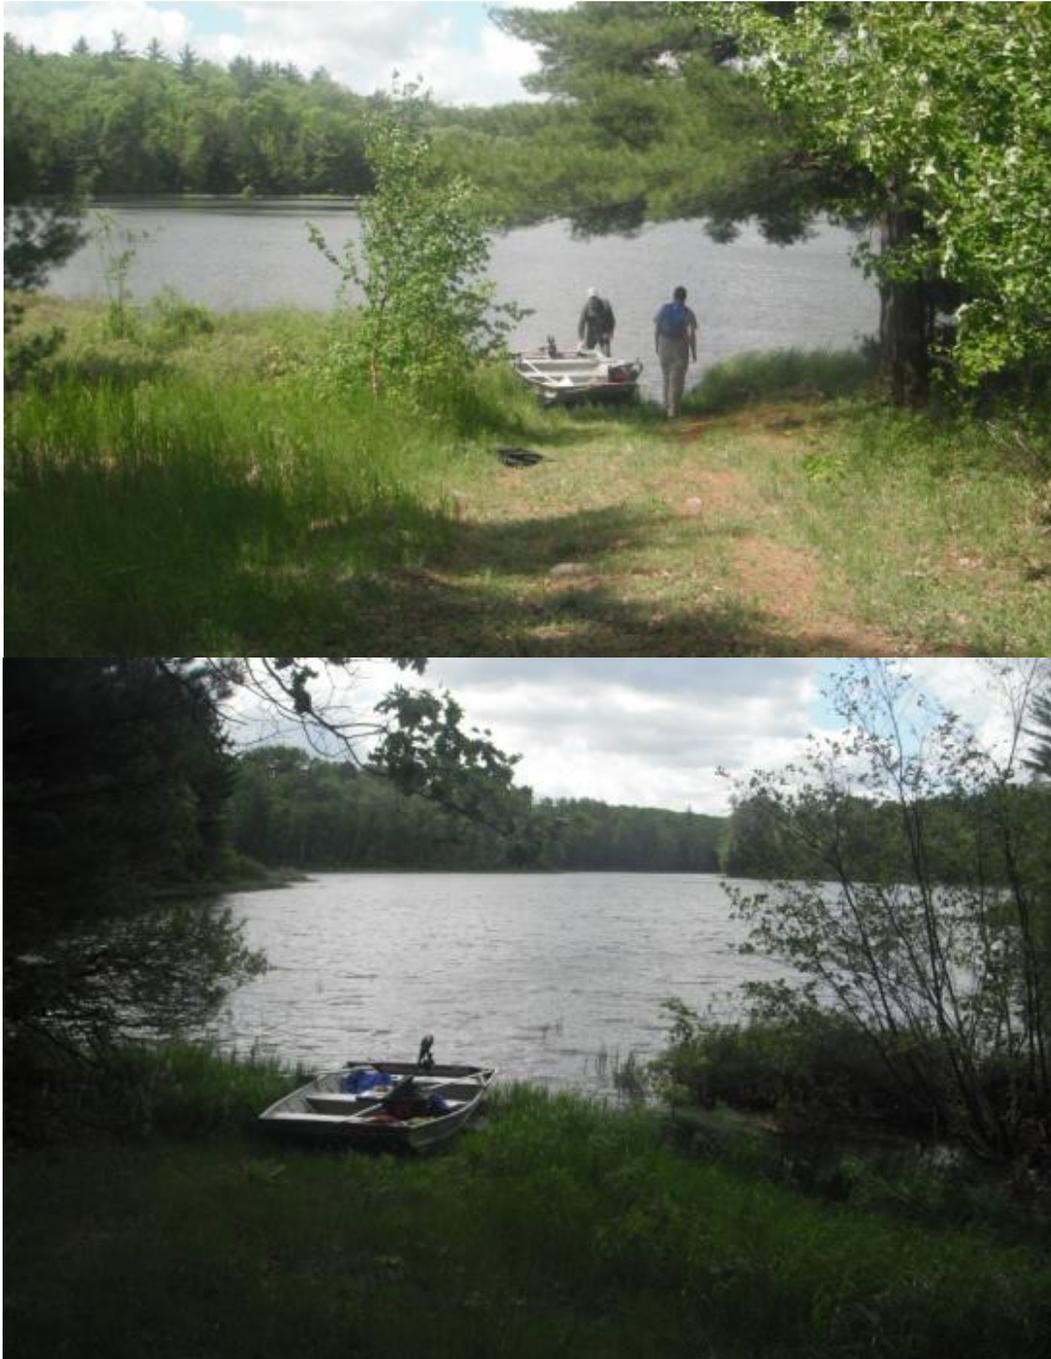
Little Rock Lake has two boat launches. One of the boat launches is on the Eastern basin of the lake, with good vehicle, boat, and trailer access. The other is on the Northern point of the lake, accessible via ATV trail. The access on the Northern point is recommended for NEON infrastructure and regular maintenance access. The Eastern basin access is proposed for requested access for the installation and seasonal removal of the buoy, as trailer access is possible without ramp improvement. Some minor improvements (removal of down trees from trail and met station clearance) may be needed on the Northern point access.

Figure 19 Photos of lake access at D05 Little Rock Lake. Top: Eastern Basin boat access. Bottom: Northern point boat access.

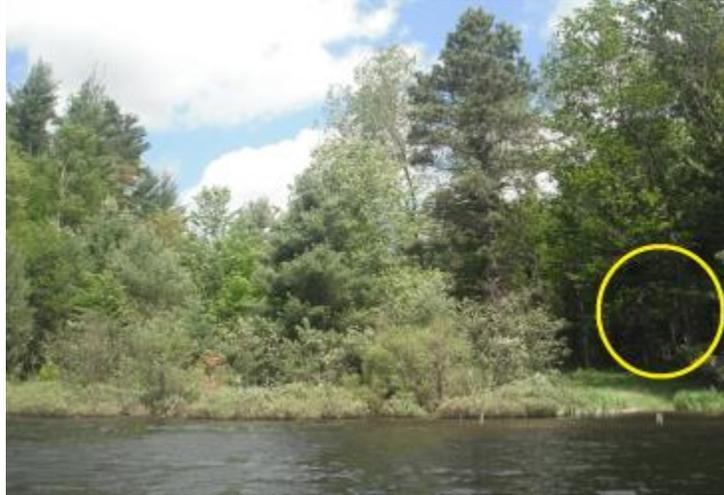
Figure 24 Proposed access at Northern point. NEON is requesting some understory vegetation be removed for clearance for Aquatic Meteorological station, designated with the yellow circle.

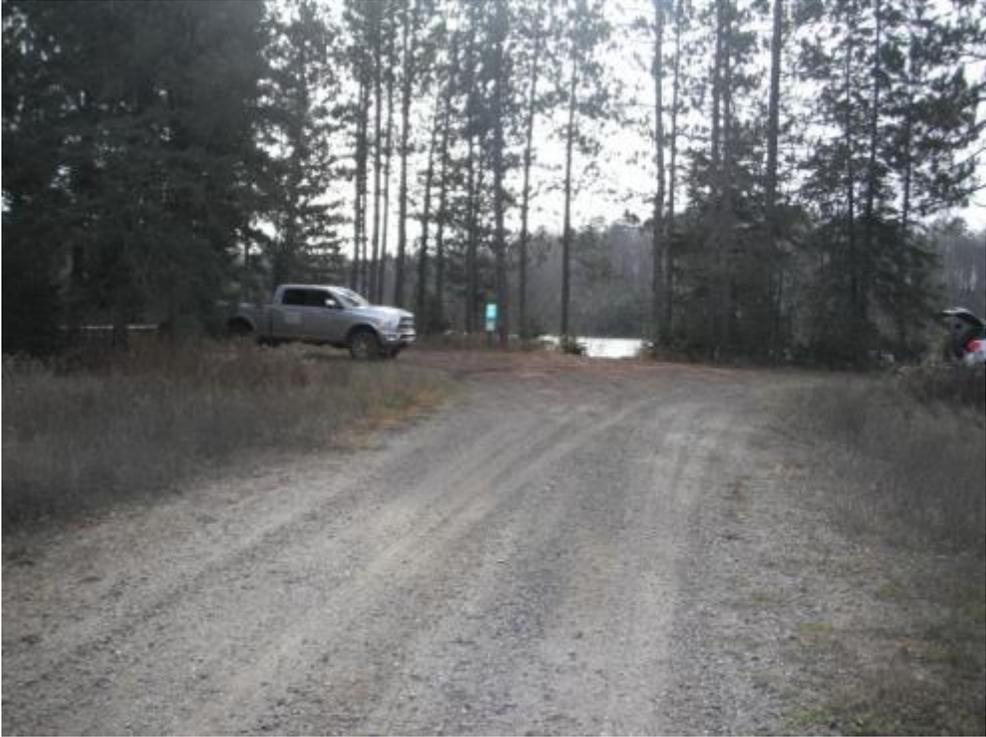
Round Lake has a public boat launch and access which are shown in Figure 18. This access is sufficient for the buoy and trailer.

Figure 18 Photo of lake access at **D05 Round Lake**
