Title: D10 AIS Site Characterization Report		Date: 02/04/2016
NEON Doc. #: NEON.DOC.02056	Author: J. Vance	Revision: B

D10 SITE CHARACTERIZATION REPORT

3 D10 AIS SITE CHARACTERIZATION REPORT

3.1 Arikaree River

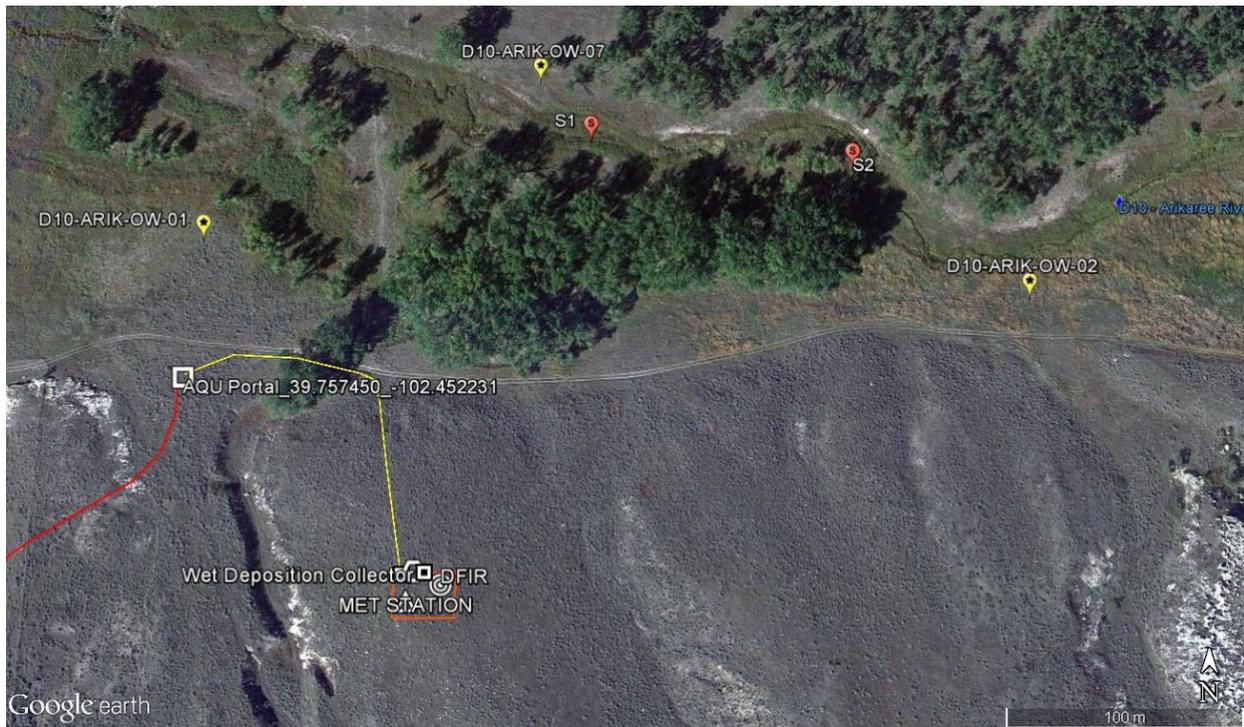
AQU, with support from EHS, has defined GPS coordinates for S1, S2, and micromet station locations (Table 3 and 4, Figure 2). The micromet station is located in the same area as S1.

Figure 2 Kmz File of D10 Arikaree River Denoting Locations of S1, S2, Micromet Station, Primary Precipitation (DIFR) and Wet Deposition Collector (NADP).

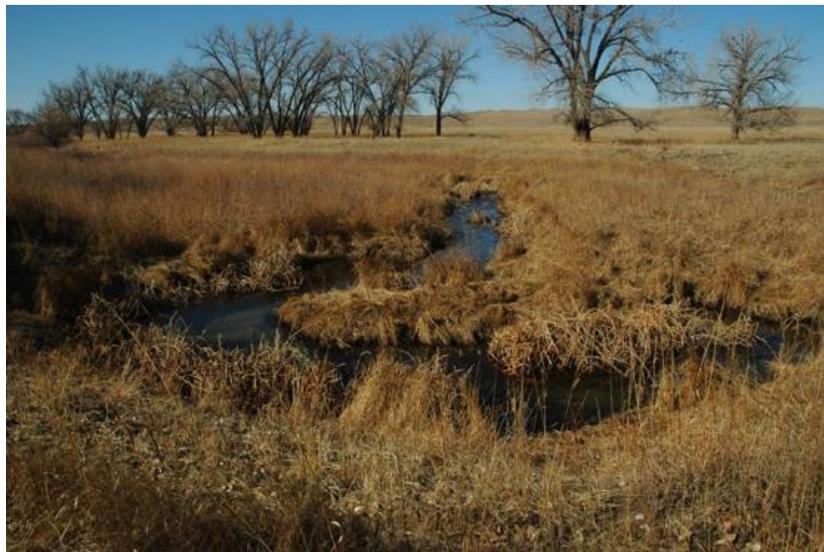
S1 and S2 locations are confined by beaver dams on Arikaree River. The general location of S1 and S2 are shown in Figures 3 and 4. Once reeration work is complete and actual distance between sensors is known, both sensor sets may move closer together and further away from ponds.

Figure 3 The General Location of S1 at D10 Arikaree River

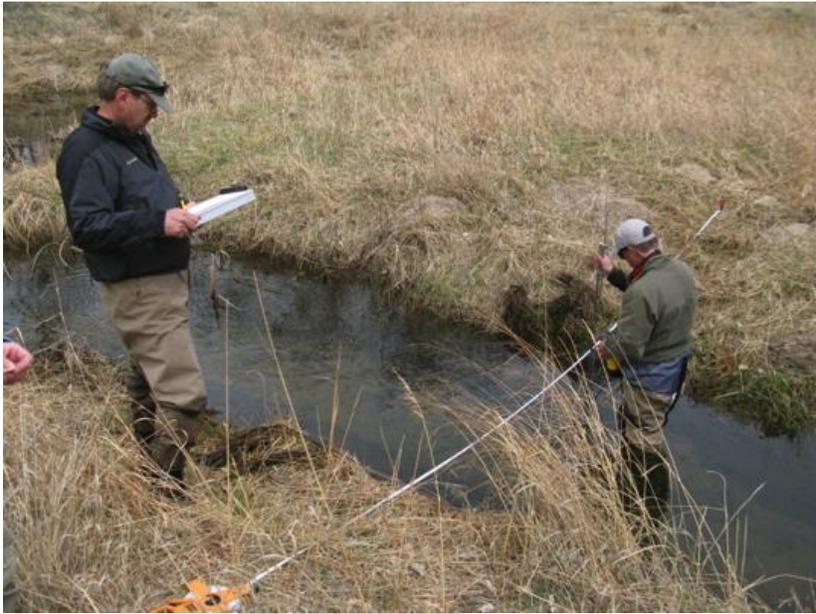
Figure 4 Photo of S2 Location at D10 Arikaree River. Here, the 2011 AQU field contractors are measuring stream discharge.

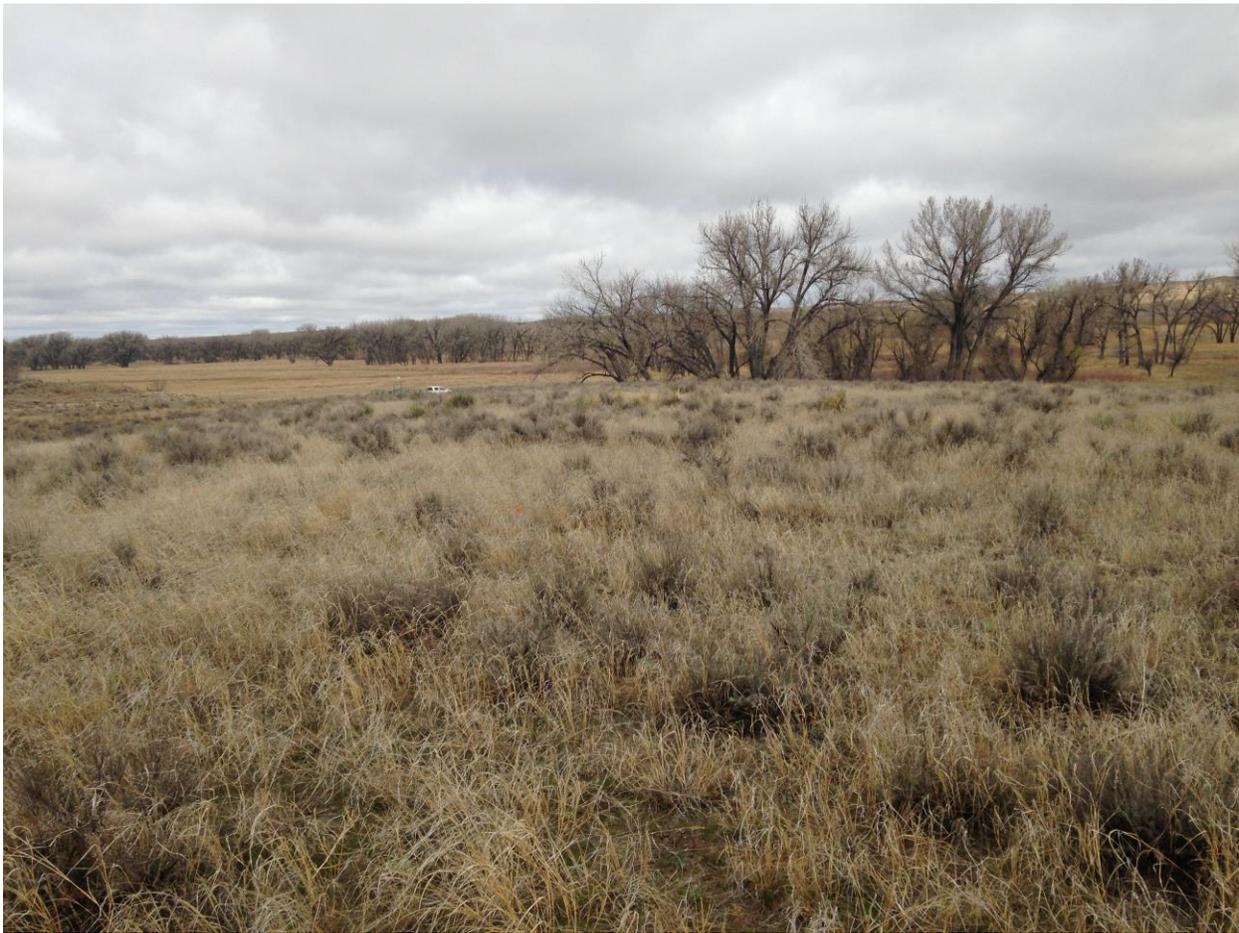
Figure 5. Photo of the met station, DFIR, and wet deposition collector location from the view of the met station looking northwest.

The DFIR and wet deposition collector locations were chosen in accordance with NEON and NOAA requirements for primary precipitation measurements and the National Atmospheric Deposition Program (NADP) requirements for precipitation sampling. Field-based sensors will need to be fenced to protect sensors, infrastructure and grazing livestock. Figure 6 shows the meteorological and precipitation sensors, their associated field device posts and the cattle fence consistent with NEON requirements. Fencing materials will be specified by The Nature Conservancy in agreement with the land manager. A gate will be needed to access the sensors.

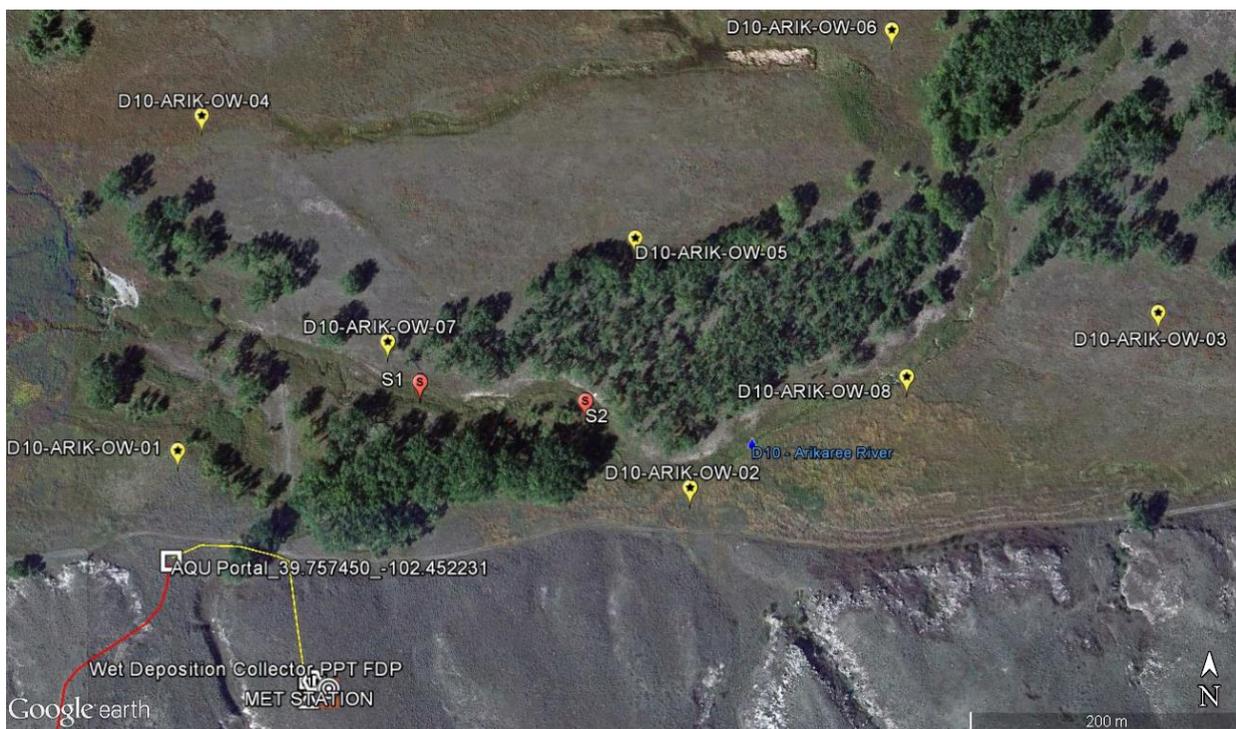
The site will be instrumented with 6 groundwater monitoring wells and it is desired to install an additional 2 piezometers near the stream. The selected location of groundwater wells and piezometers are shown in Figure 5 and associated GPS coordinates are in Table 5. Construction of the wells will utilize prefabricated sections of solid and factory slotted 2-inch-diameter schedule-80 PVC. The maximum anticipated drilling depth for the monitoring wells is 40 feet below ground surface. This assumes a depth to water of 15 feet, top of screen 10 feet below water, a 5-foot-long screen, and a 5-foot-long sump. Surface finishing of the wells will utilize square steel pipe that will surround and protect the above ground portion of the PVC casing. Setting the steel casing in a concrete pad approximately 2-feet by 2-feet in area is desired for longevity of the monitoring well. Drilling of the monitoring wells will be by one of two methods.

Figure 7 Map of groundwater well locations at **D10** Arikaree River

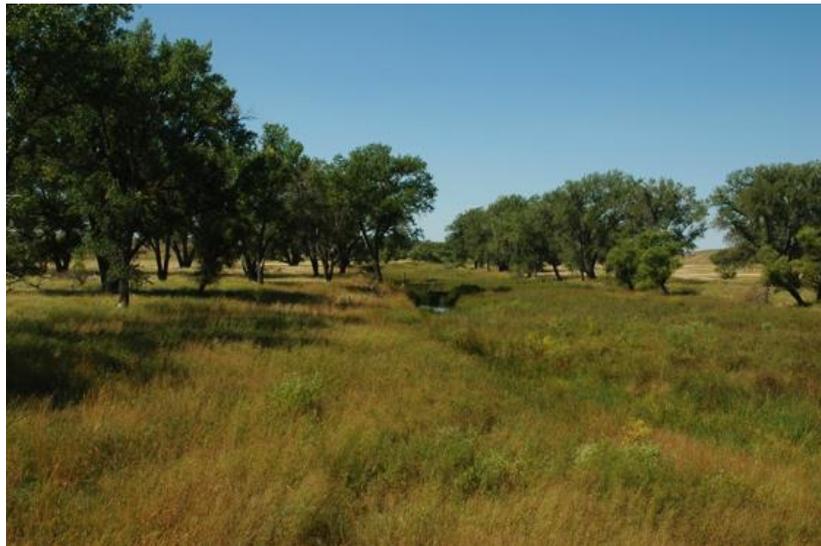
- Grass – 95% cover near the stream and in the surrounding area.
- Cottonwood trees – 30% cover in the surrounding area. There are a few trees at the stream edge, but they are mostly 5-10 feet back from the stream bank.
- Willow – 10% cover at the stream bank and surrounding areas; dense stand of willow upstream of S1.

Figure 8 The Riparian Canopy at D10 Arikaree River

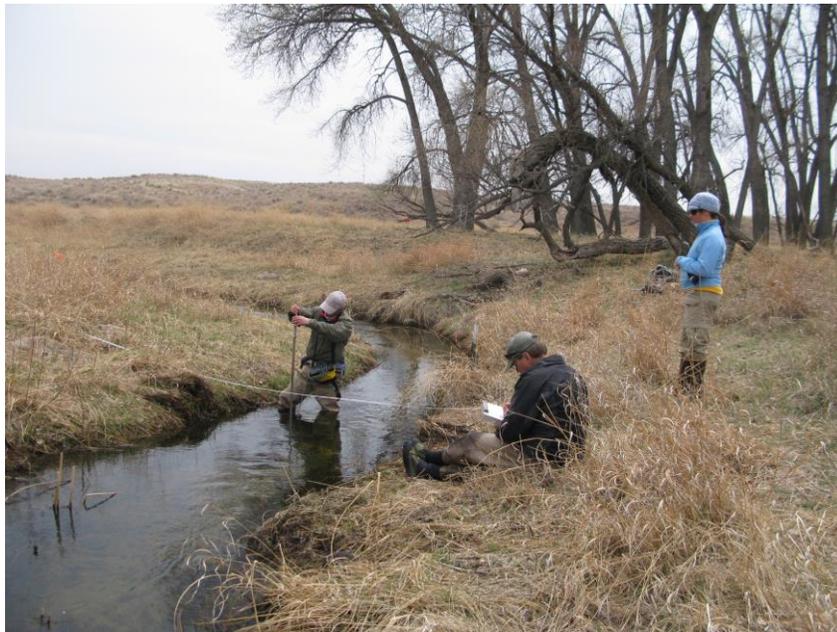
RB* angle	150°	140°
LB* angle	150°	130°
Maximum water height	~0.4 m	0.5 m
Bankfull width	~2.9 m	2.1 m
Substrate composition	Sand	Sand

Figure 10 Bank view of S2 during high flows.

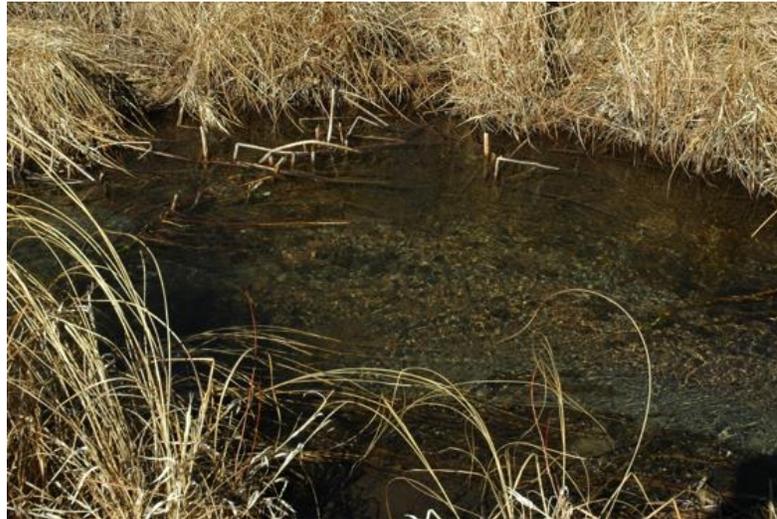
Figure 11 Typical Substrate in D10 Arikaree River are mostly sand with some cobble.

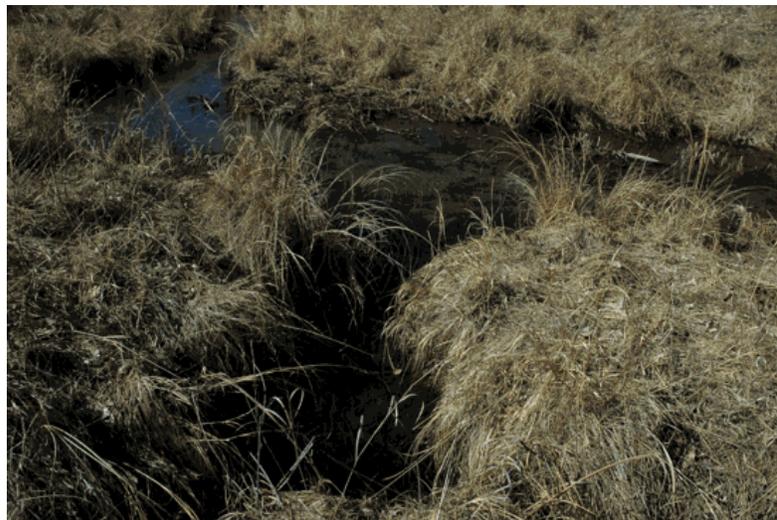
Figure 12 This is a beaver run off the main channel. These areas should be avoided as beaver are active in these areas (will chew on infrastructure) and this is an area of potential high erosion.

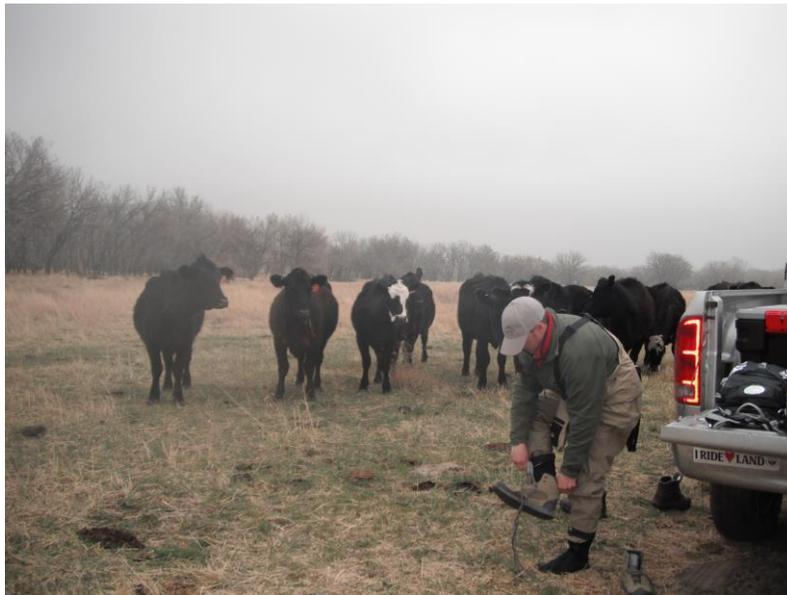
Figure 13 Cattle are often by the stream and looking for food.

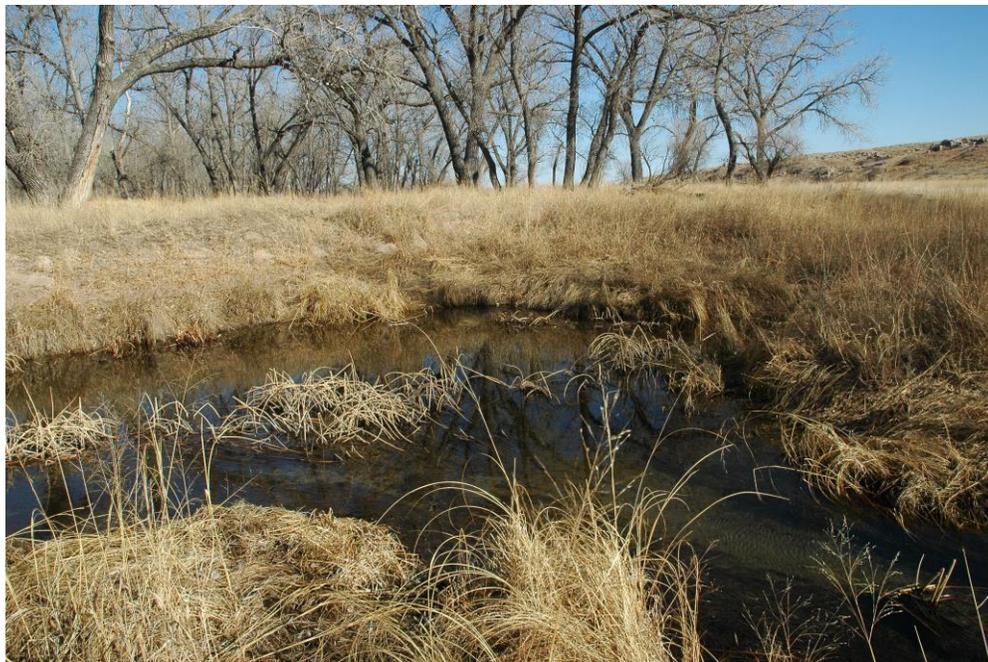
Figure 14 Large bend in stream just above S2 creates a very shallow pool. There are lots of soft sediments in this pool and care should be taken (e.g. it is easy to sink in past your waste).

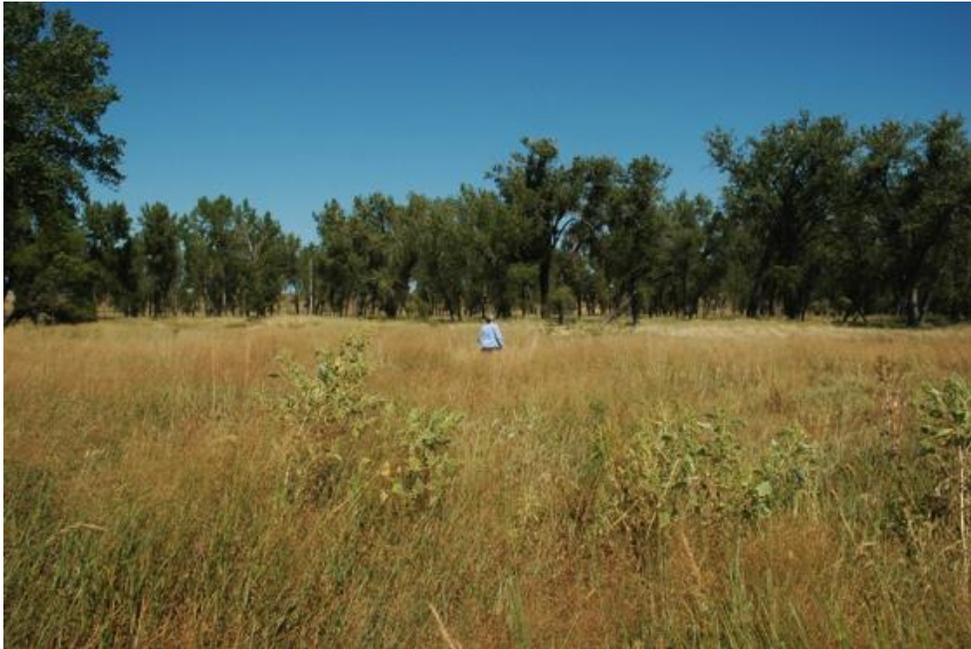
Figure 15 D10 Arikaree River is managed for diversity of tallgrass prairie species. Care should be taken to minimize fire hazards and removal of vegetation.

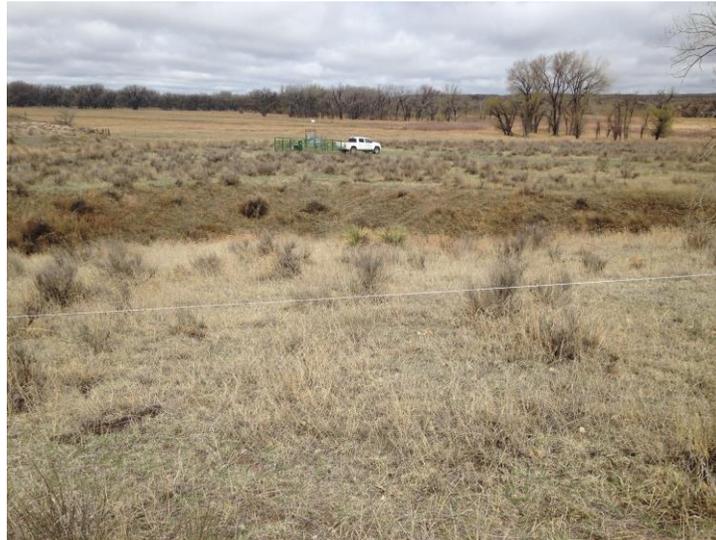
A gate through an electrified fence may need to be installed to access the meteorological station. This will need to be coordinated with the site manager, Nathan. He currently has an electrified fence that put up for part of the year (winter) running primarily east-west along the south side of the permitted area.

Figure 17 Picture of electrified fence running east-west just north of met station.
