D03 AQUATIC INSTRUMENT SYSTEM (AIS) SITE CHARACTERIZATION REPORT

<i>Title:</i> D03 AIS Site Characterization Report	<i>Author:</i> J. Vance	<i>Date:</i> 03/30/2016
<i>NEON Doc. #:</i> NEON.DOC.001591		<i>Revision:</i> C

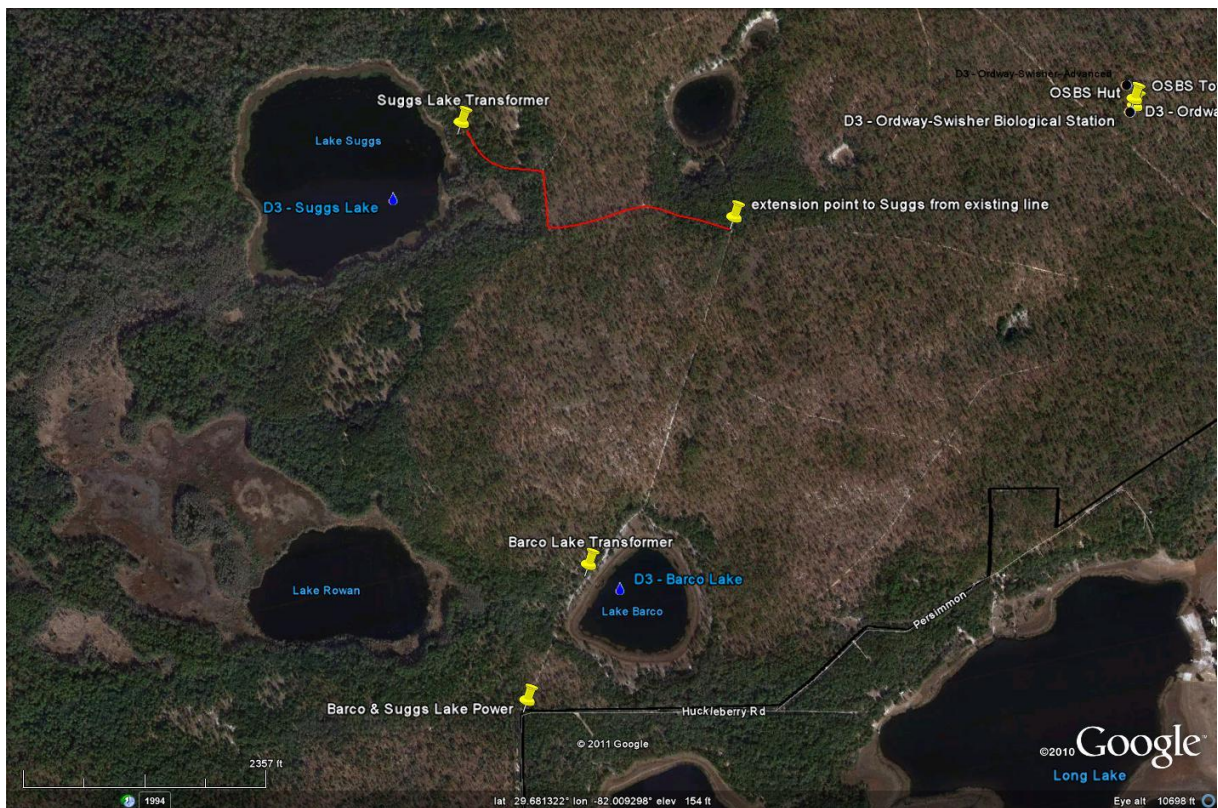
Figure 1 A Google-Earth-Derived Image of Aquatic Auxiliary Portal for D03 Lake Barco

Power and communication will not come from the FIU site, however will come from the same provider. The initial estimated location for the Aquatic Auxiliary Portal is illustrated in Figure 1.

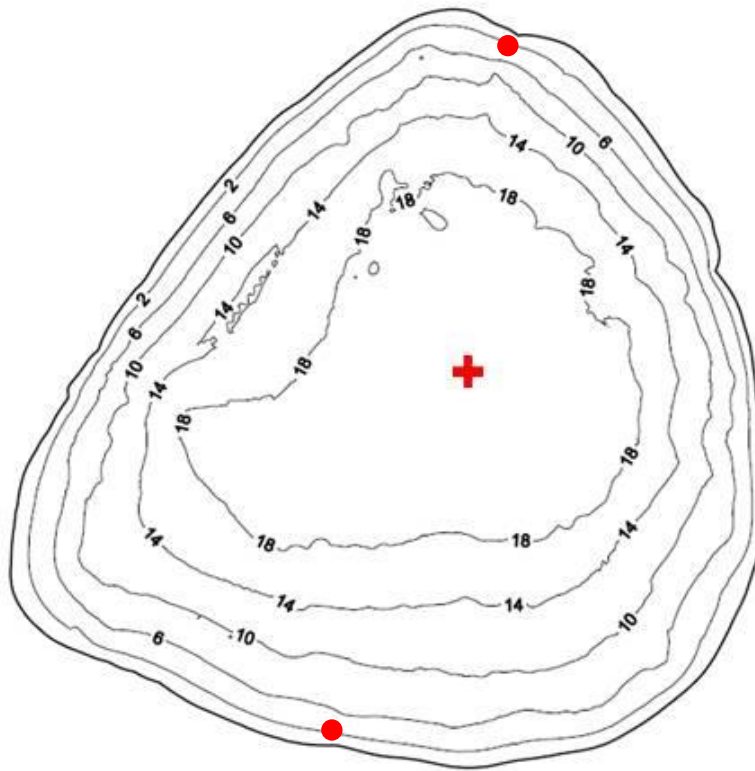
Figure 3 Map of **D03 Lake Barco** bathymetry denoting water depths (in feet) and the location of the profiling buoy and inlet and outlet infrastructure.

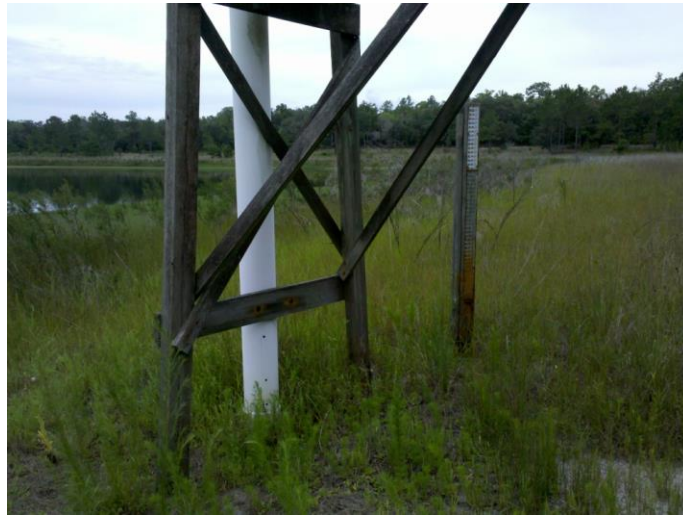
Figure 9 The existing pier in **D03 Lake Barco** with old staff gauge. The water levels are low and the end of the pier is not submerged.

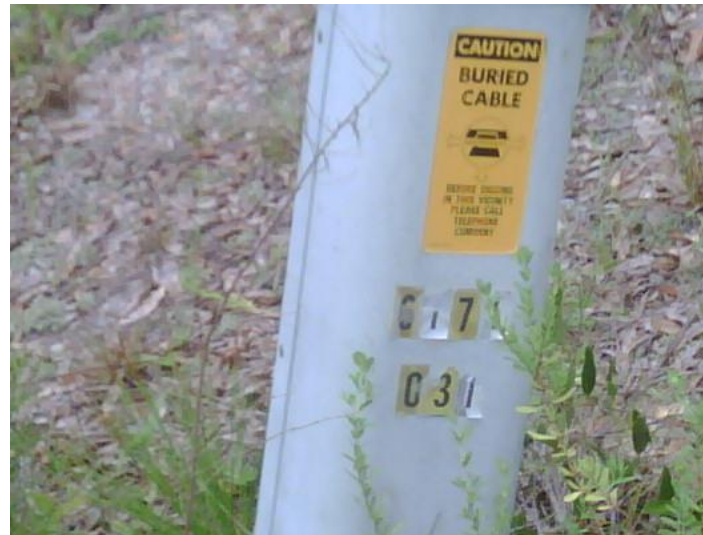
The local communications company is Windstream; the coordinate is 29.67319, -82.01221 (Figure 13).
ALL - See table in Appendix C for additional IT info.

Figure 13 The power pedestal nearest Barco Lake.

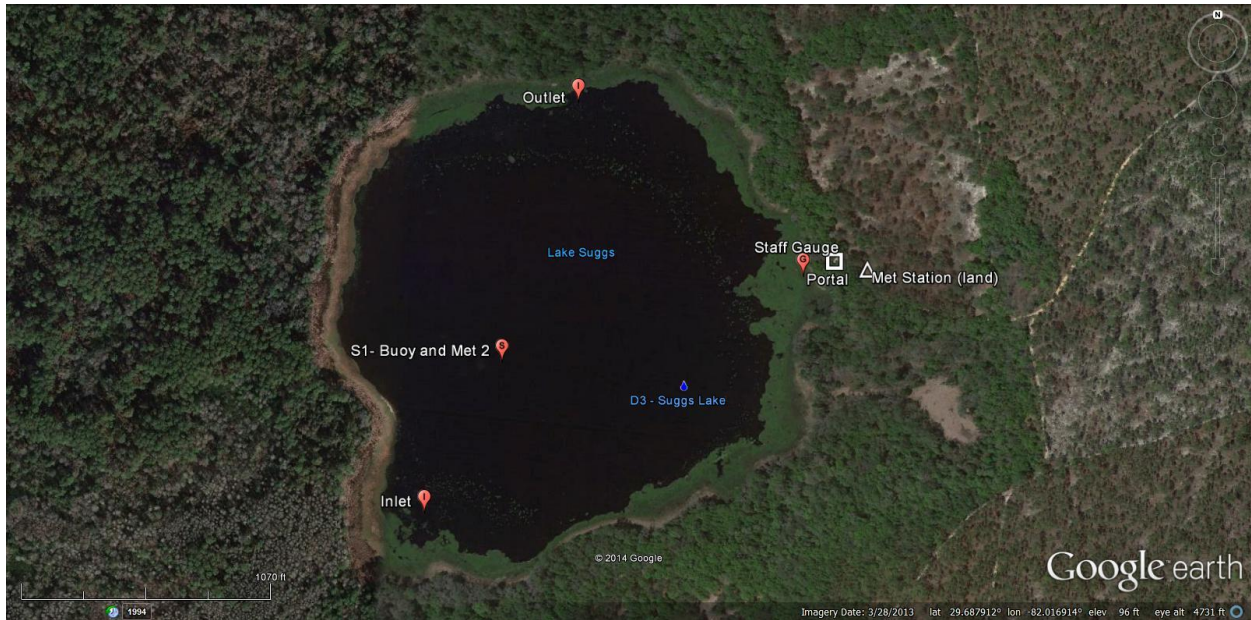
Figure 15 Map of D03 Suggs Lake Denoting Sensor Locations. The red cross denotes the location of S1 (buoy) and the co-located Met Station 2. The red star denotes the location of Met Station 1. The red cylinder denotes the location of the pressure sensor near the lake access point (yellow arrow). The red dots denote the location of the inlet and outlet sensors.

Sensor	Latitude	Longitude
Met Station	29.688416	-82.013637
Inlet	29.685553	-82.019685
Outlet	29.690379	-82.017599
Camera	29.688314	-82.014336

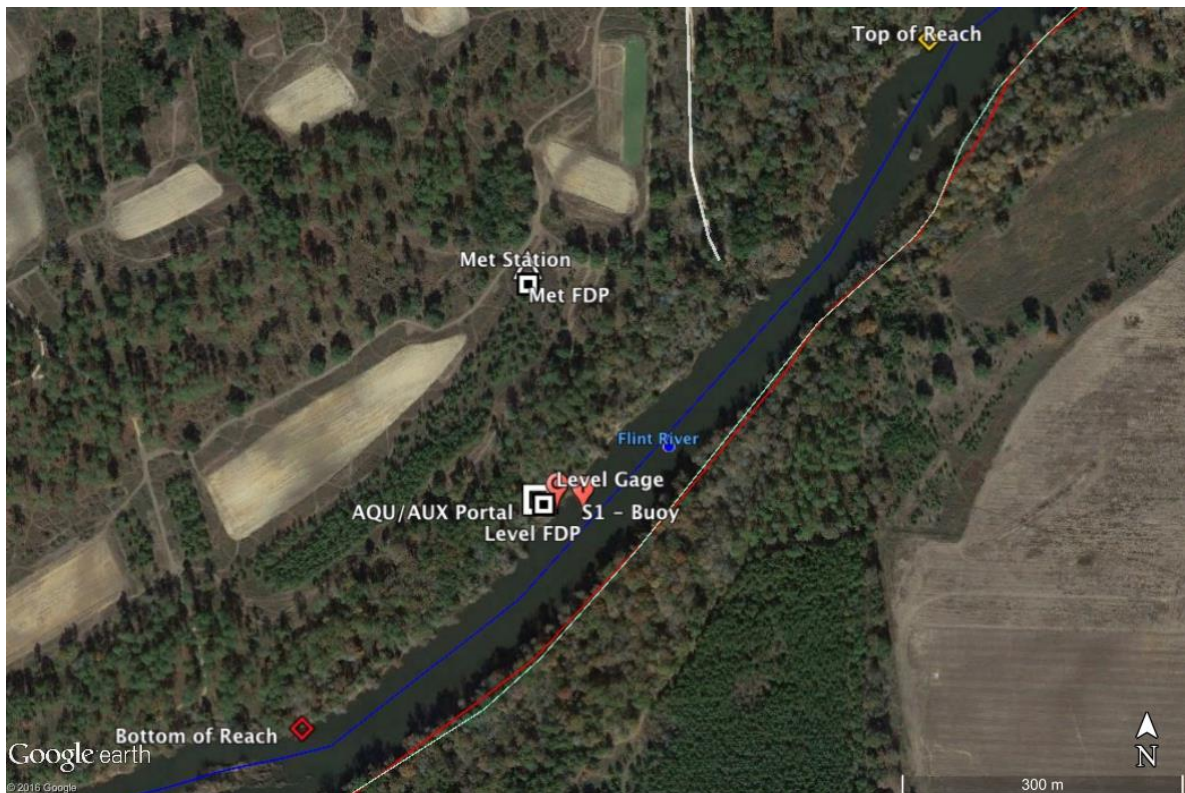
Figure 30 Locations of S1, S2, Met Station, Secondary Precipitation Gauge and associated Field Device Posts for D03 Flint River.

Sensor	Latitude	Longitude
Met Station	31.186975	-84.439049
Met - FDP	31.186803	-84.439032
Primary Precipitation Gauge (DFIR)	NA	NA
Secondary Precipitation Gauge (Tipping Bucket)	NA	NA
Wet Deposition Collector (NADP)	NA	NA
Precip - FDP	NA	NA

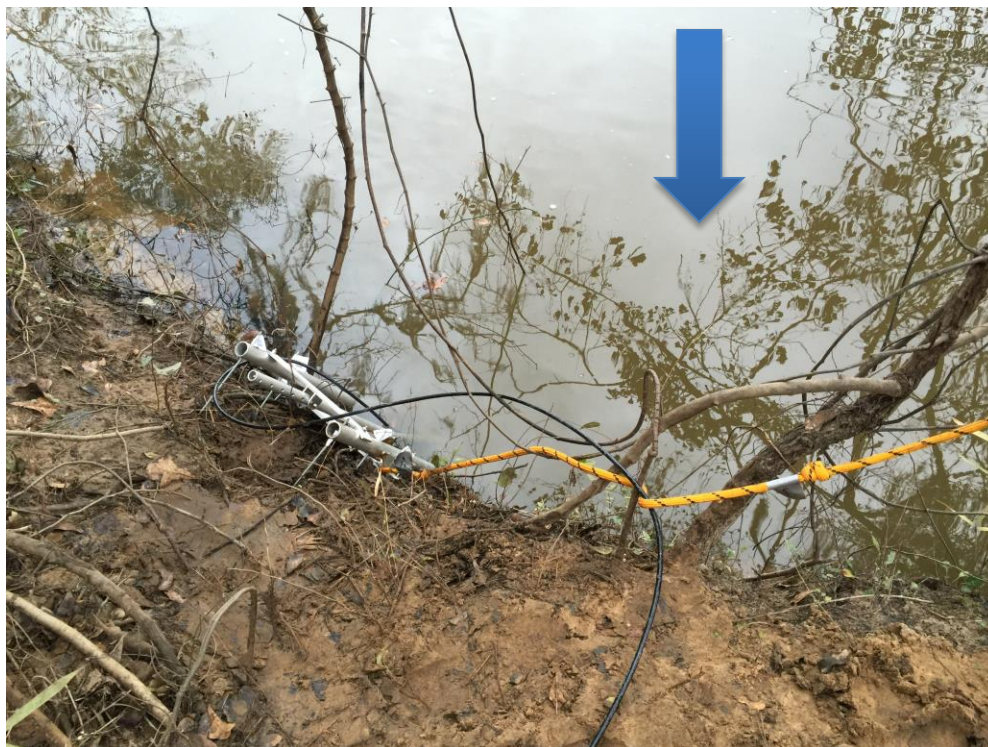
Figure 32 Picture of location of the level gage. (shows temporary infrastructure for deploying ADCP used to measure discharge and velocity fields.)

To determine the discharge and velocity profile of the river, we deployed a Sontek Argonaut SL 500 from the level gage location shown in Figures 14 and 17. The wetted width of the river was measured using satellite imagery for the discharge location and was determined to be 92 m. The mean depth was estimate at 5 m based on preliminary bathymetric data. A standard trapezoid geometry was used for the calculation of discharge. Table 5 shows the measured velocity (speed and direction) for the 10m cells at the discharge transect. The discharge at the time was measured to be 230 m³s⁻¹ which is consistent with hydrographic record shown above. The bathymetry measured at the discharge was linearly interpolated across the transect (see Figure 23). The speed of the flow of water was interpolated along this surface to show an integrated velocity profile of the river and is shown in Figure 21. The velocity measurements show a high flow, particularly through the thalweg of the river.

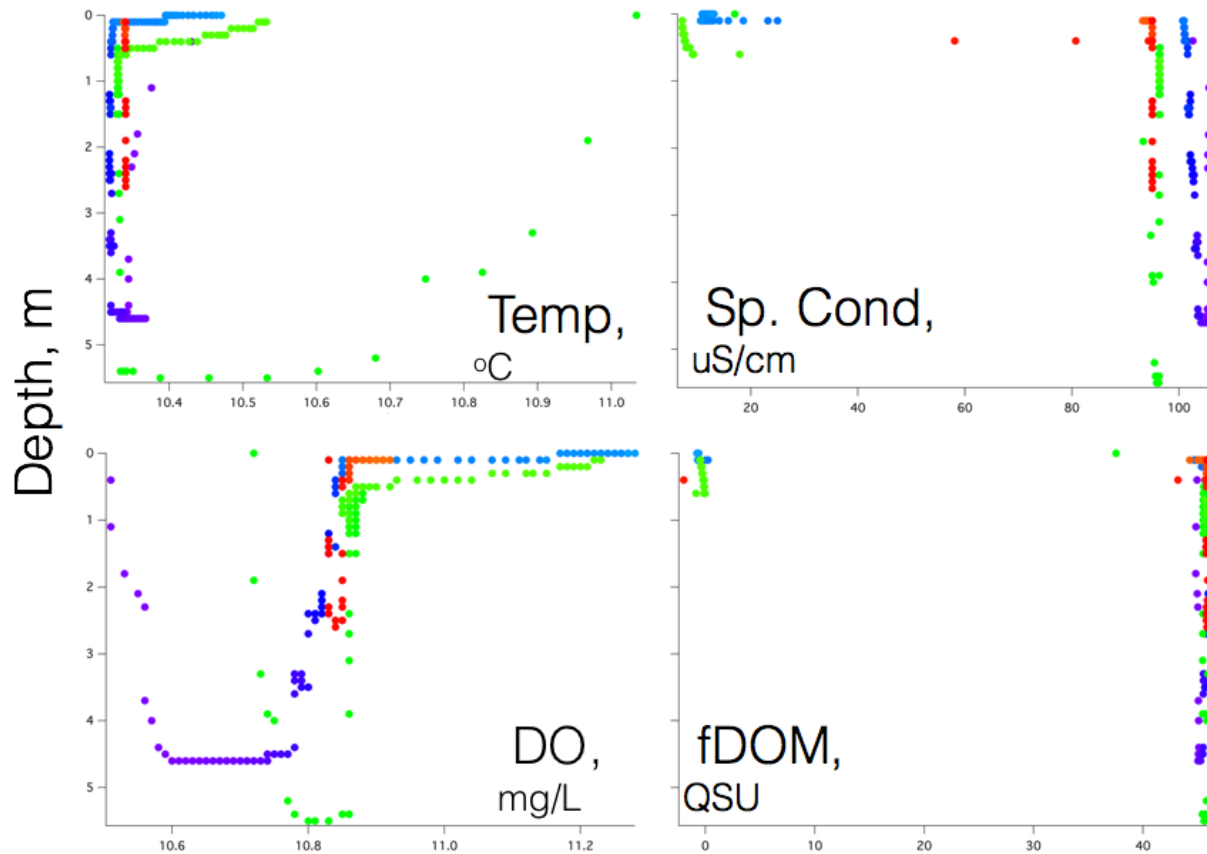
Figure 37 Graphs of profile and transect measurements of water quality parameters: temperature, specific conductance, dissolved oxygen and fluorescent dissolved organic matter.

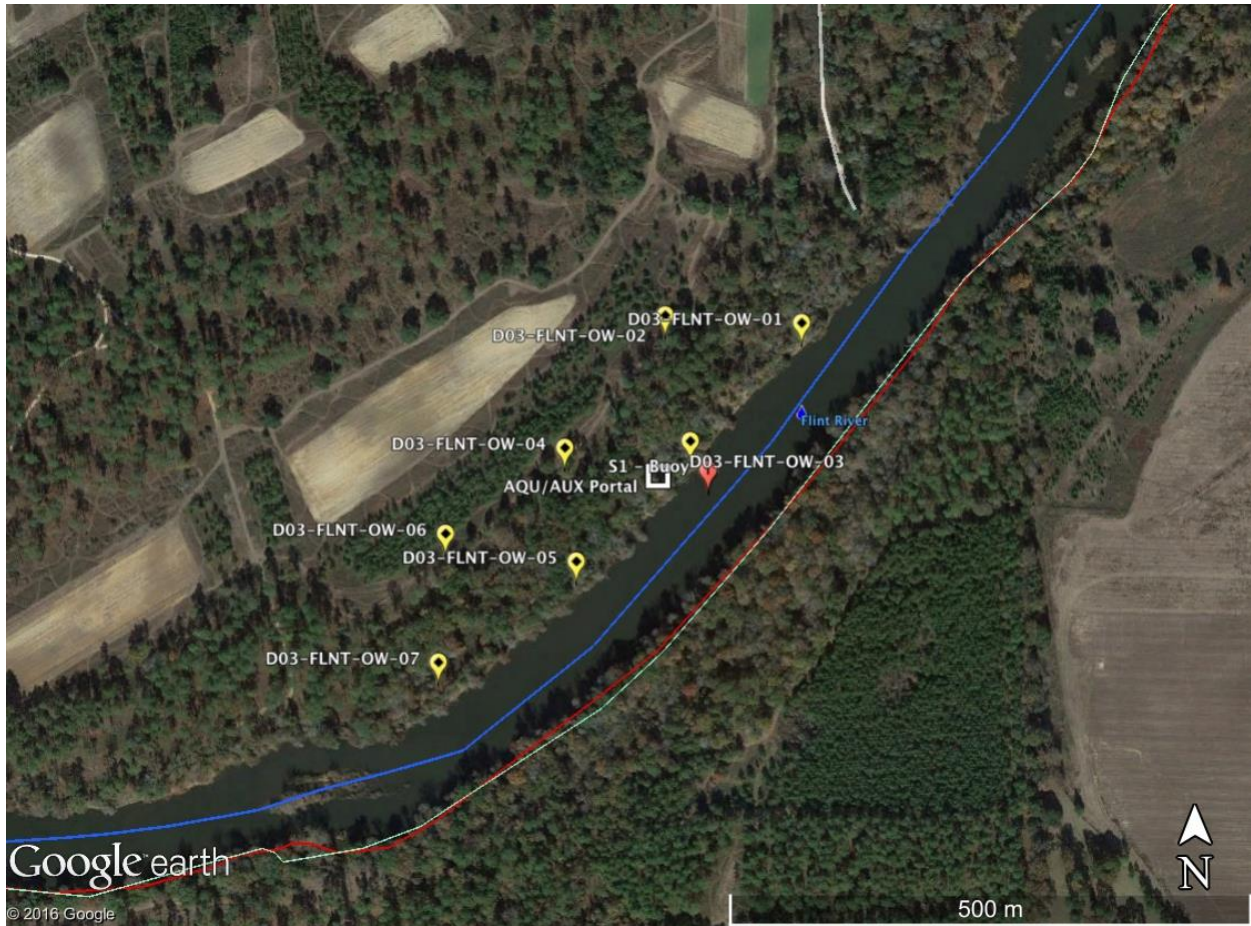
Figure 40 Initial groundwater well locations at D03 Flint River.

The groundwater wells will transmit data back to the location controller located within the AQU portal via a radio-based wireless DAS system. The system will be power by solar with a panel of approximately 27" and transmit radio signals using an antenna mounted to the well casing.

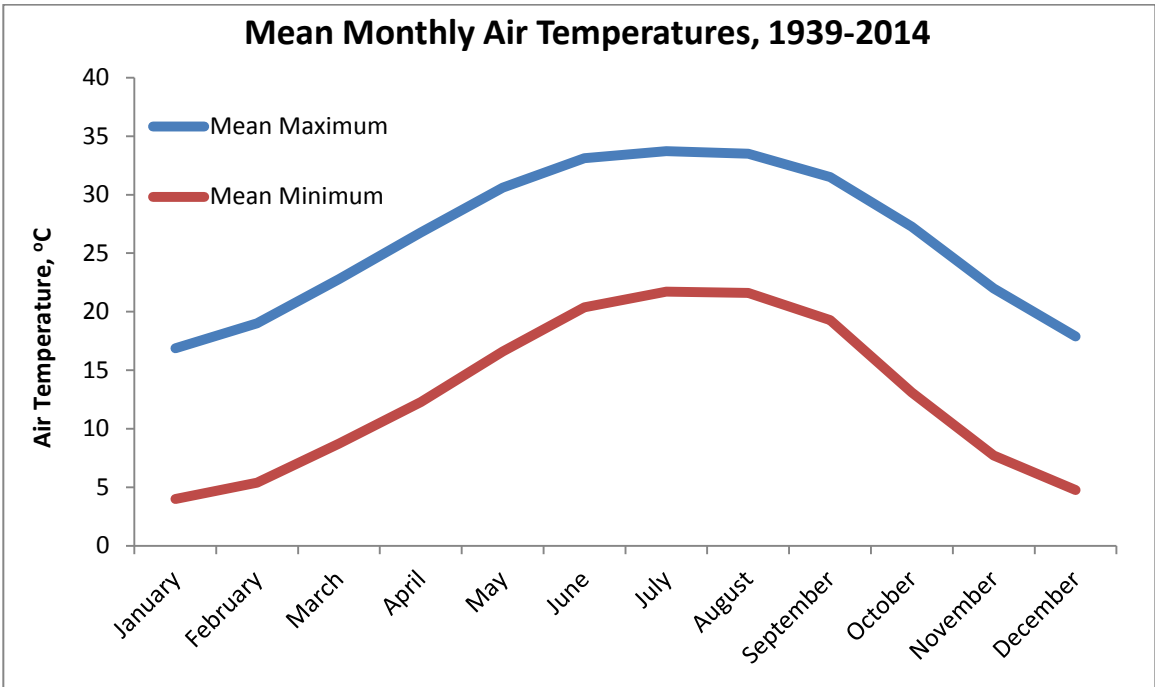
Figure 50 Time series for the air temperature for 1939-2014.
