<i>Title:</i> D04 AIS Site Characterization Report	<i>Author:</i> J. Vance	<i>Date:</i> 1/05/2016
<i>NEON Doc. #:</i> NEON.DOC.001648		<i>Revision:</i> C

## D04 AQUATIC INSTRUMENT SYSTEM (AIS) SITE CHARACTERIZATION REPORT

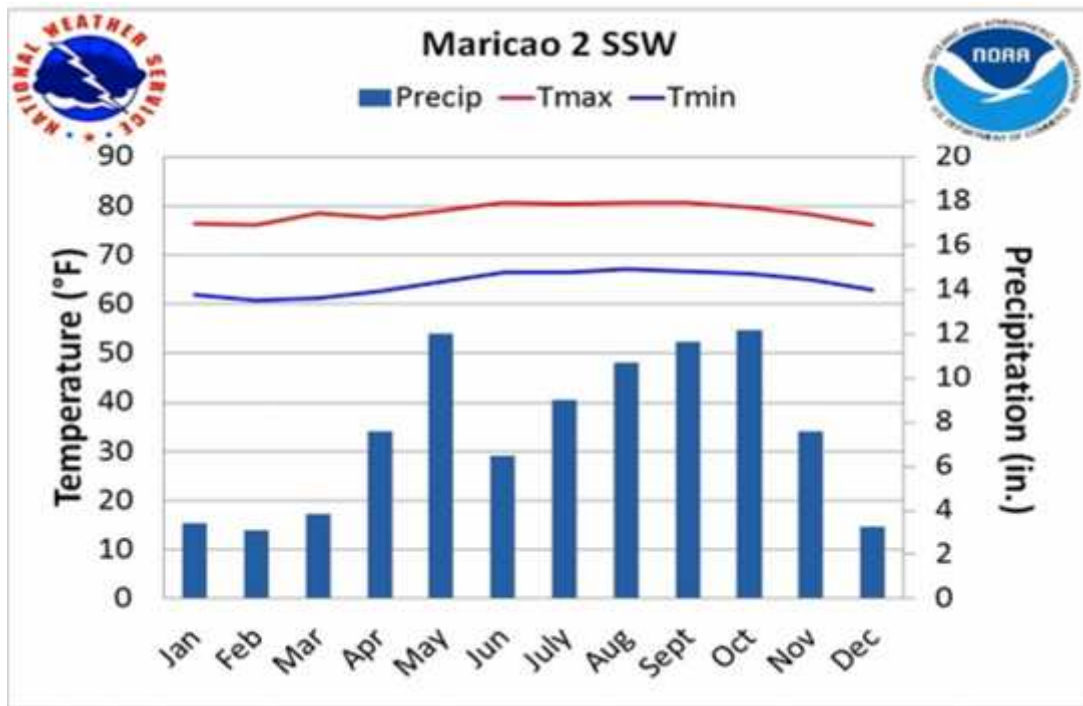
**Figure 5.** Monthly averaged data for 1981 -2010 collected in Maricao, PR.

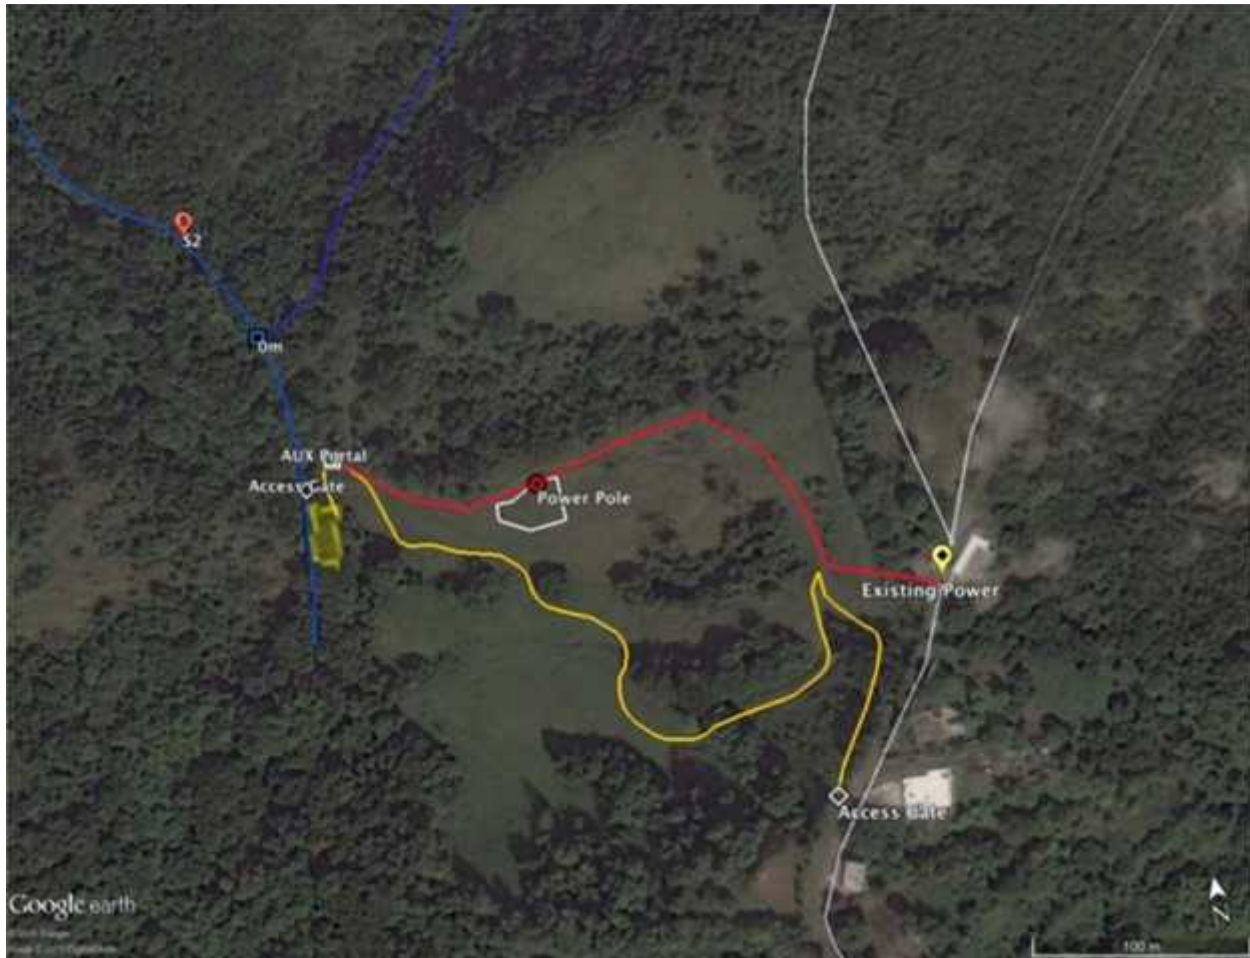
**Figure 6** A Google-Earth-Derived Image of Aquatic Auxiliary Portal for **D04 Río Cupeyes**

The initial estimated location for the Aquatic Portal and Auxiliary Portal is near the stream access gate just west of the old (not currently used) access road. It is planned to run the pole power down to the Portal location. Rather than run conduit back up the hill to the met station location, it is planned to run power and communication lines back up the poles to extend them back to the met station and precipitation field device posts. This will provide lower risk to infrastructure for the core site. The pole near the met station needs to be carefully placed with respect to the sensor locations to ensure that it does not impact measurements and meets the NEON science requirements. In particular the distance between the pole and the precipitation sensors (rain gauge and wet deposition collector) must be two times the difference in the height of the pole and the inlet of the sensors (60" above ground). This must also take ground slope into account. The location of the power pole and its distance and orientation relative to the met station and precipitation sensors are described in the following section (3.1.3).

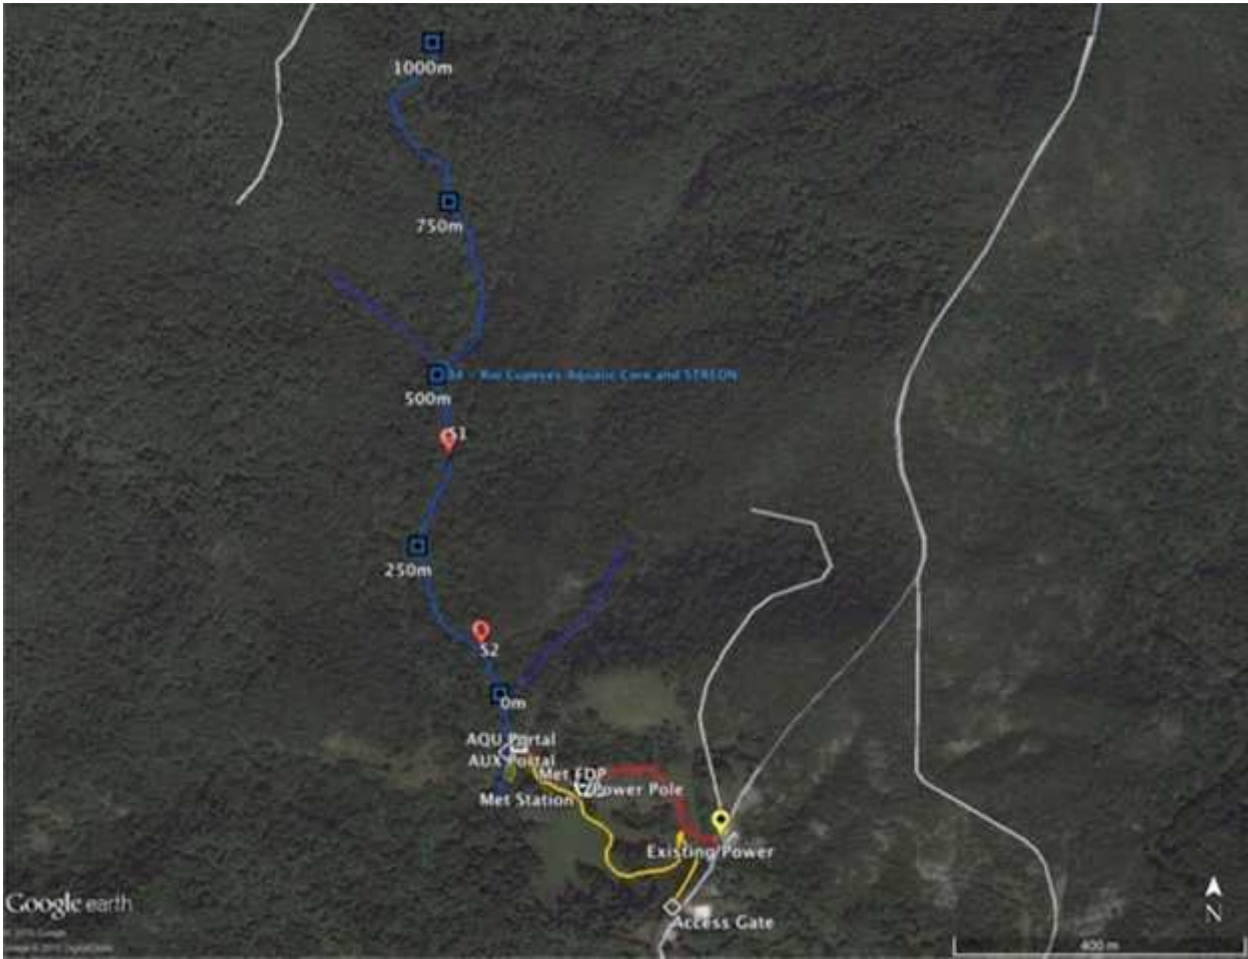
**Figure 7** Kmz File of D04 Río Cupeyes denoting locations of S1, S2, Met Station and precipitation sensors.

The met station and precipitation sensors (tipping bucket and wet deposition collector) as well as their associated power and communication boxes (Field Device Posts) can be located in the pastoral land on the western slope below the AQU reach. There are several flatter plateaus that have been cleared of trees for grazing cattle. These plateaus provide ideal locations for capturing the local meteorology of the watershed. We initially chose three potential locations that were presented to the landowner and manager. The hosts have chosen the location that is presented here. Cattle fencing will be needed to protect both livestock and NEON property given that this land is actively grazed.

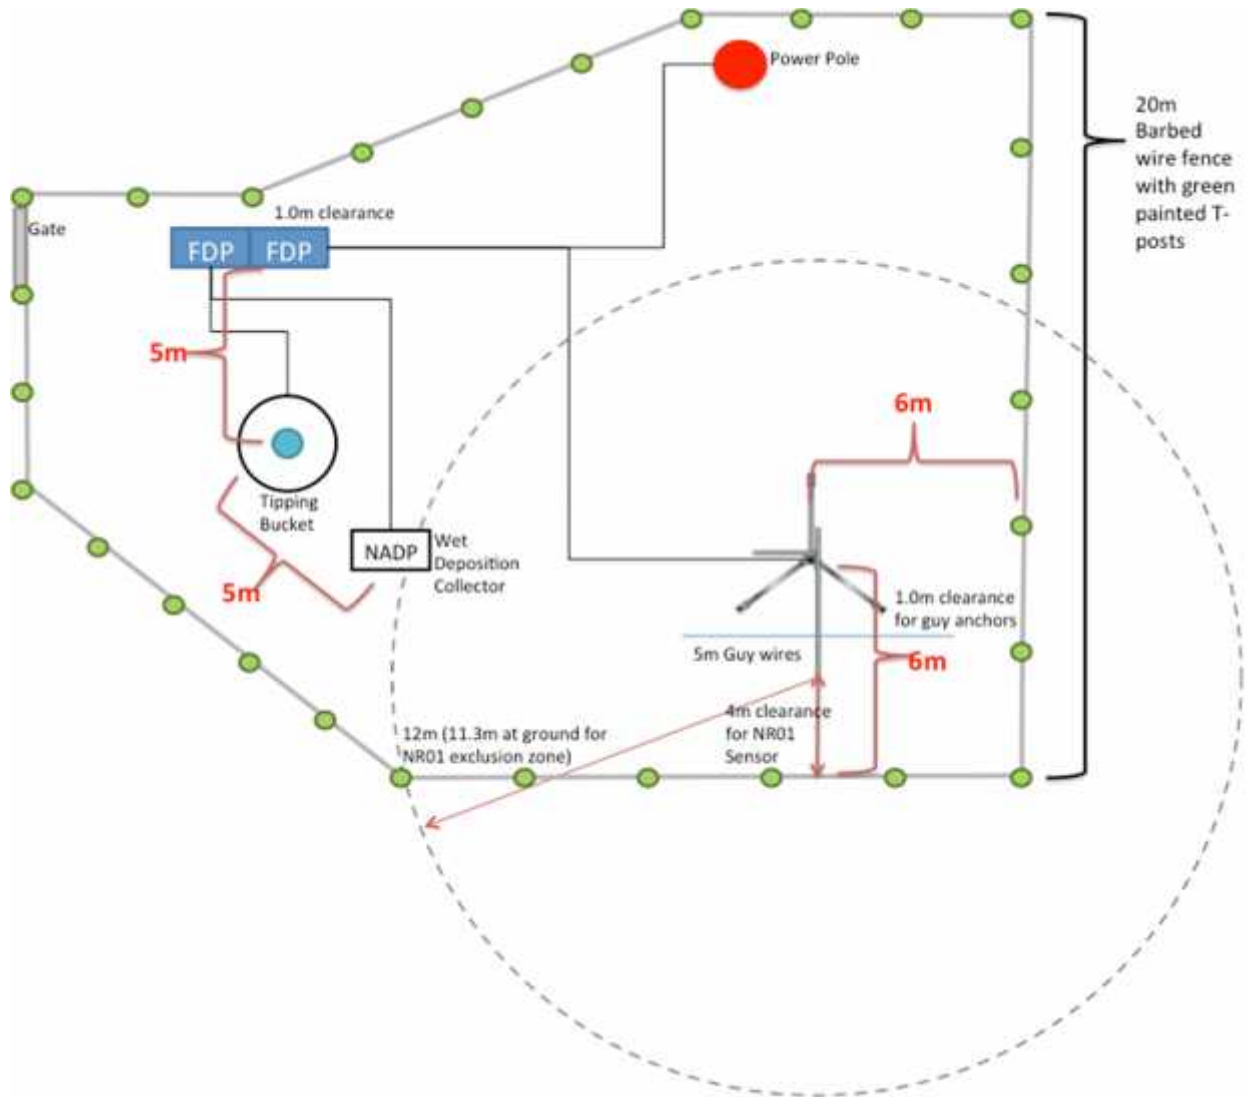
**Figure 9.** Schematic representation of met station, precipitation sensors, power pole and cattle fencing layout.

The cattle fence will be placed in a perimeter that minimizes the area needed while meeting NEON requirements. The cattle fence shall be placed 6 m away from the mast of the met station. There are no other spatial requirements. The fence here is placed around the rocky outcrop that forms the plateau on the hillside for ease of construction and maintenance. It then provides a 1 m buffer around remaining infrastructure for safe access.

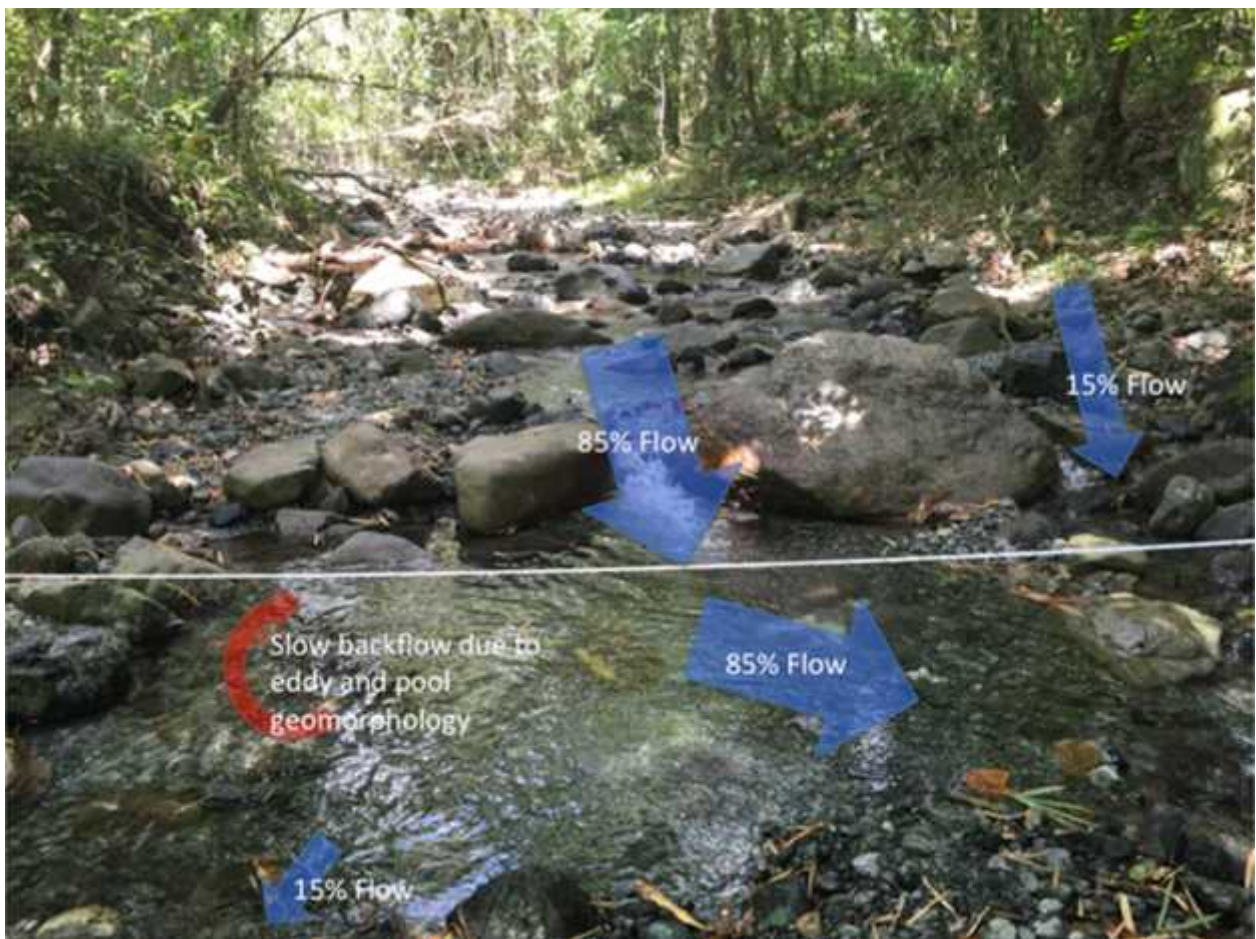
**Figure 10.** Upstream perspective of S1 location at **D04 Río Cupeyes**.

recent October 6, 2015 visit). One important feature to note is the area of significantly reduced flow on the right bank side of the pool. Areas of increased residence time of the water allow for more biological and chemical activity in the water, which create microenvironments that may be different than the bulk of the flowing water. When attempting to monitor the aquatic ecology at the reach scale it is important that the sensors be placed in areas that capture the “average” of these microenvironments along with other habitats present in the system rather than being placed in an area that may bias the measurements. To mitigate the risk of the hydrodynamics of the pool biasing the sensor measurements in S1, the gravel bar at the tail of the pool will be excavated and this material will be used to partially fill the right bank downstream boundary of the pool in order to 1) allow for secure placement of the aquatic infrastructure in the appropriate location and depth within the pool; and 2) maximize flow past the sensor set. Figure 11 shows the downstream perspective of the S1 location and illustrates the areas of excavation and placement of the bed materials to accomplish the stated objective.

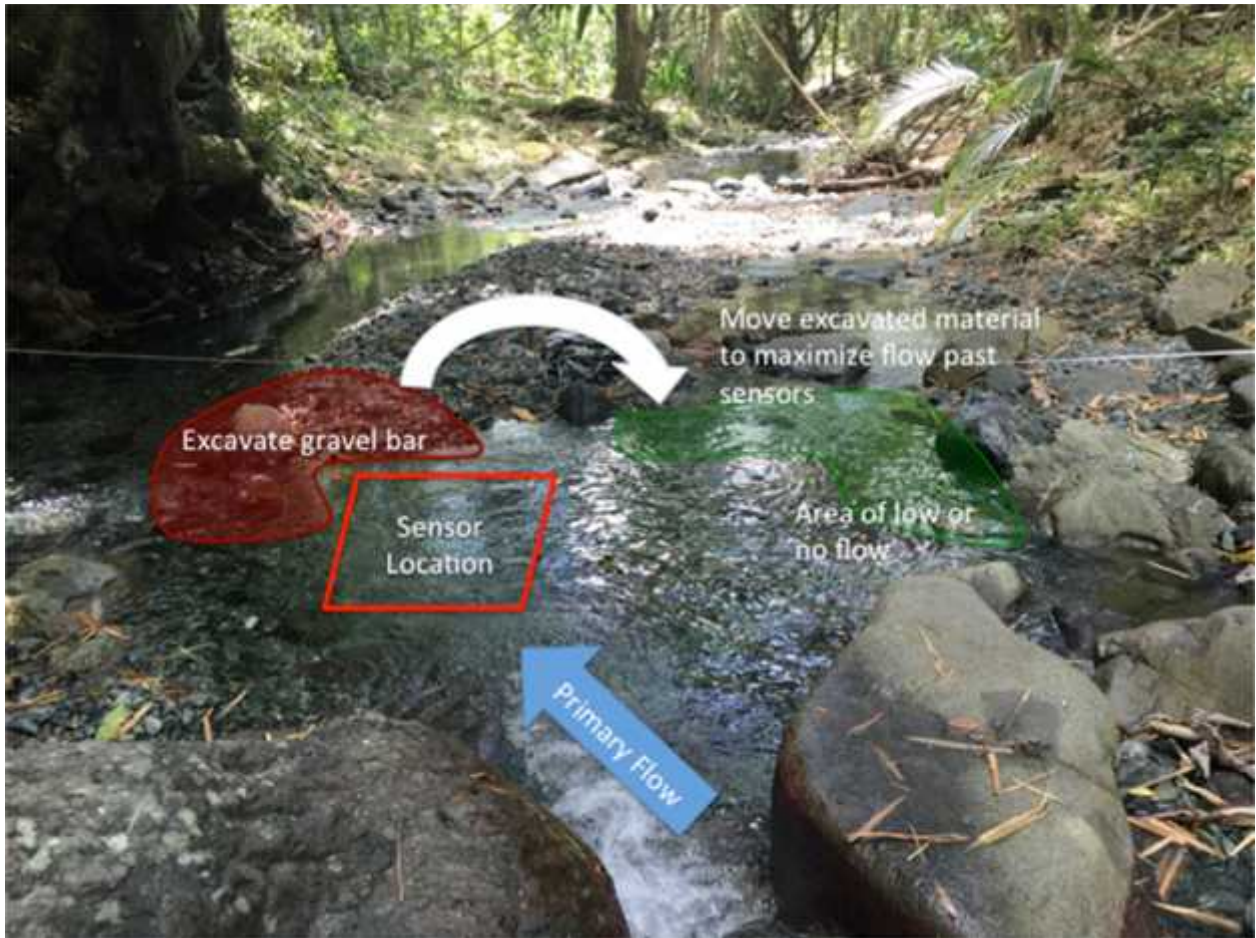
**Figure 11.** Downstream perspective of S1 location at D04 Río Cupeyes showing the sensor location within the pool (red box), the primary flow (blue arrow), area of excavation (red) within the existing gravel bar and where excavated material is to be delivered (green).

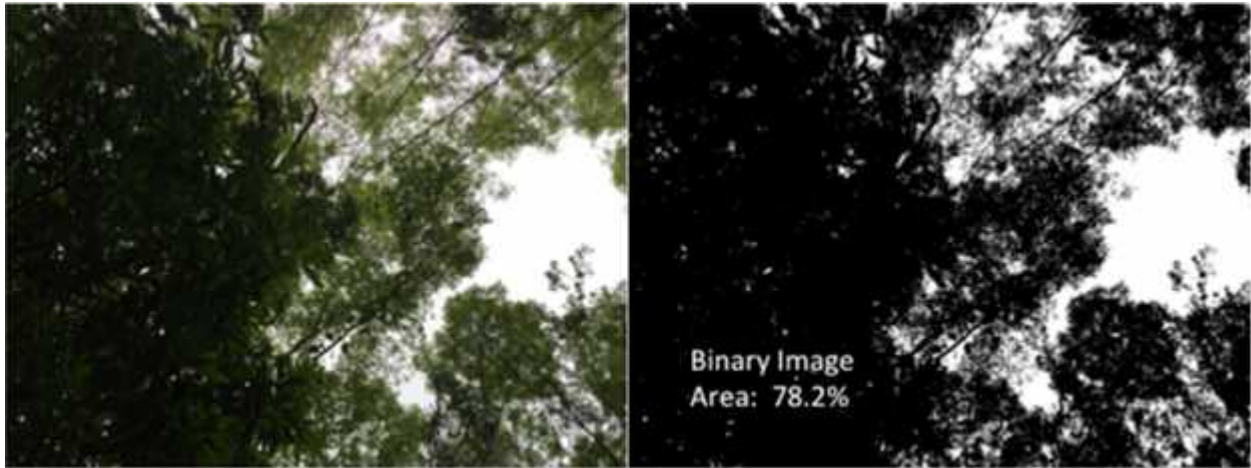
**Figure 12.** Raw and processed image of canopy taken at the 350 m marker near the 359 m S1 pool.

During an October 2015 site visit canopy pictures were captured at 50 m increments (measured and flagged markers) up the stream reach. These images were processed using ImageJ in which the images were converted to RGB stacks; the grayscale layer thresholds were adjusted to convert each image to black and white (low = 0, high = 100) and then the percent area was calculated. The percent canopy coverage ranged from 22.8 – 83.2% with the average across the 1000 m reach being 68.6%.

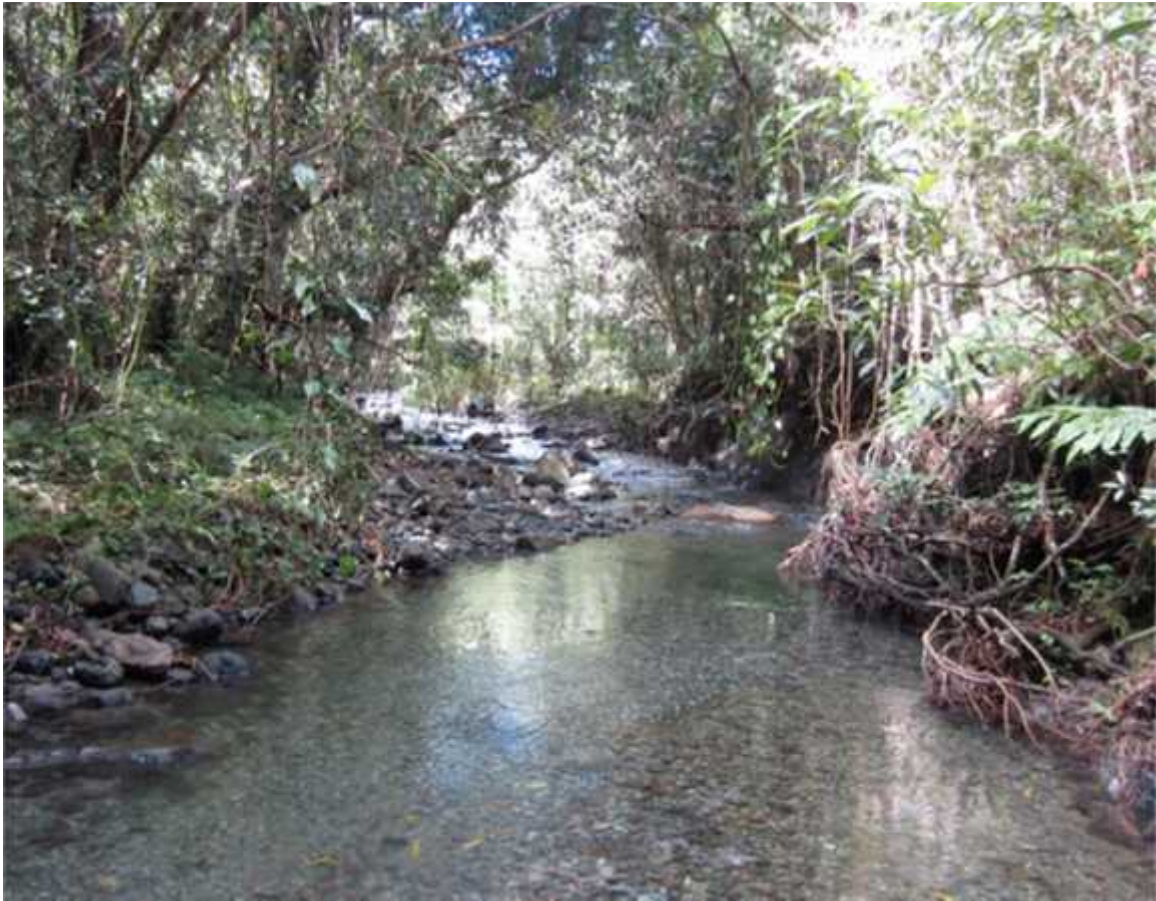
**Figure 13.** Upstream perspective of S2 location at D04 Río Cupeyes.

Figure 13 shows the upstream perspective of the pool where S2 will be located. This pool currently spans 11 m in the longitudinal distance and is approximately 4 m wide with an average depth of 100 cm. The canopy cover near this location is 80.5%. This pool is more of a run-type pool that is formed from a single boulder and a bend in the left bank. The sensors will be located in the tail of the pool near the end of the exposed roots on the left bank. This is a well mixed pool within a stretch where the channel is constrained. Figure 14 shows the downstream perspective of the pool and the location of the proposed sensor infrastructure.

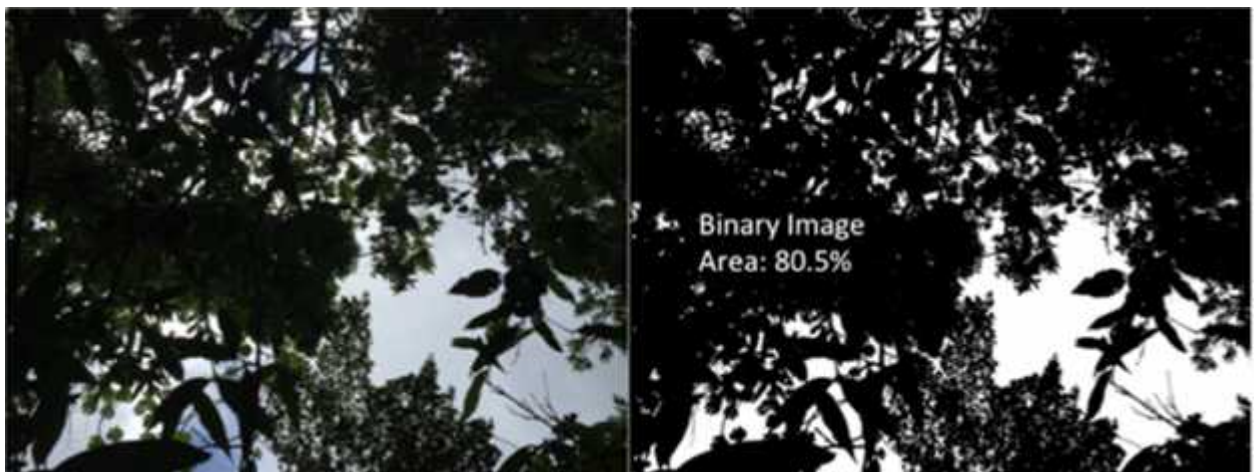
**Figure 15.** Raw and processed image of canopy taken at the 50 m marker near the 64 m S2 pool.

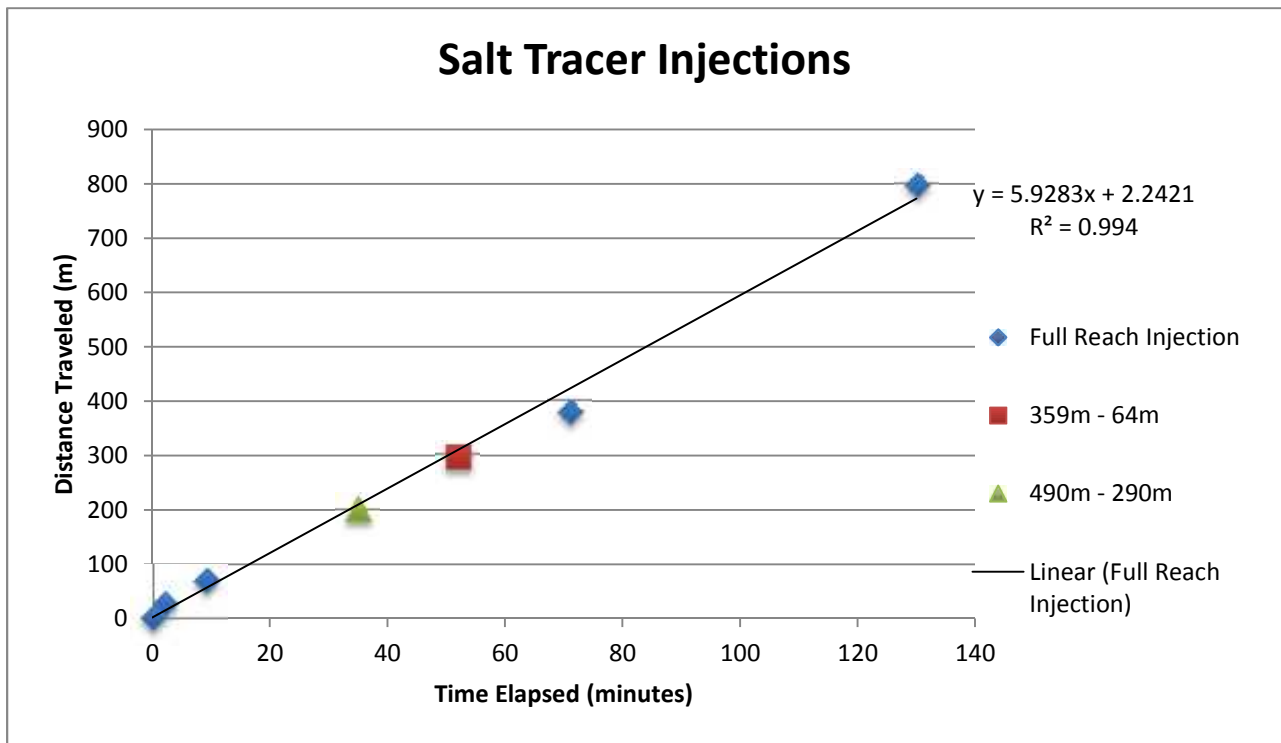
**Figure 17.** Graph showing the linear correlation of travel time along the stream reach.

minutes. This ensures that we will be able to maximize our accuracy and data coverage for calculations of whole stream metabolism. To assess the travel time, a single pulse of NaCl (table salt) is injected as a tracer which is then monitored with conductivity probes. Three salt injections were performed during October 2015 site visits. We did a single pulse from near the top of the reach at 860 m and then monitored the response at 4 pools at 835 m, 792 m, 481 m and 64 m. On subsequent days, injections were also performed between 359 m and 64 m and 490 m and 290 m. All of these flow times were consistent across the reach which suggests that the reach is relatively homogenous at the reach scale within our permitted site boundary. That is to say, the gradient, number of various habitats (pools, runs, riffles – see Appendix), meanders and subsurface flow and hyporheic exchange is consistent across the 1000 m reach. This is illustrated by the regression shown in Figure 17.

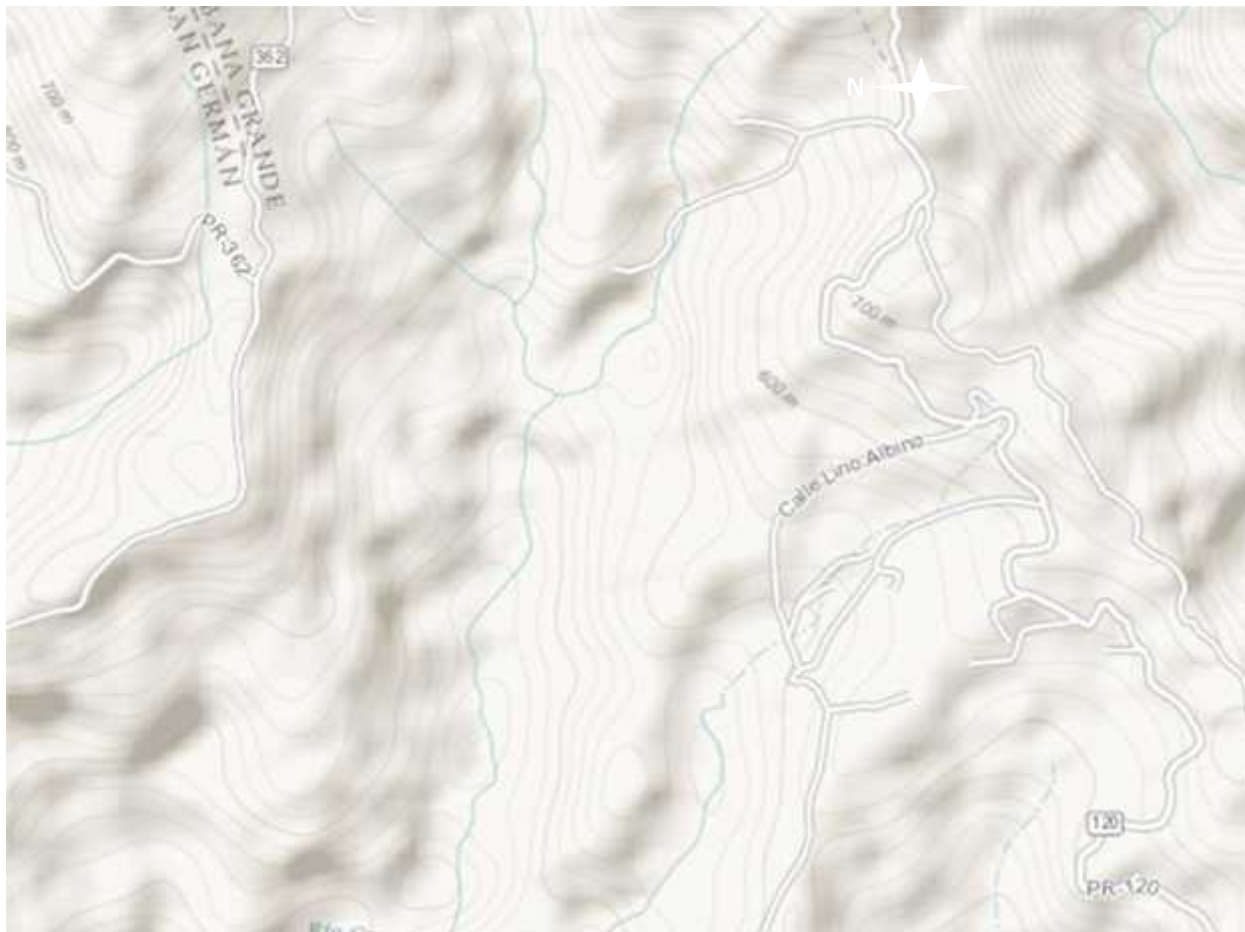
**Figure 19.** Topographic map of D04 Río Cupeyes.

(Figure 19). Scattered along the stream banks are relatively flat terraced areas constructed of shallow soils overlaying the bedrock. The wells will be installed in these flat terraced areas along the stream reach. The required drilling depth will vary between 5-10 feet below ground surface. Access to the site for drilling activities will be via one of the proposed pathways directly east or west of the stream. Access to the well locations is anticipated to be relatively challenging due to the topography of the region and dense vegetation on the stream banks. Prior to initiation of the drilling activity, the access pathway will be established to provide easier access to the drilling locations.

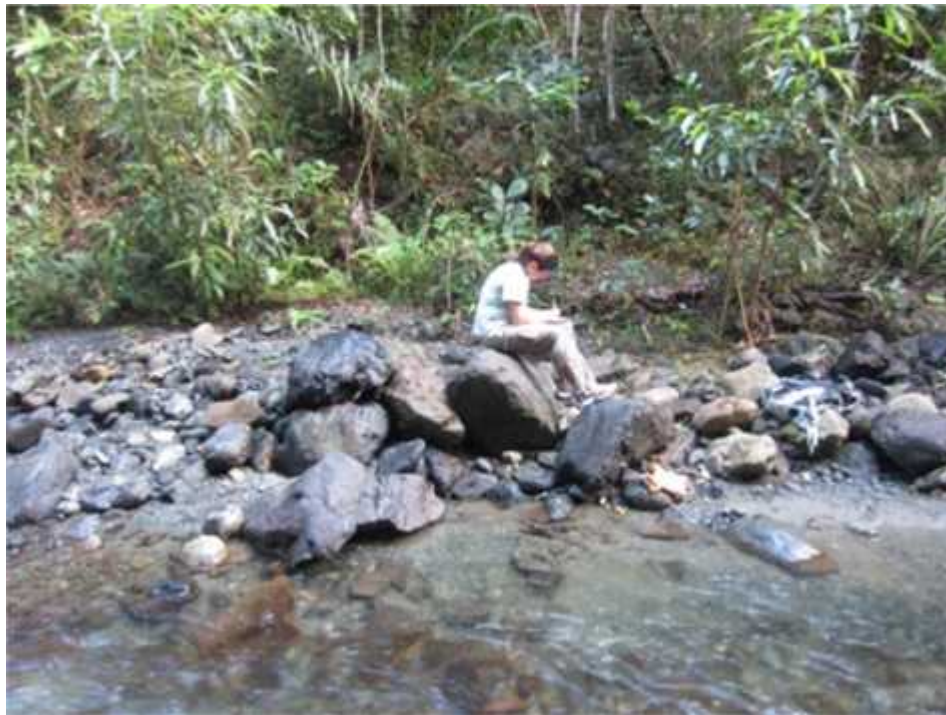
**Figure 33.** At least one bank is typically gently-sloping along most locations of Río Cupeyes.

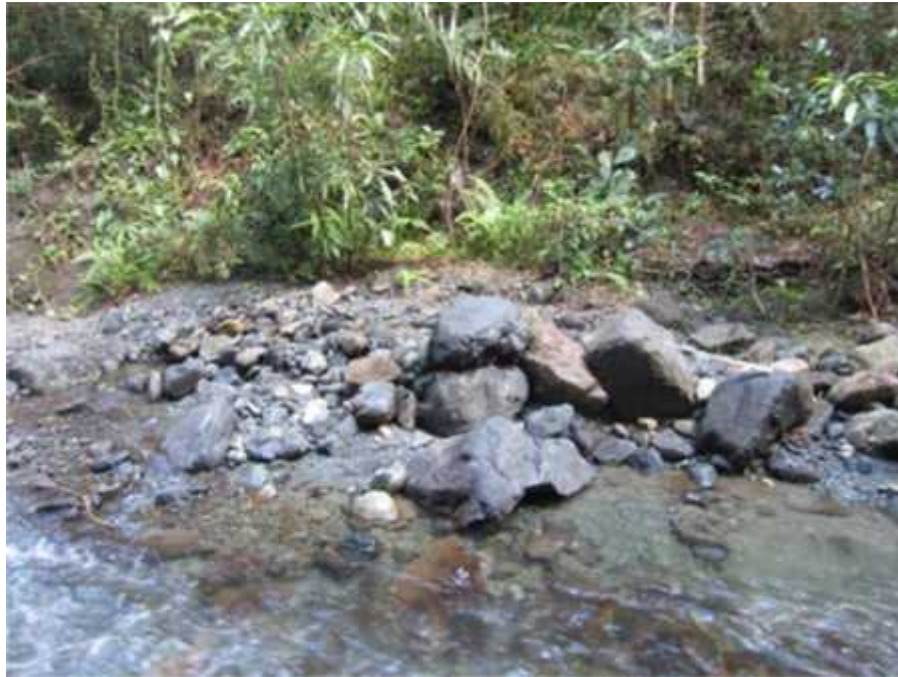
**Figure 34.** Typical bank along the AQU reach of Río Cupeyes. While banks are occasionally very steeply sloped, gradual slopes are more common.

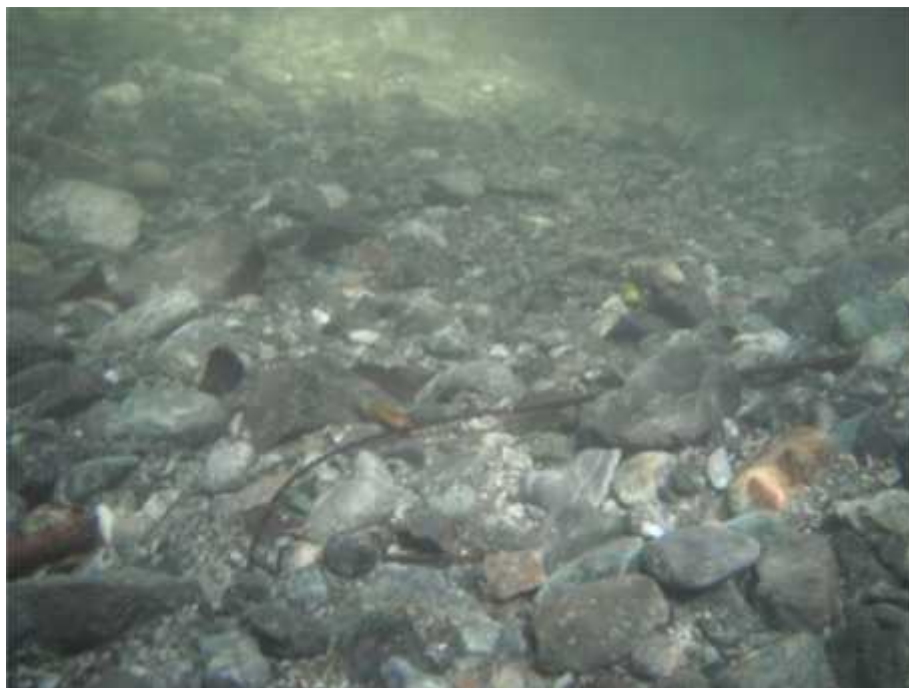
**Figure 35.** Channel substrate in D04 Río Cupeyes consists of a heterogeneous mix of sand, cobble, pebble, large boulder and large areas of exposed bedrock.

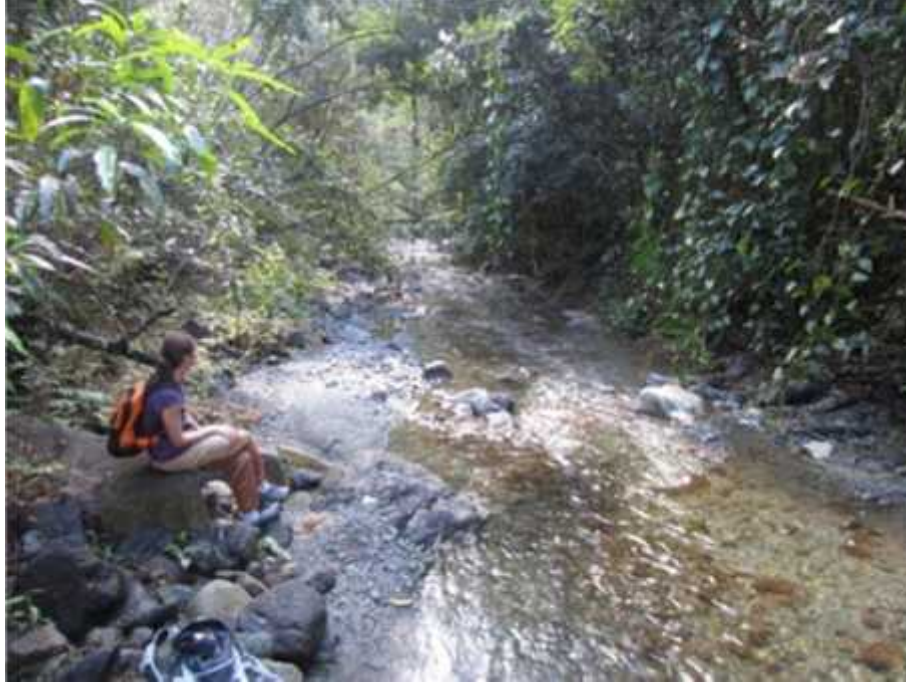
**Figure 36** Although much of the channel substrate consists of small particles that will likely be displaced during high discharge events, large, relatively immobile boulders are also ubiquitous along the channel margins.

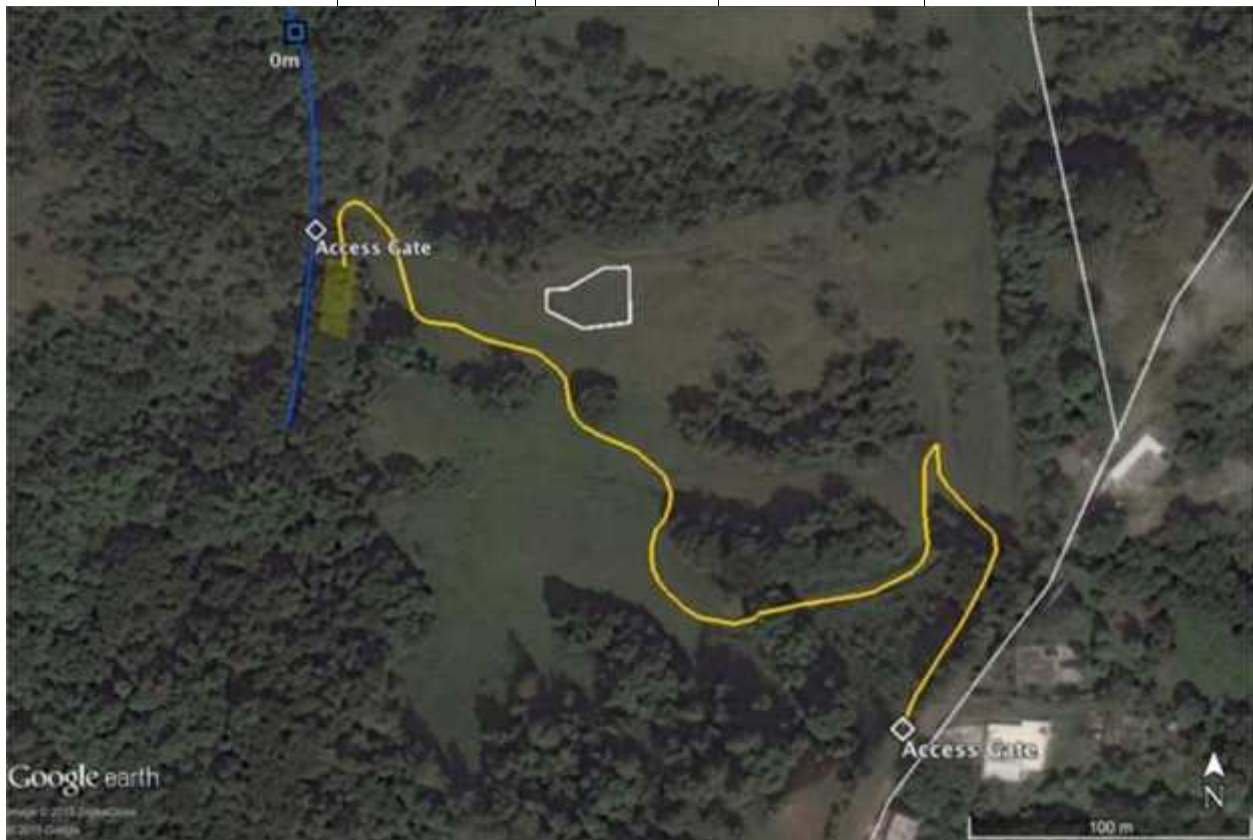
**Figure 37.** Access gates are indicated by the white diamonds at the road and the stream. The access road through the site is shown in yellow and the stream shown in blue.

It is proposed that NEON will install controlled access gates at the road and the stream. The locations of the proposed gates are given in Table 6. There is an unpaved road cut into the mountain side that is maintained by the landowner (see Figure 18). The road becomes more difficult to navigate safely beyond the switchback where deep ruts and exposed roots make traction very difficult when wet. The final descent to the stream bank on the road is steep and composed of loose cobble, boulders, and exposed bedrock. It is proposed that NEON may enter into an agreement to share use and maintenance of this road. This will provide driving access for hauling sampling and maintenance equipment by field technicians. There is a parking area next to the stream bank at the bottom of the road, which is shown as the yellow shaded area in Figure 18, which may accommodate up to 4 vehicles.

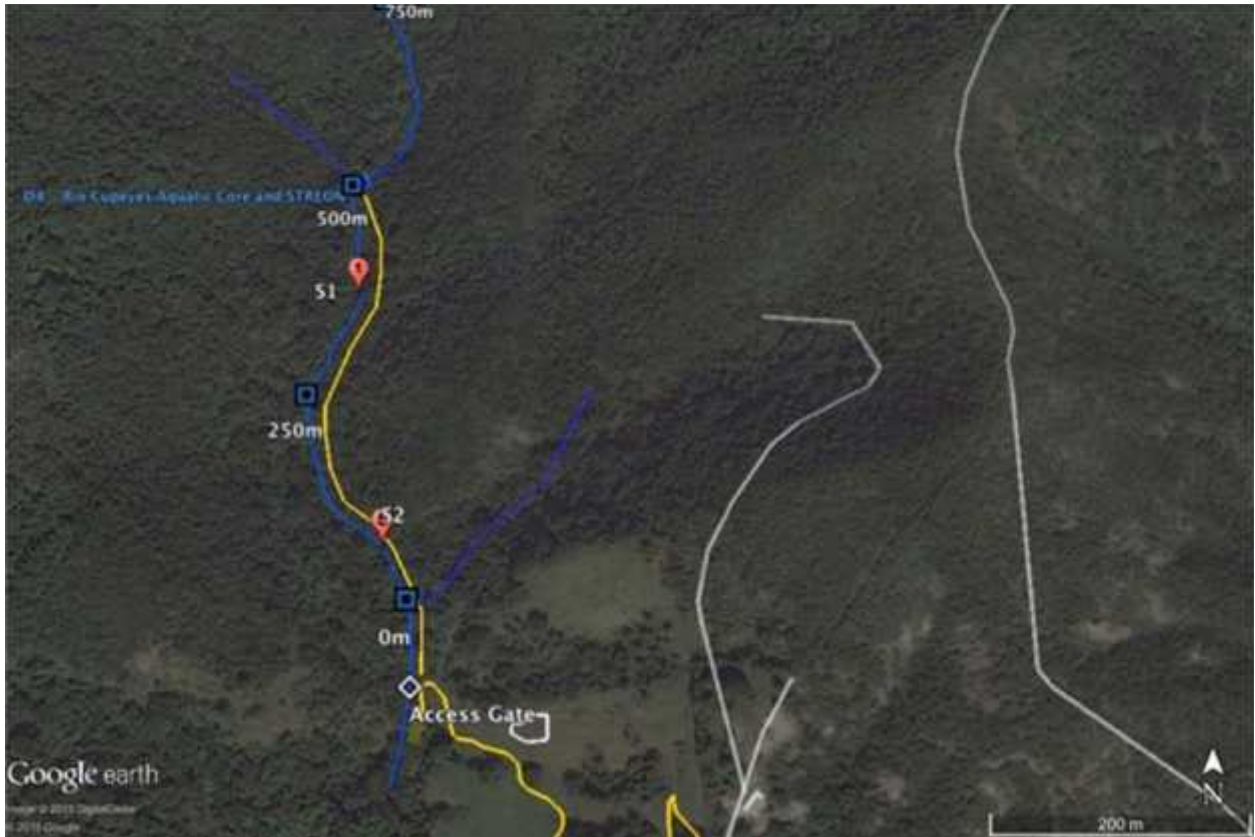
**Figure 39.** Proposed trail to be constructed on the eastern property to provide access and deliver power and communications to S1.

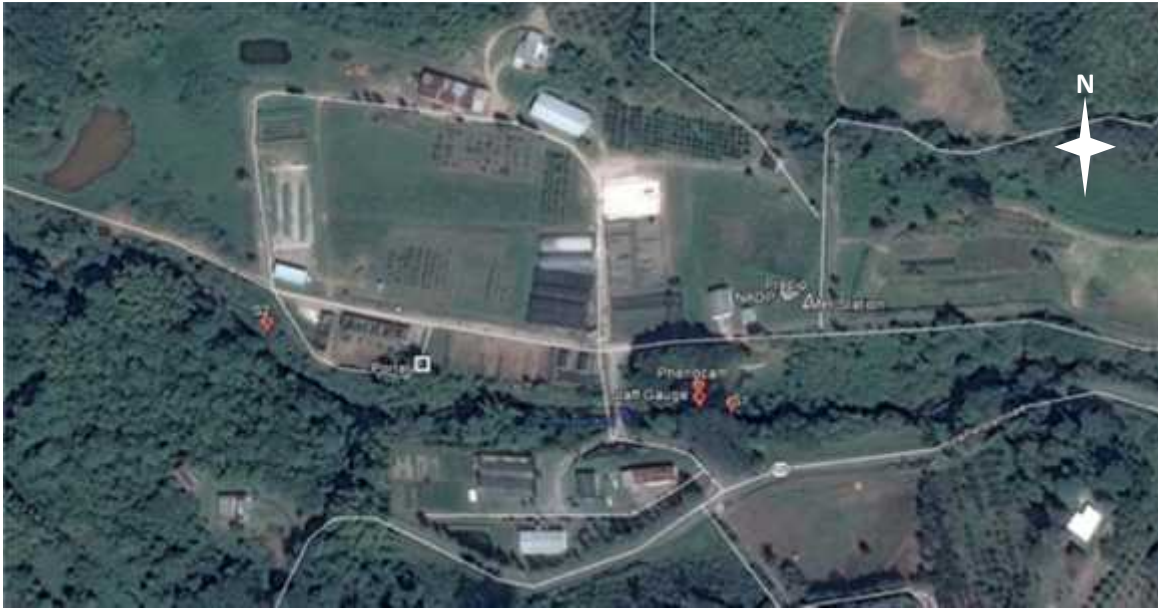
**Figure 40** Kmz File of D04 Río Guilarte Denoting Locations of S1, S2, NADP and Met Station and Precipitation Sensors

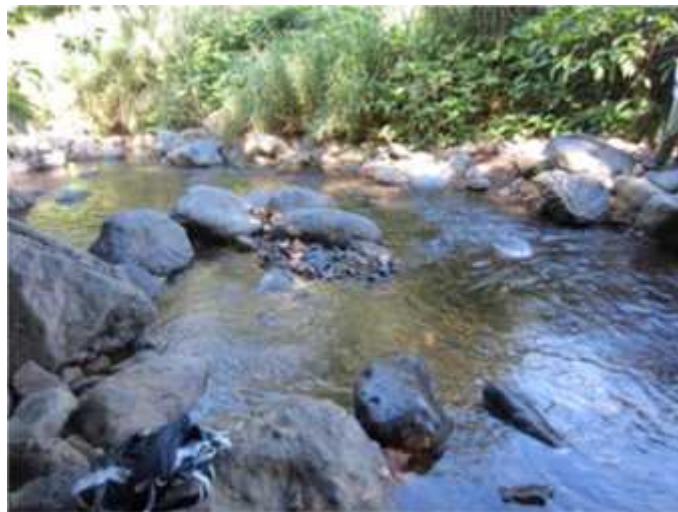
**Figure 41** S1 location at D04 Río Guilarte, facing downstream and right bank.

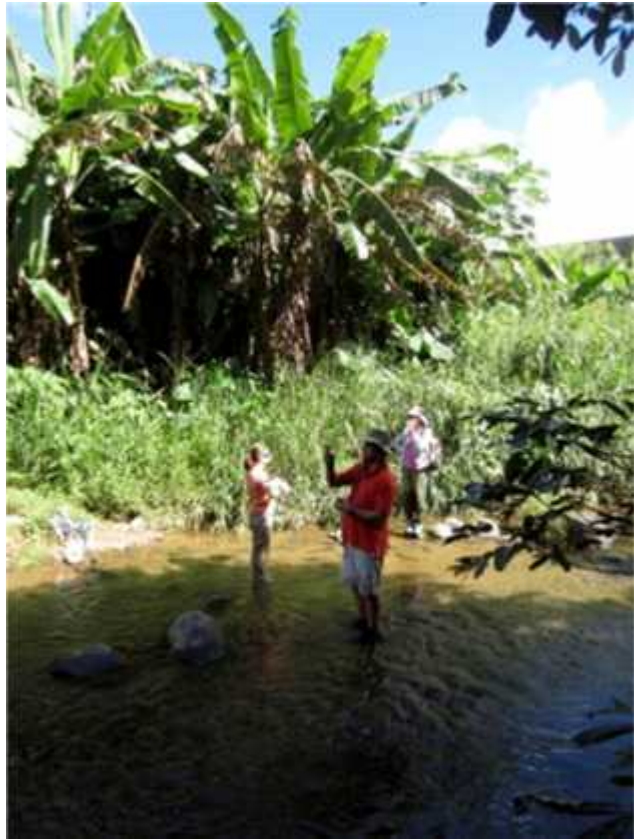
**Figure 42** S2 location at D04 Río Guilarte, facing the right bank.

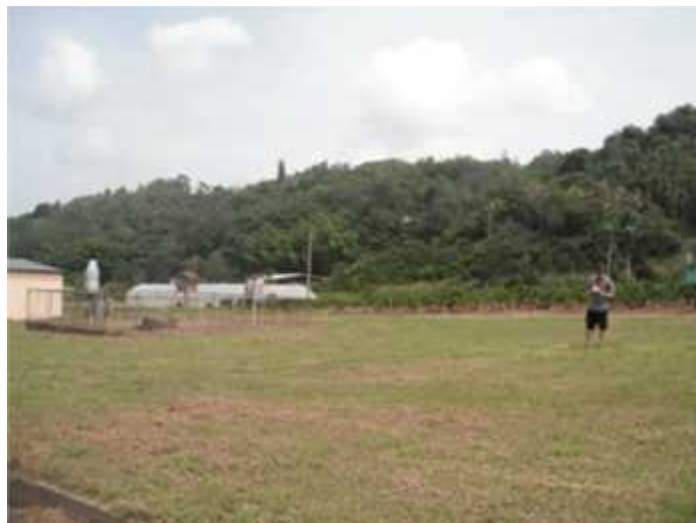
**Figure 23** met station and precipitation sensors location at D04 Río Guilarte next to an existing NOAA weather station.

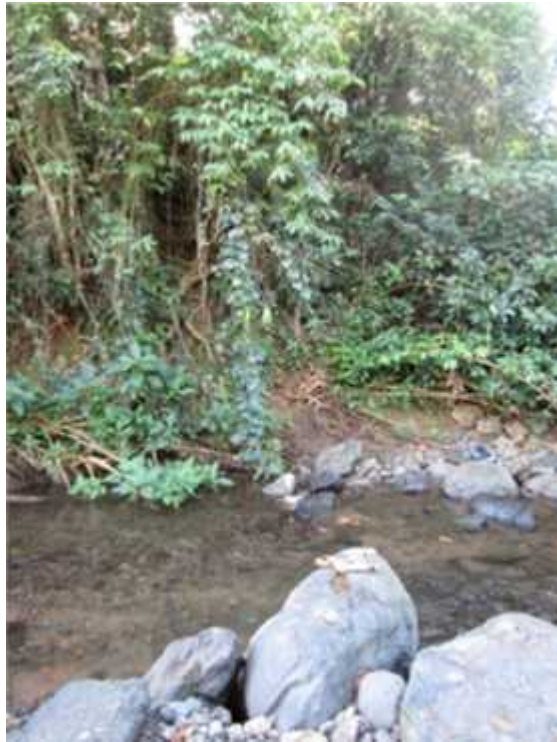
**Figure 43** The left bank of Río Guilarte is typically steeply-sloped and tall (~12 m). Thus NEON infrastructure would best be positioned from the right (north) bank. Shown here is the S1 location left bank.

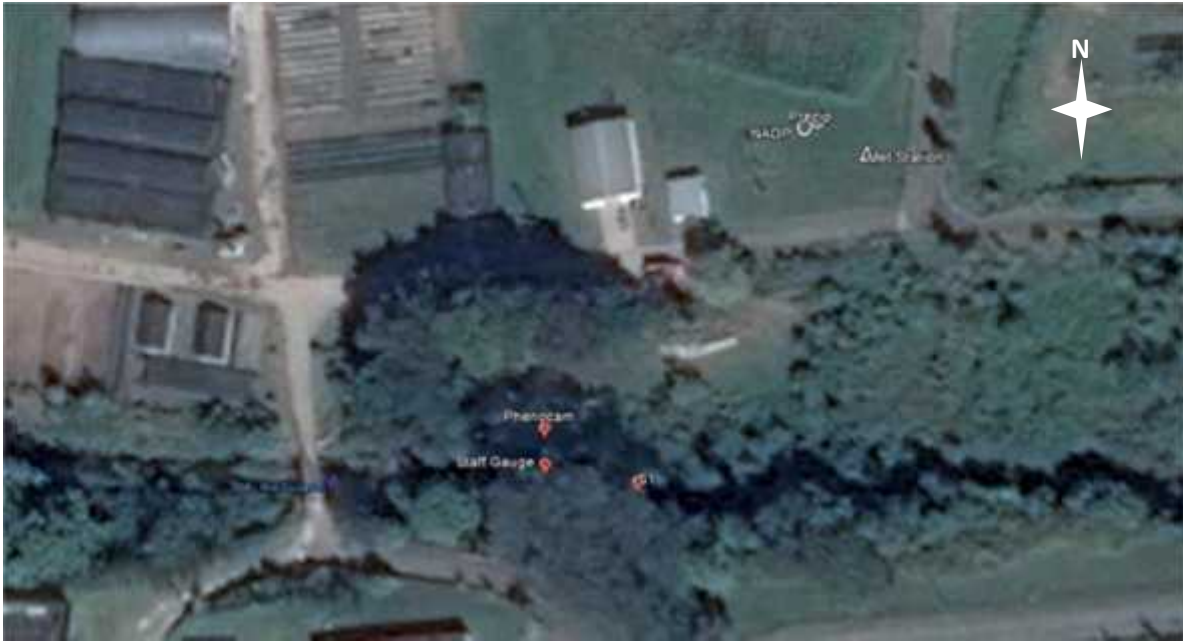
**Figure 44** Phenology camera and staff gauge locations near S1.

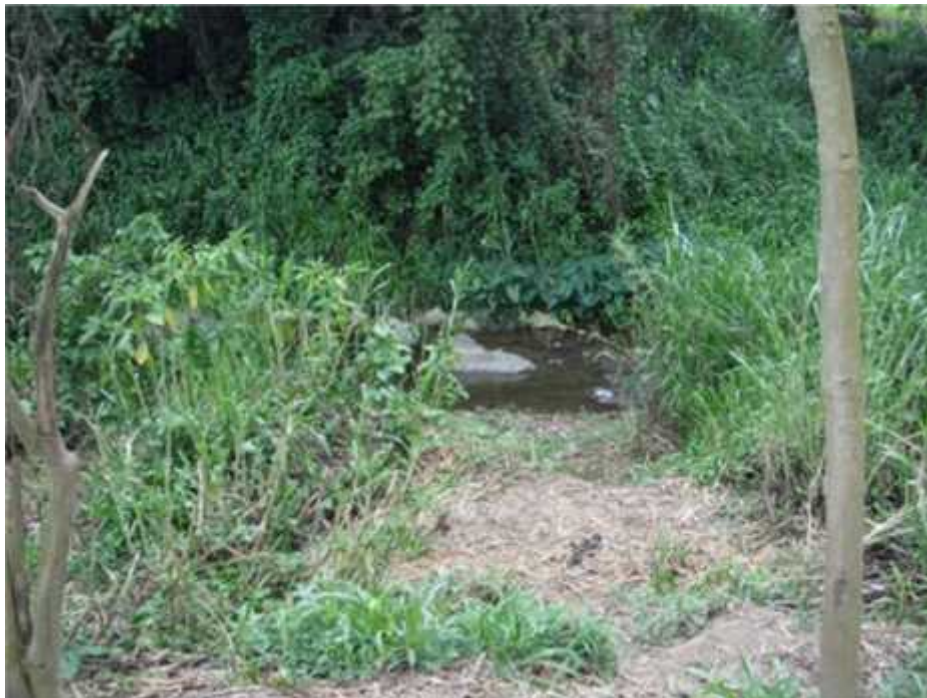
**Figure 45** Location of staff gauge in the stream from the view of the phenocam location.

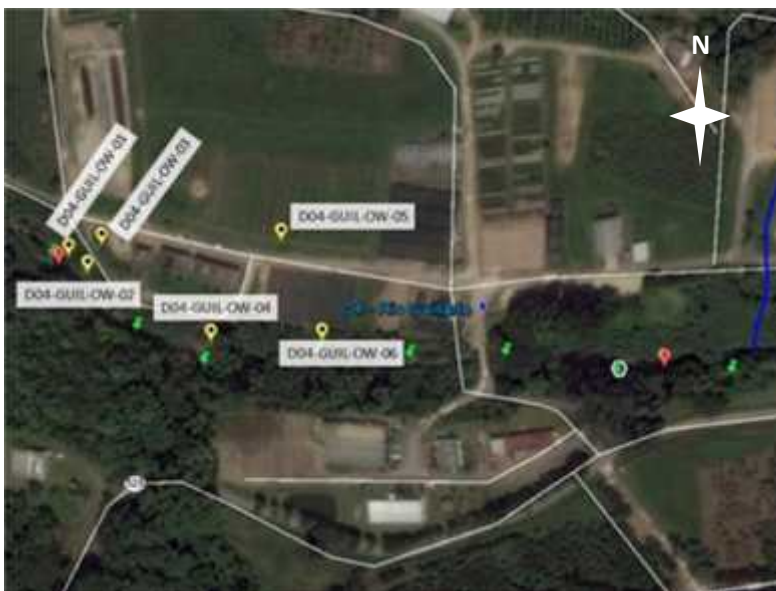
**Figure 25** Initial Groundwater Well Locations Based on EMS kmz File at **D04 Río Guilarte**
