<i>Title:</i> D04 AIS Site Characterization Report	<i>Author:</i> J. Vance	<i>Date:</i> 1/05/2016
<i>NEON Doc. #:</i> NEON.DOC.001648		<i>Revision:</i> C

## D04 AQUATIC INSTRUMENT SYSTEM (AIS) SITE CHARACTERIZATION REPORT

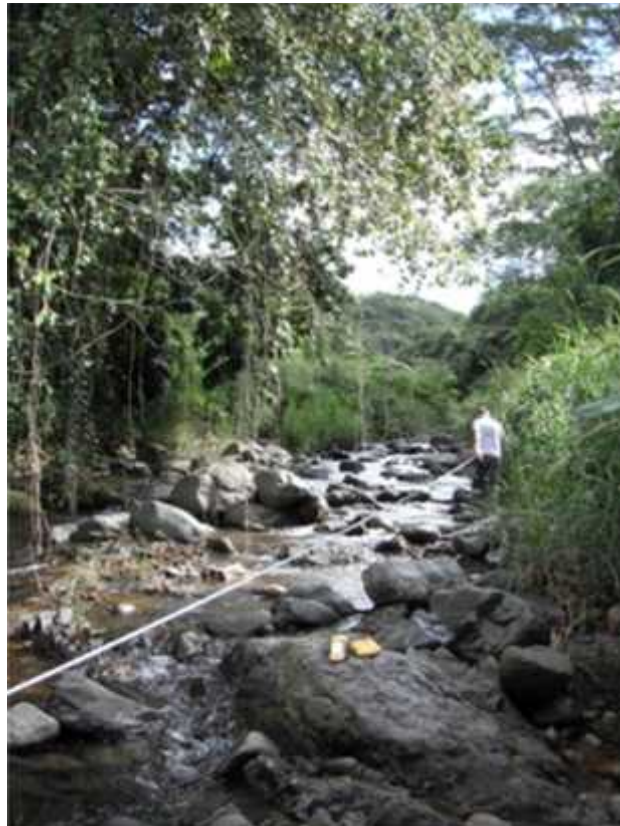
**Figure 48** Large boulders are a dominant feature of the Río Guilarte substrate regime.

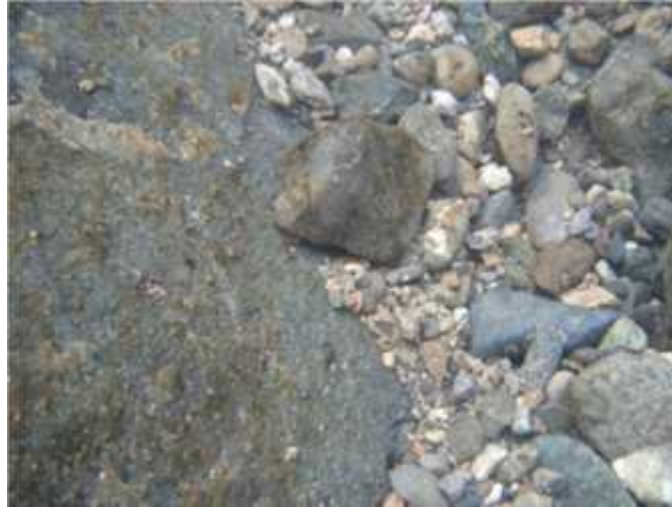
**Figure 49** Aside from large boulders, Río Guilarte substrate consists of a heterogeneous mixture of cobble, pebble and sand.

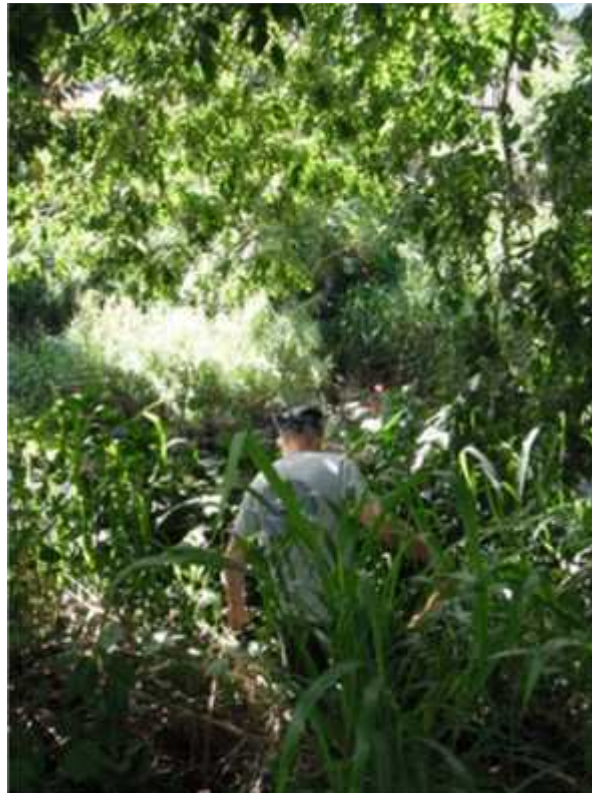
**Figure 50** Although the NEON Río Guilarte reach is close to the agricultural station roads, some vegetation will need to be cleared to facilitate access to sensors.

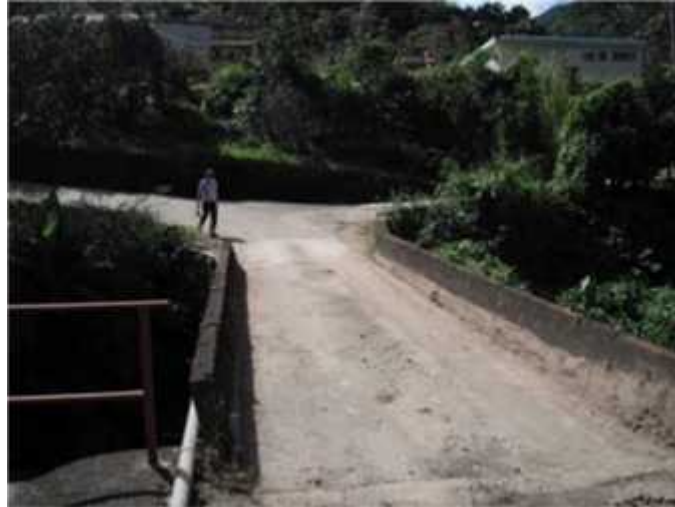
**Figure 51** A single-lane bridge crosses Río Guilarte approximately midway through the NEON reach.

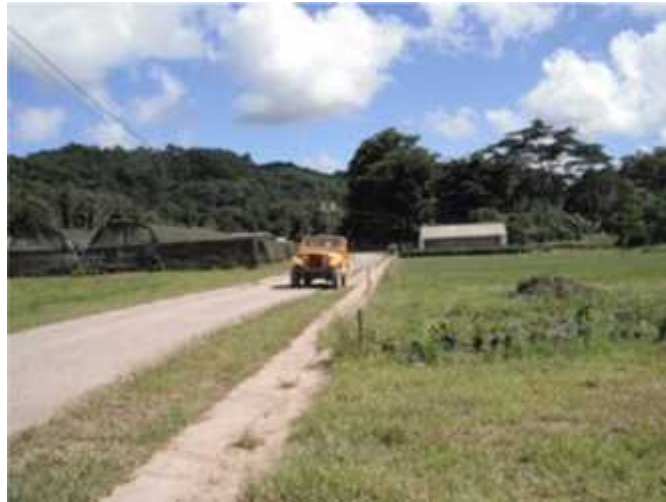
**Figure 53** Well-maintained access roads traverse the property surrounding the NEON reach of Río Guilarte.

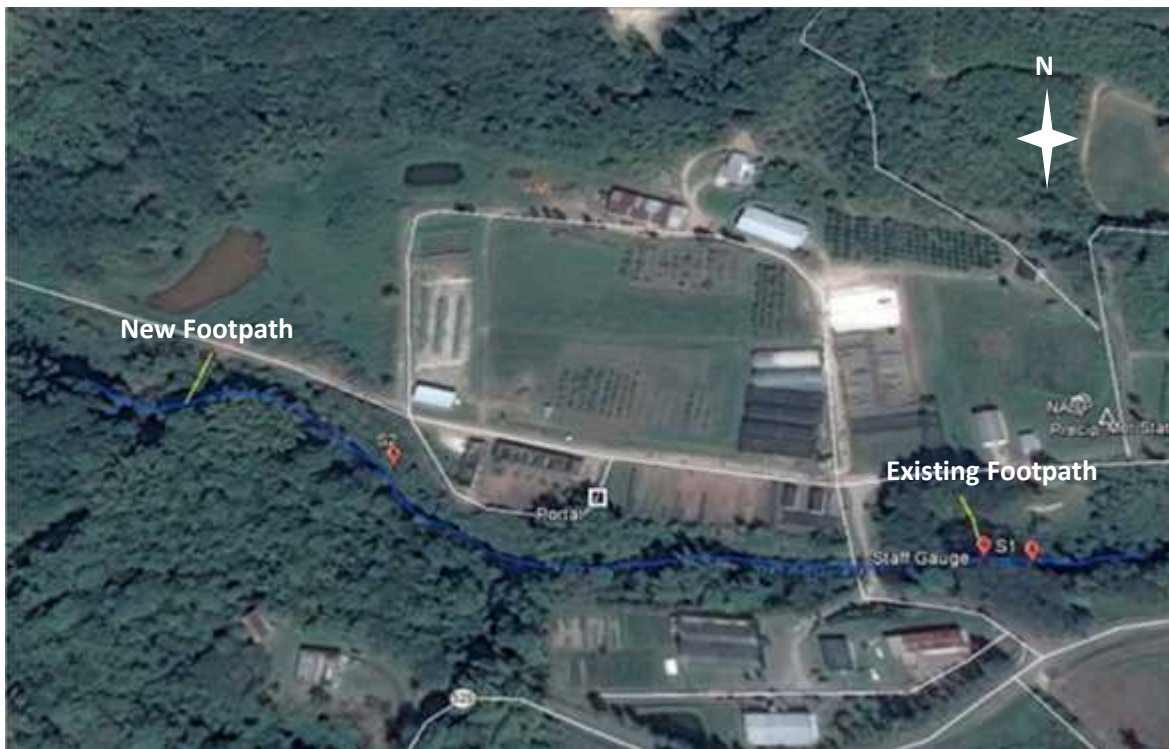
**Figure 55** Routes of required paths to provide access at **D04 Río Guilarte**.
