<i>Title:</i> D17 AIS Site Characterization Report	<i>Author:</i> J. Vance	<i>Date:</i> 02/25/2016
<i>NEON Doc. #:</i> NEON.DCO.003536		<i>Revision:</i> A

## D17 AQUATIC INSTRUMENT SYSTEM (AIS) SITE CHARACTERIZATION REPORT

AQU site characterization information presented in this document is for the **D17** aquatic site locations: **Teakettle 2 Creek** (core) and **Upper Big Creek** (relocatable). Issues and concerns for each site that need further review are also addressed in this document according to our best knowledge. Unless otherwise noted, the information contained herein takes precedence over the same information repeated elsewhere; thereby, this document contains the official change-controlled information pertinent to these sites.

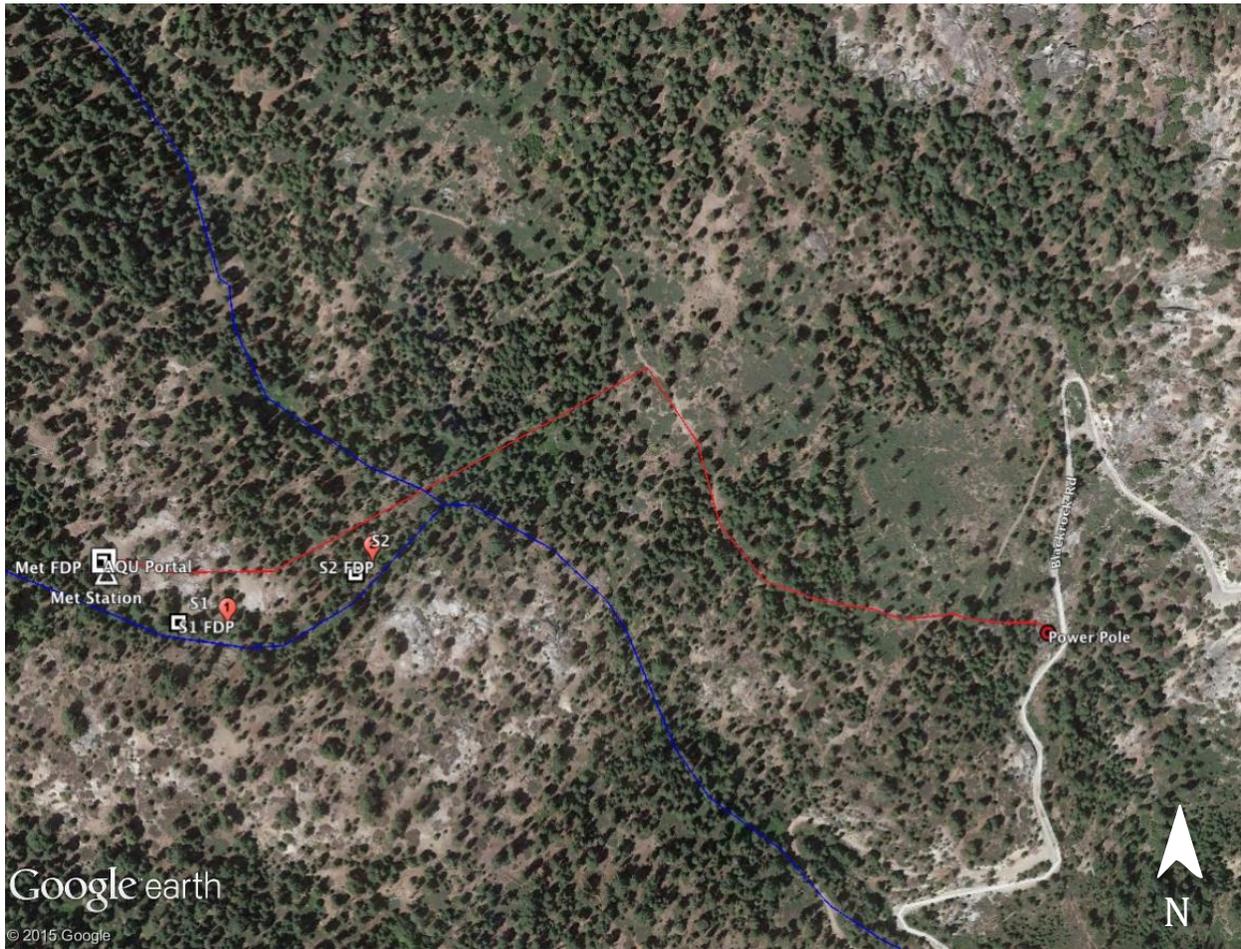
**Figure 10 A Google-Earth-Derived Image of Aquatic Auxiliary Portal for D17 Teakettle 2 Creek.**

The initial estimated location for the Aquatic Auxiliary Portal is:

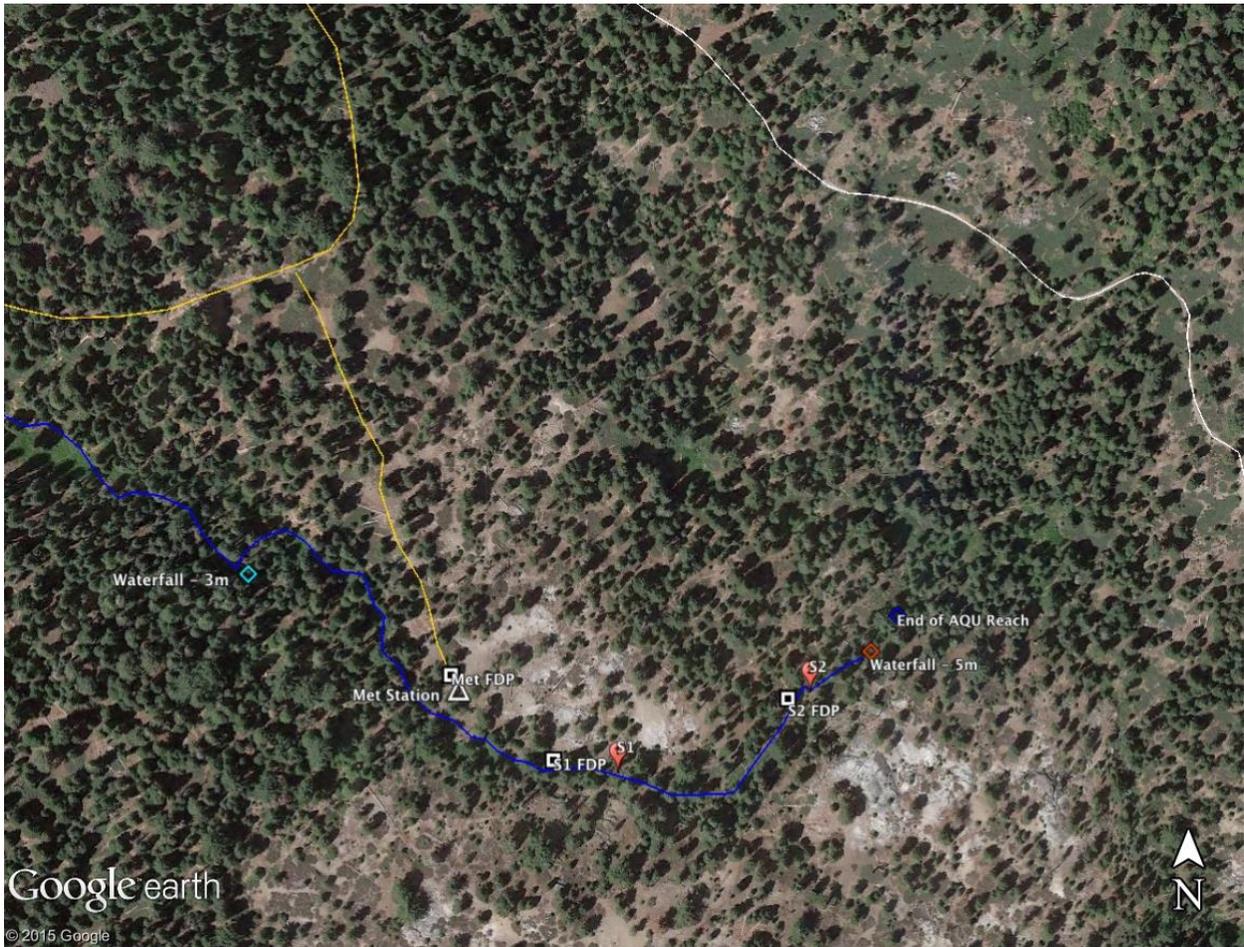
Figure 11 Kmz File of D17 Teakettle 2 Creek Denoting Locations of S1, S2, and Met. Station

Sensor	Latitude	Longitude
Met Station	36.955269°	-119.026122°
Met – FDP	36.955360°	-119.026171°

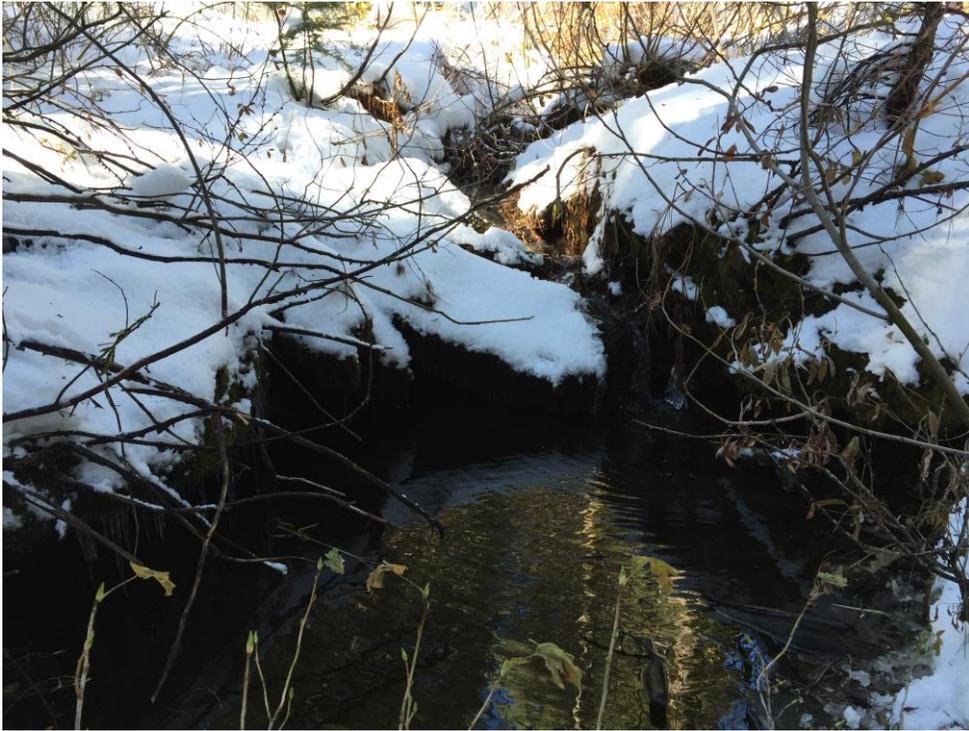
**Figure 12 Upstream view of the S1 location at D17 Teakettle 2 Creek.**

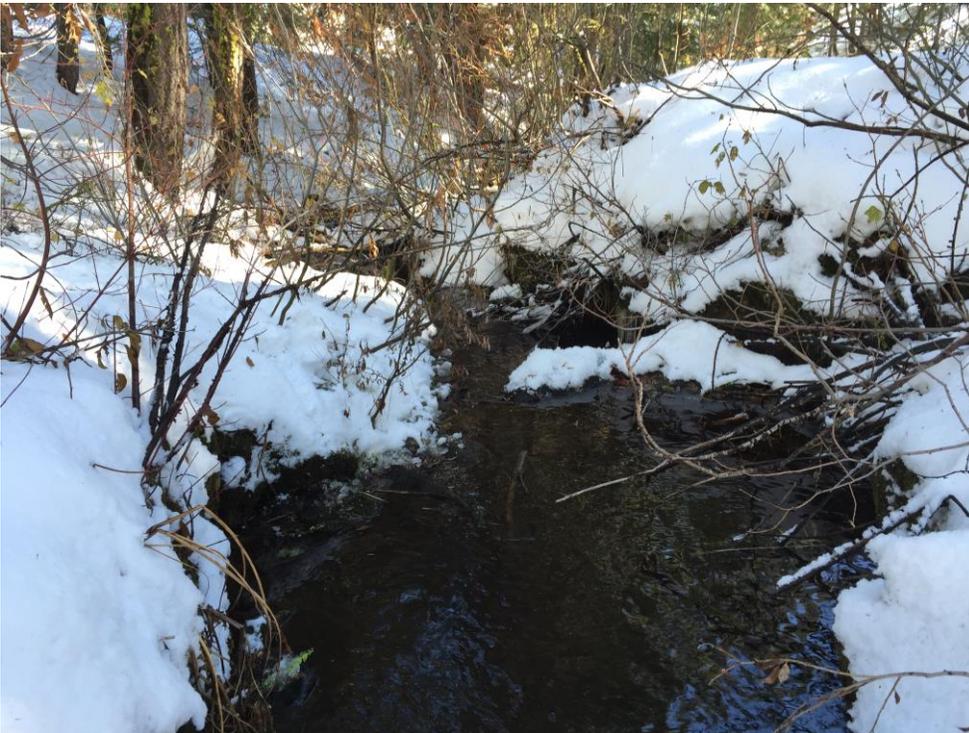
**Figure 13 Downstream view of the S1 location at D17 Teakettle 2 Creek.**

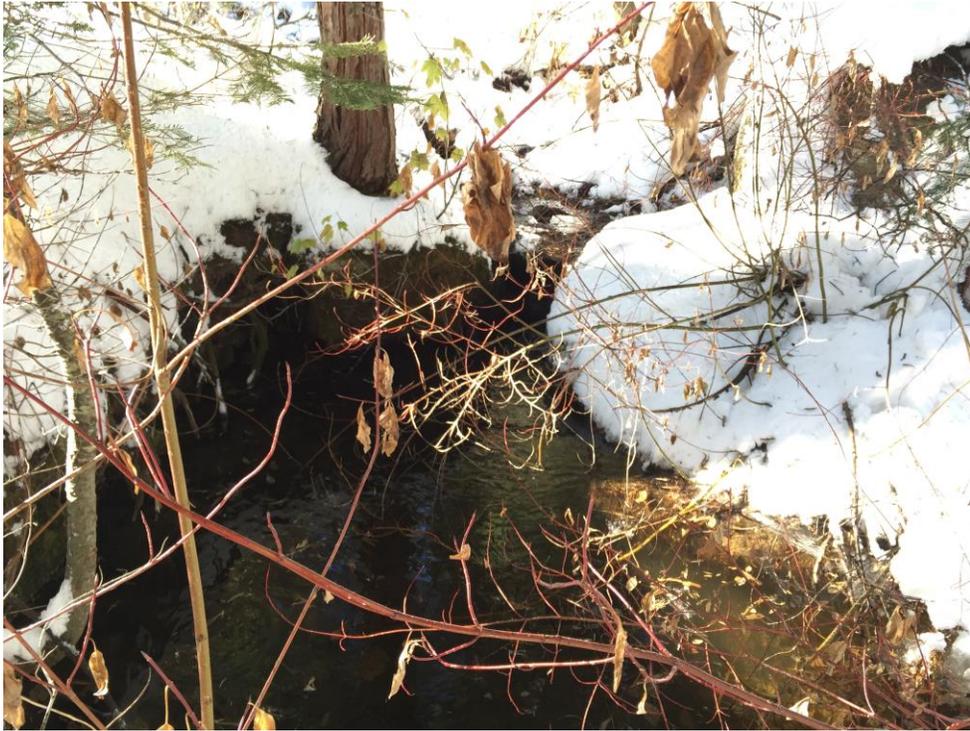
**Figure 14 Upstream view of the S2 location at D17 Teakettle 2 Creek.**

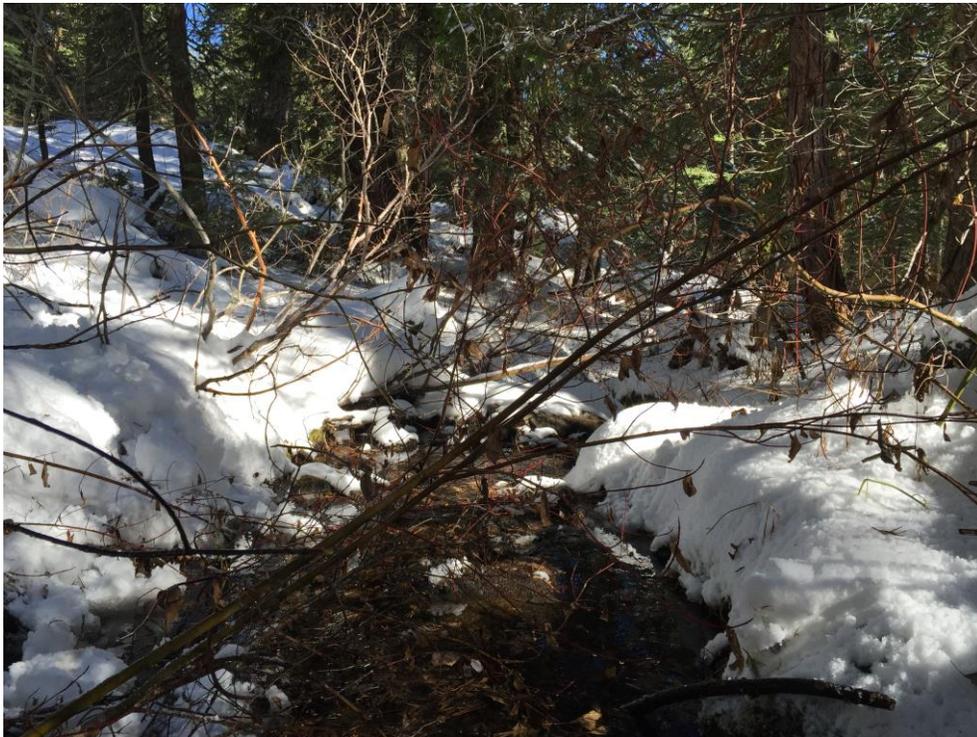
**Figure 15 Downstream view of the S2 location at D17 Teakettle 2 Creek.**

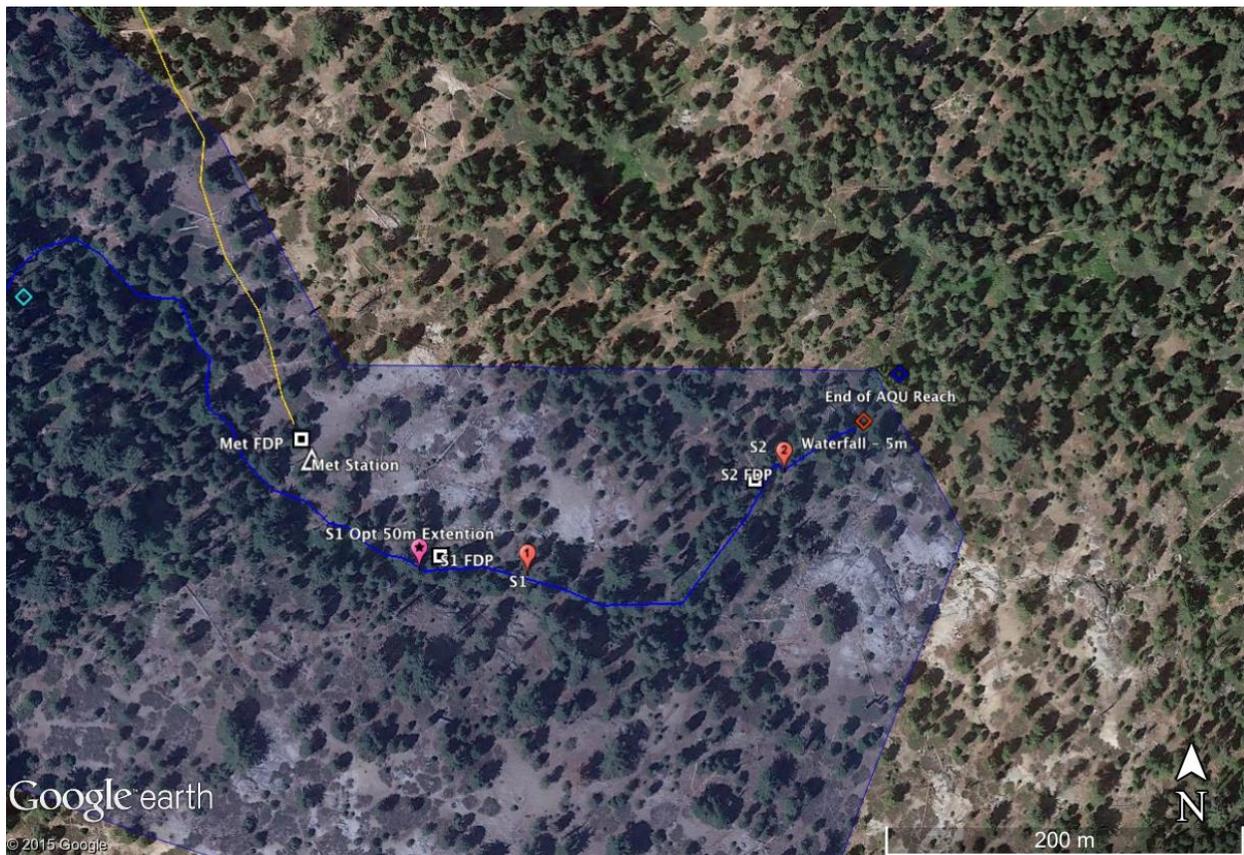
**Figure 17 Map showing the location of an optional S1 pool (pink star balloon) if it is found during operations that the current sensor reach is insufficient to capture the data required.**

It should be noted that the difference between base and seasonally high flows is approximately 18 times. Therefore it may result that a 190m reach length it too short to successfully measure stream metabolism at a temporal coverage that meets the observatory requirements. To mediate this risk, we have placed the S1 FDP 30m upstream from the sensor location. There is a pool located approximately 50m upstream of the chosen S1 location to which the sensor may be moved without changing the power/comms installations. This may not be needed and will not be determined until approximately one year into operations of the site.

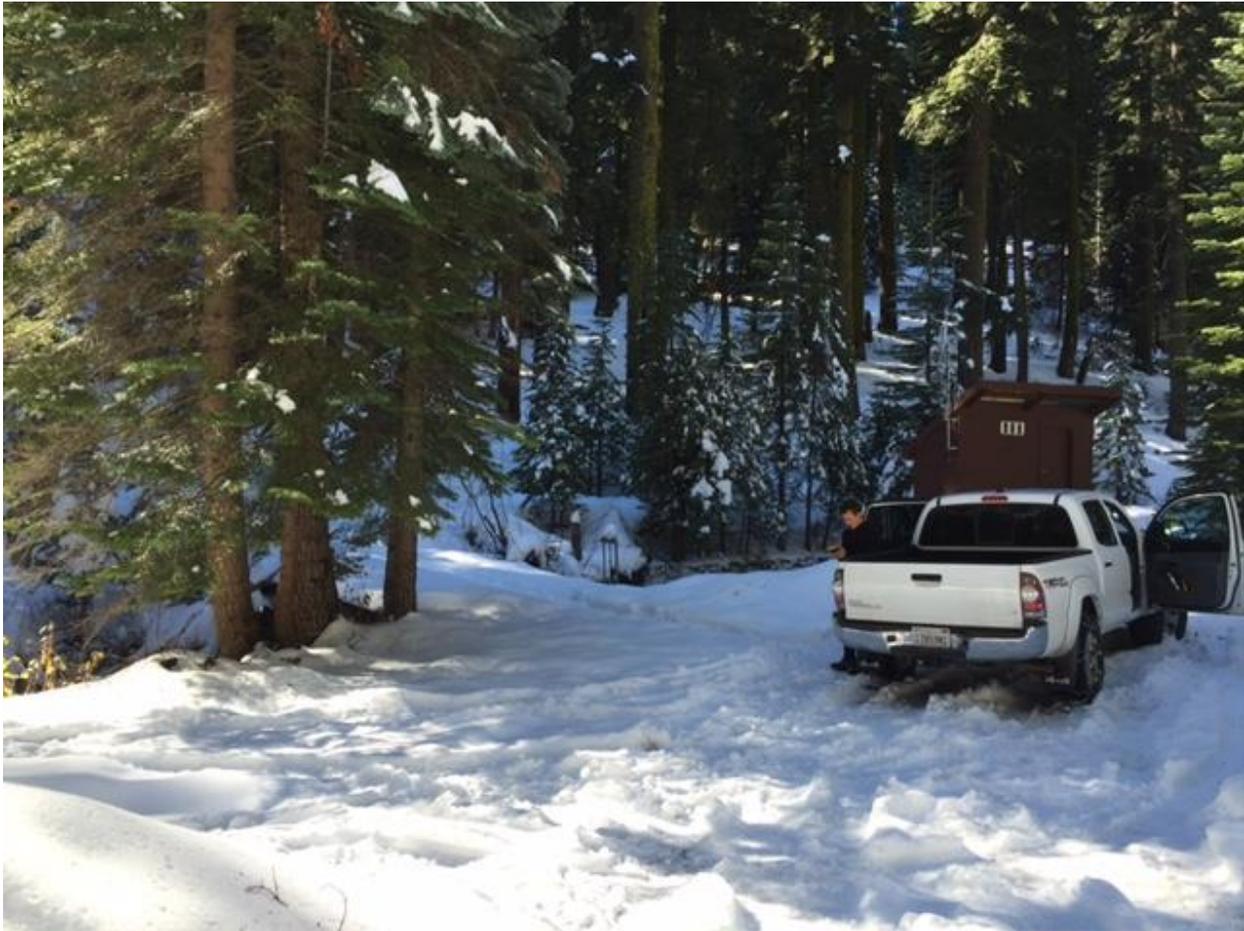
**Figure 24 Photo of parking area where road terminates at existing bridge and gauging station on TEAK3.**

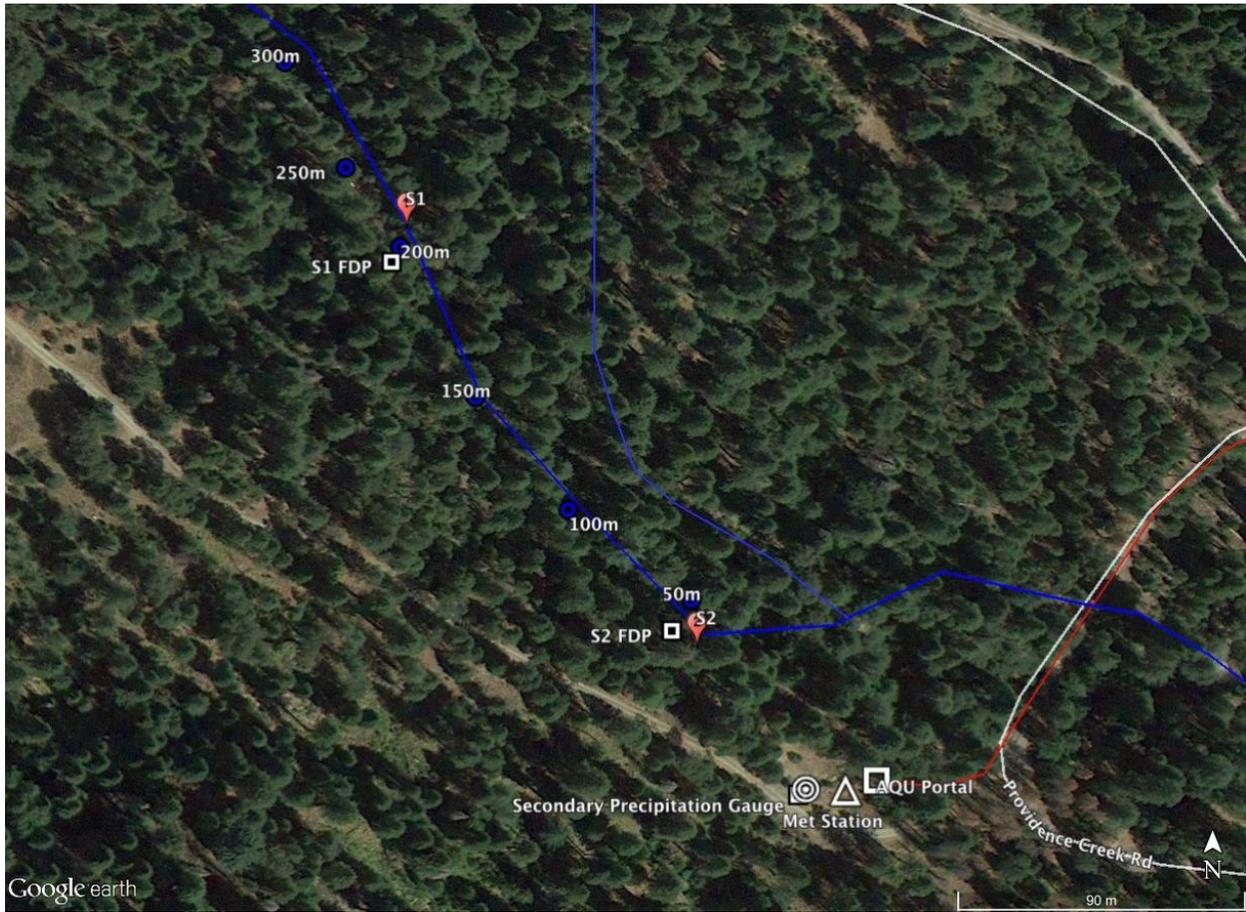
**Figure 35 Locations of S1, S2, Met Station and Secondary Precipitation for D17 Upper Big Creek.**

There are existing gravel roads that extend up both sides of the AQU reach (see Figure 35). These may be used to access the stream for sampling and maintenance activities. Therefore no pathway construction or improvements will be needed from this site.

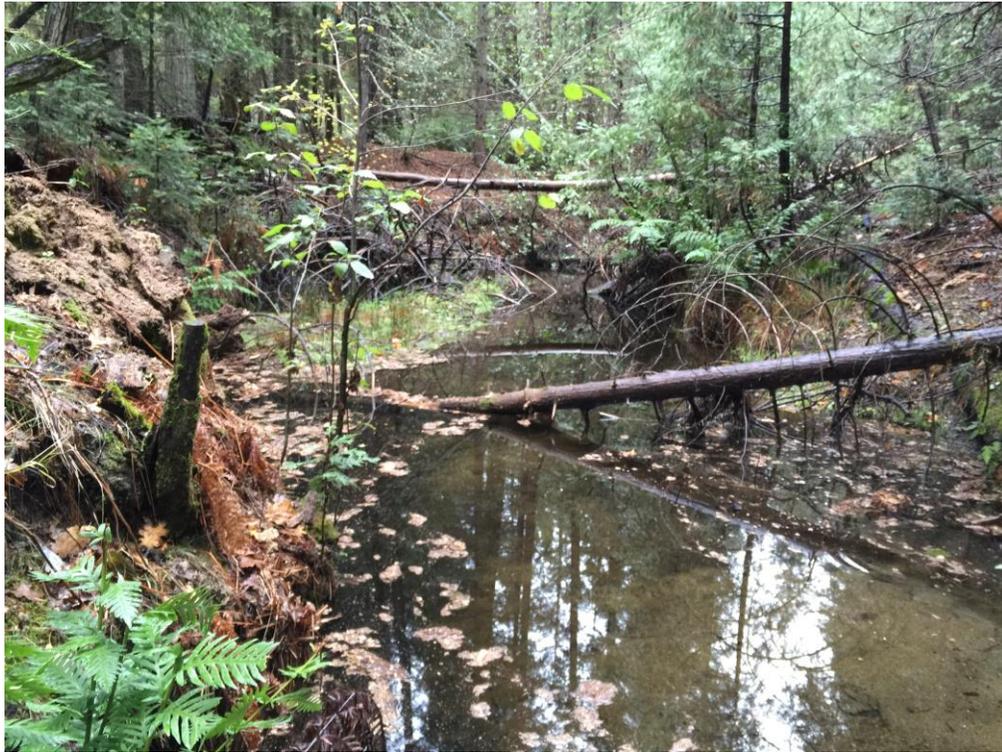
**Figure 36** Downstream of S1 location at D17 Upper Big Creek.

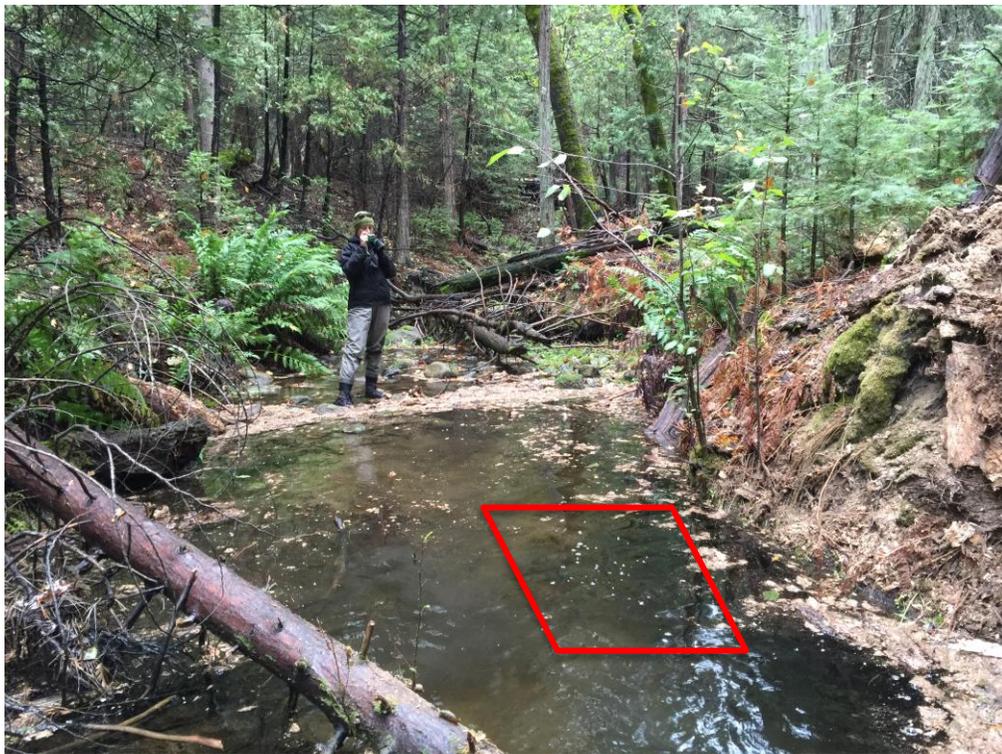
**Figure 37** Upstream view of S1 location at D17 Upper Big Creek.

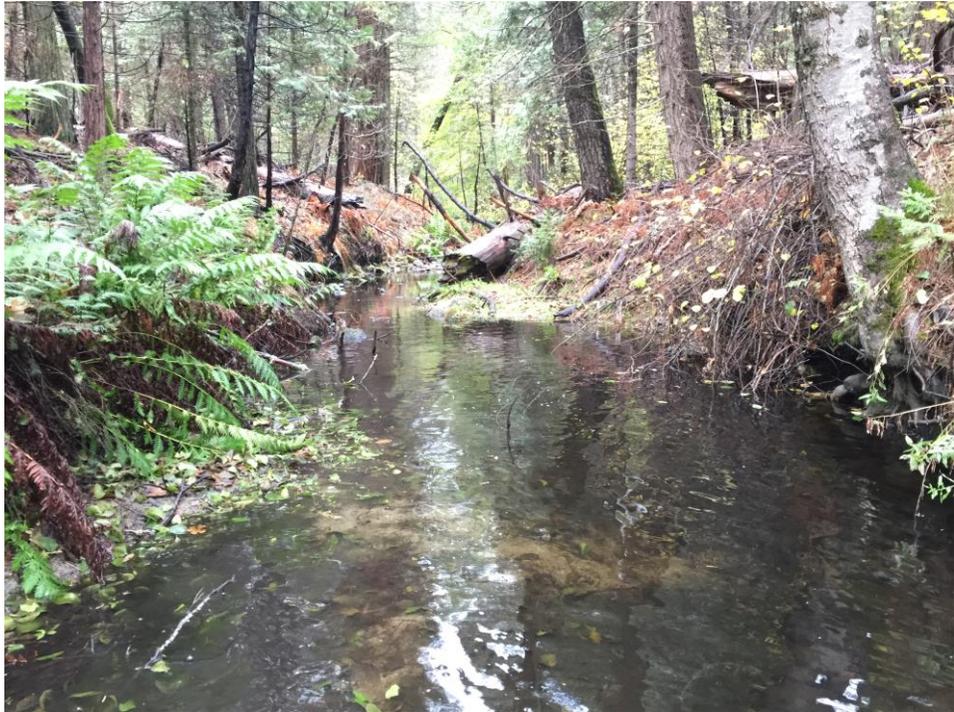
**Figure 38** Upstream view of S2 location at D17 Upper Big Creek.

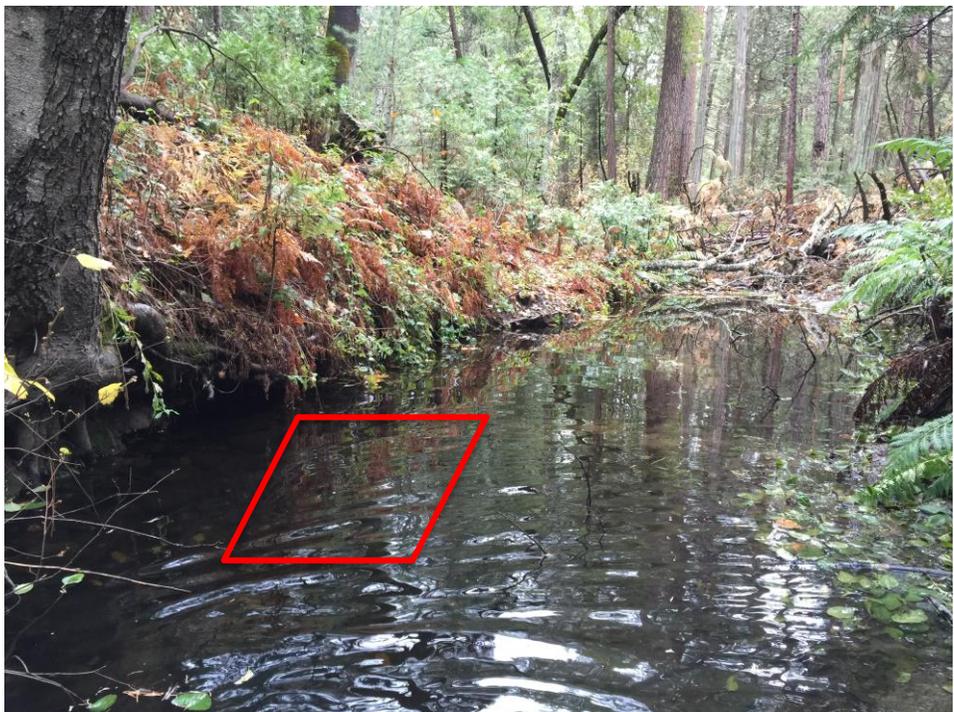
**Figure 39** Downstream view of S2 location at D17 Upper Big Creek.

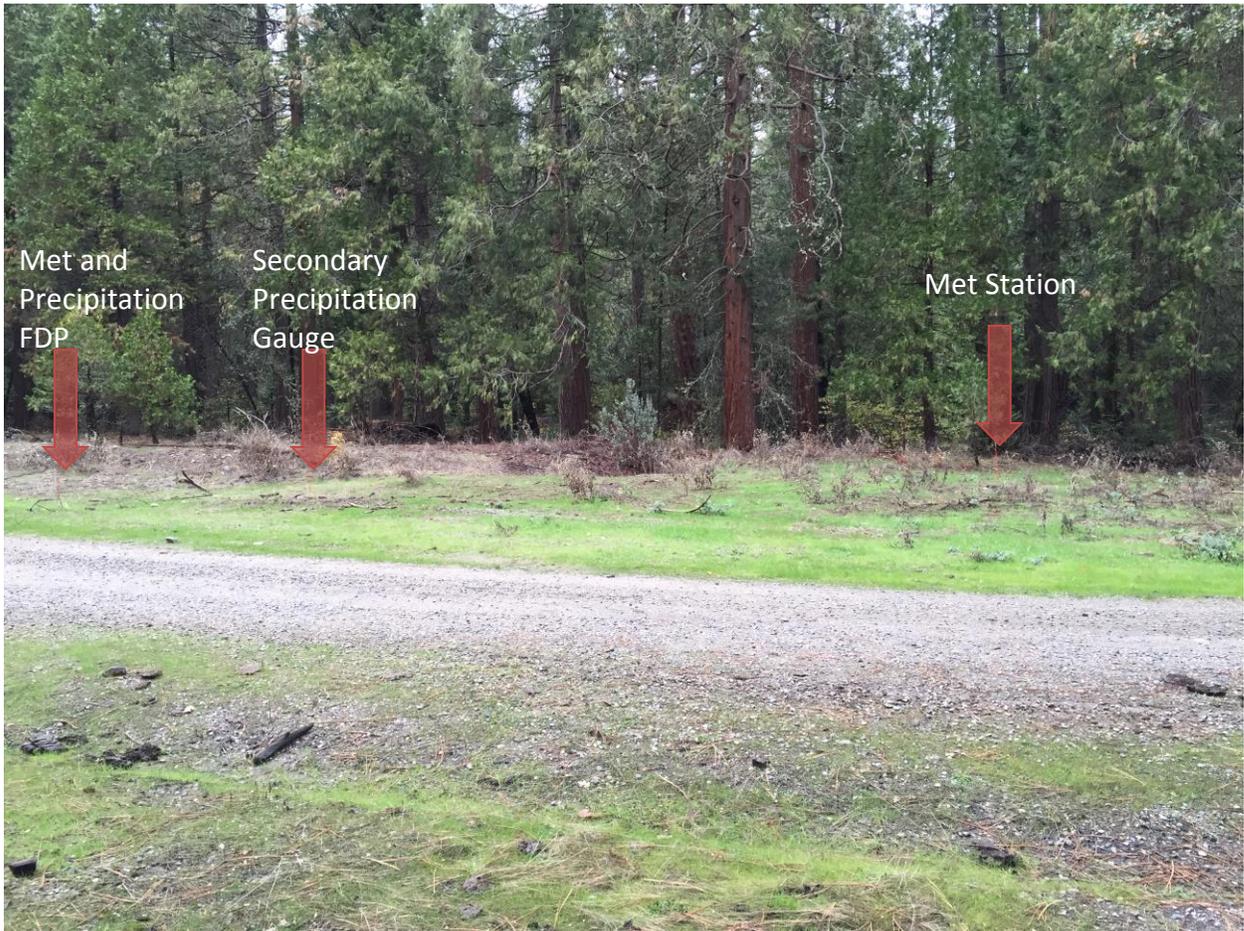
**Figure 40** Photo of met station and secondary precipitation gauge location at D17 Upper Big Creek.

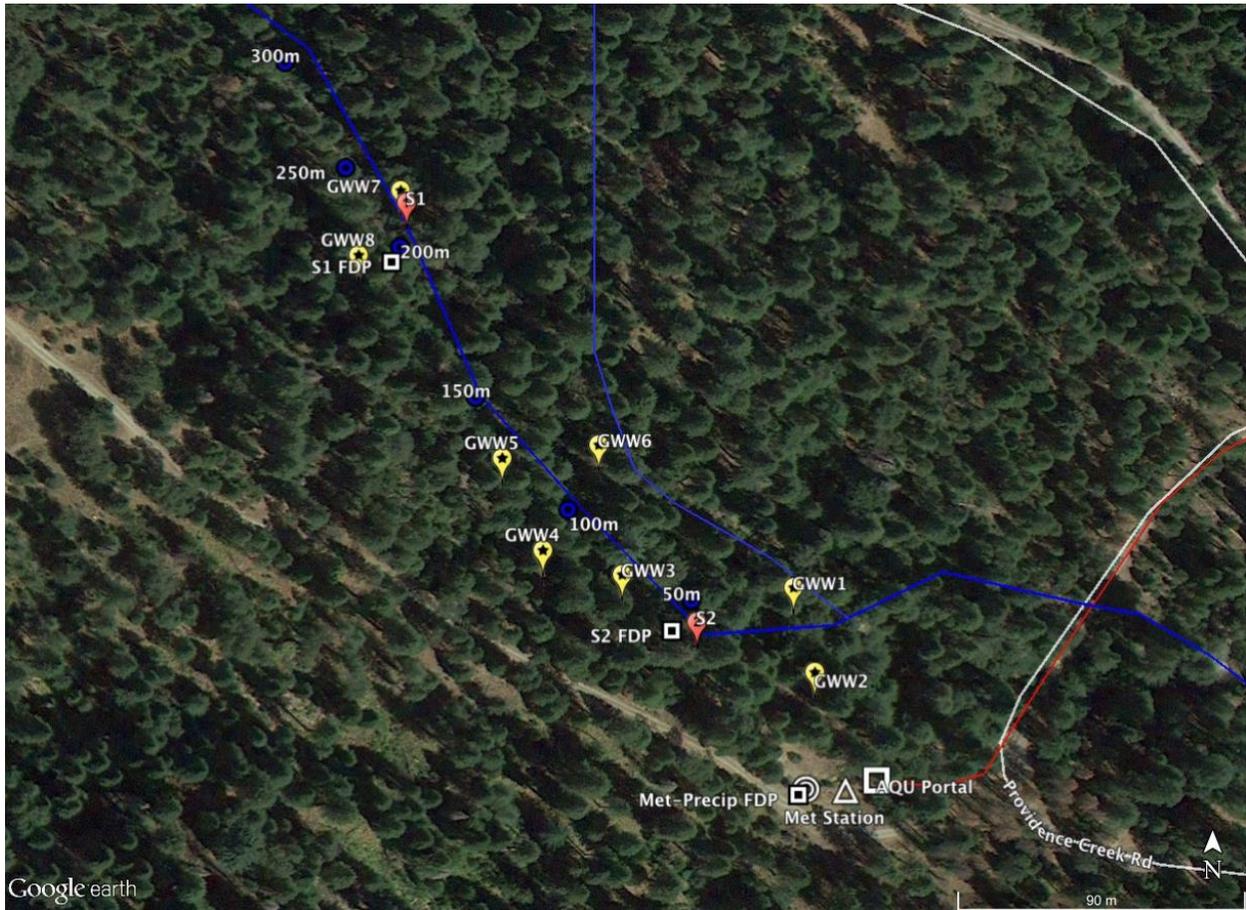
**Figure 44 Initial Groundwater Well Locations Based on EMS kmz File at D17 Upper Big Creek.**

AQU prefers the surface completion of the wells to include an above-grade stick-up protective cover and be minimally invasive. The State of California has several requirements for construction of groundwater monitoring wells that NEON will either need to meet or apply for a waiver. Chief among the State requirements are 1) an acceptable grout to fill the annular space such as neat cement, bentonite chips, or a bentonite / cement mixture; 2) surface seal of the well requires a poured concrete or cement slab poured around a steel outer casing with a locking cap from a depth of 2 feet below land surface to the top of land surface.

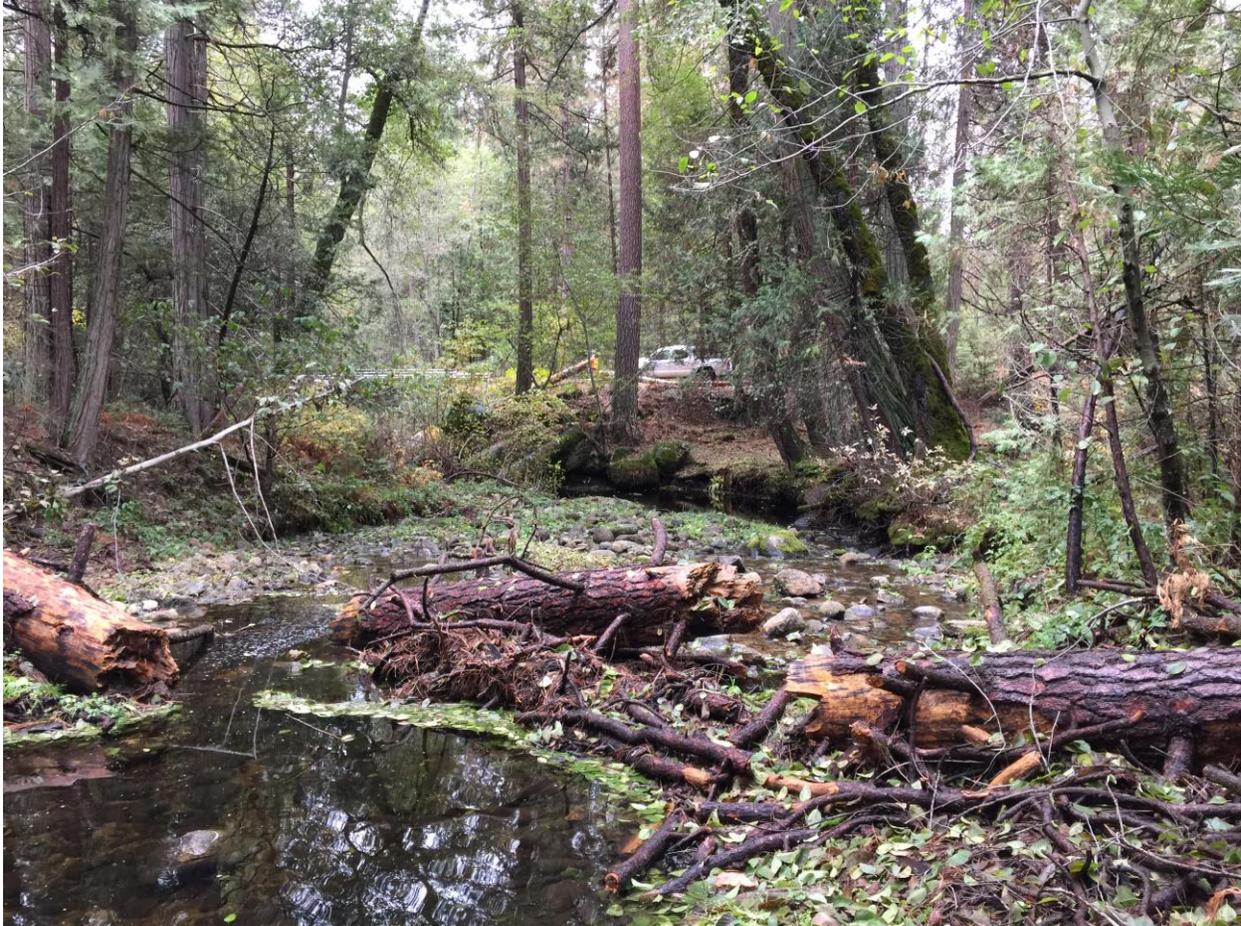
**Figure 45 Photo of parking area at bridge at the base of the AQU reach.**

reach the site. Travel in the area is via maintained paved roads to the parking area. The parking is suitable for two vehicles and there are turn-around areas at the intersecting roads near the bridge.
