<i>Title:</i> D08 AIS Site Characterization Report	<i>Author:</i> J Vance	<i>Date:</i> 06/03/2016
<i>NEON Doc. #:</i> NEON.DOC.001370		<i>Revision:</i> B

D08 AQUATIC INSTRUMENT SYSTEM (AIS) SITE CHARACTERIZATION REPORT

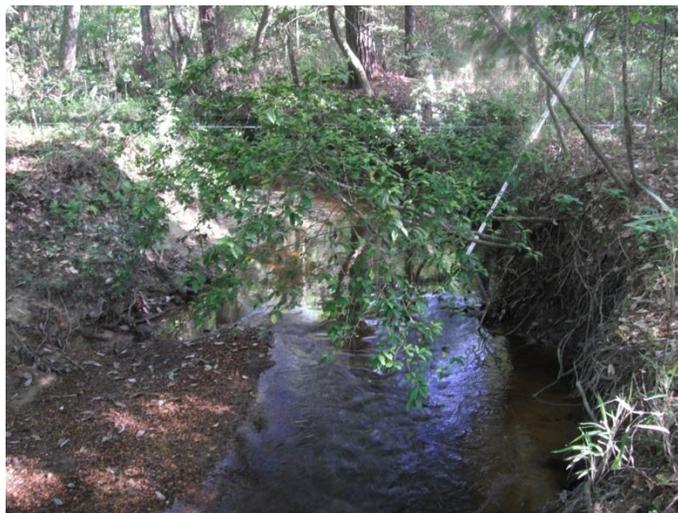
Figure 3. S1 Location at D08 Mayfield Creek. Note that the left bank rises vertically from the channel, while the right bank is more gently graded. Perspective is facing upstream.

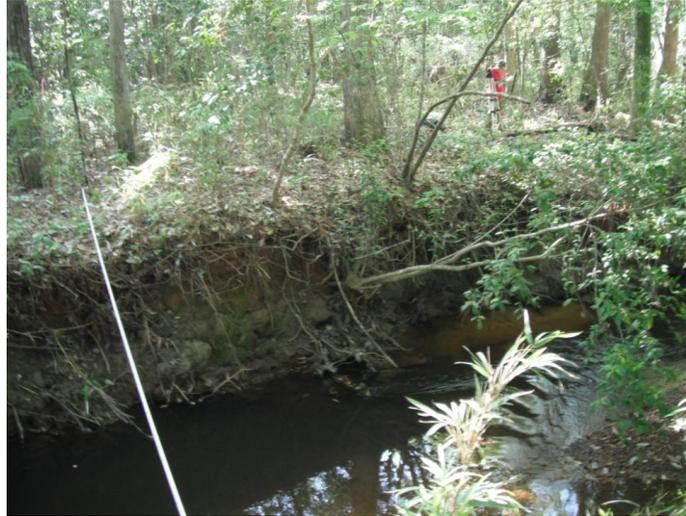
Figure 10. Typical bank attributes at sensor locations. Shown here is the left bank of the S1 location.

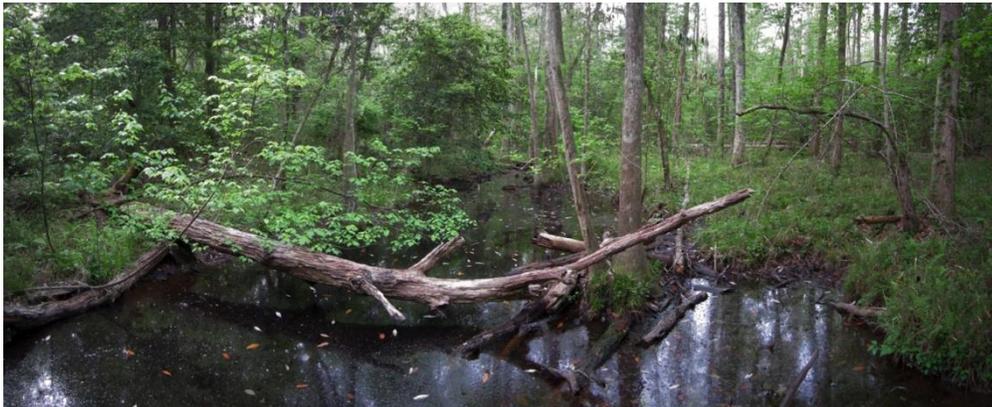
Figure 13. Small patches of riparian wetland areas that are noncontiguous with the stream channel are present in the Mayfield Creek watershed. The above wetland was separated from the stream channel by about 20 m of dry land. Such areas likely influence hydrologic and biological attributes of Mayfield Creek and should therefore not be disturbed by infrastructure such as trails.

Furthermore, as shown in Figure 13, patches of riparian wetlands are sporadically located in the immediate vicinity of **Mayfield Creek**. These include any areas with standing water or evidence of prolonged standing water during certain seasons (they may completely dry in the later summer or early fall). *The access pathway must avoid these areas*, as they likely influence the hydrologic and biological attributes of **Mayfield Creek**. The precise locations of these areas are currently unknown, though developing a pathway that does not disturb these areas should not prove particularly difficult, as these wetlands are small, isolated patches of habitat.

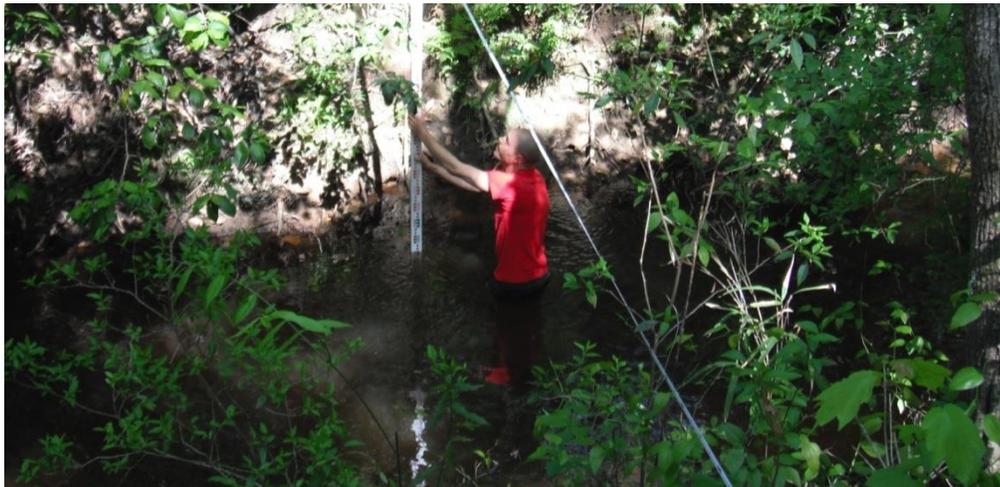
Figure 15. Isolated sections of **Mayfield Creek** may be waist-deep during baseflow, though the majority of the channel is under 0.5 m deep.

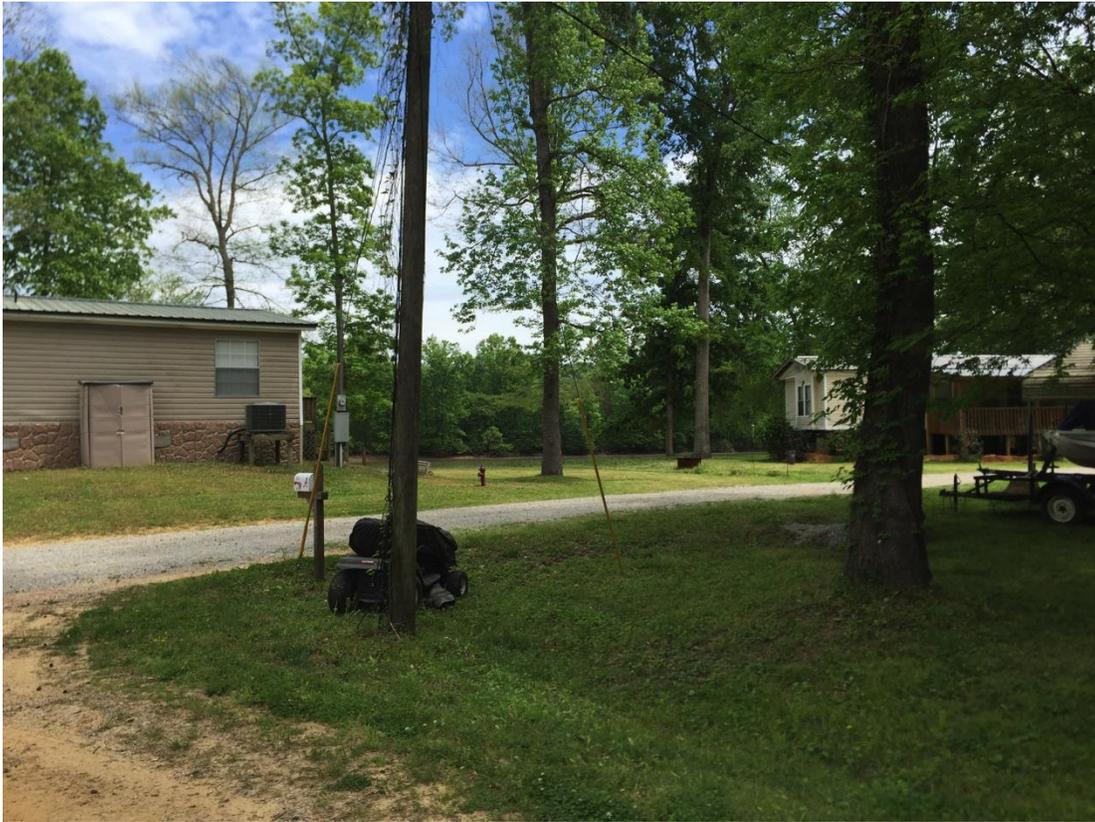
Figure 20. Picture of existing power pole where AQU and AUX Portals shall be installed.

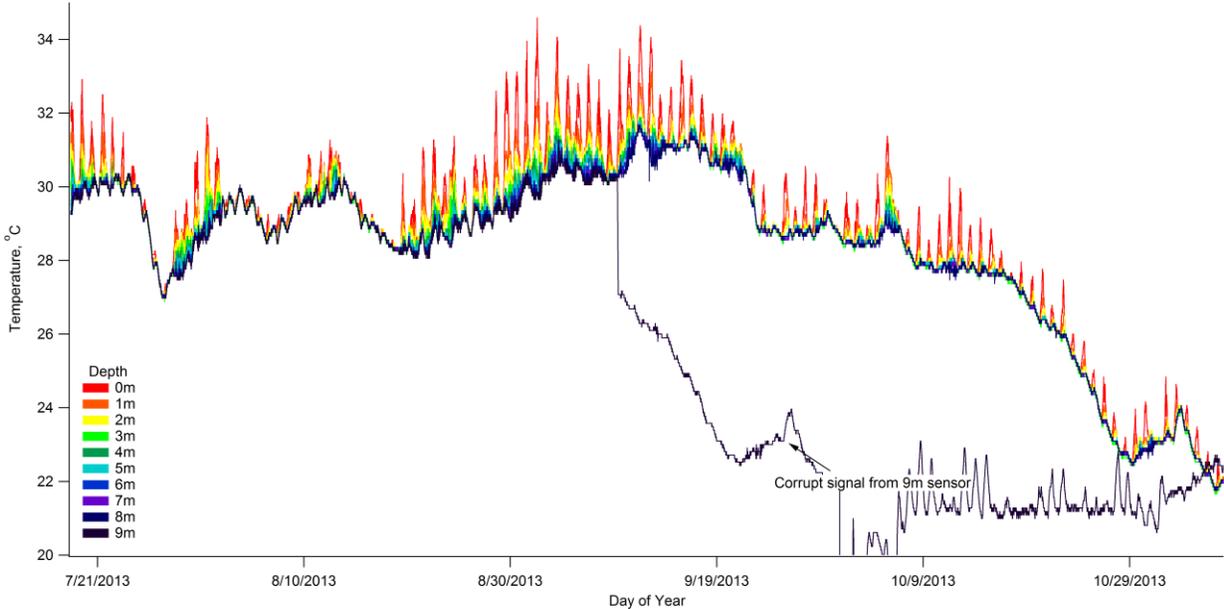
Figure 29 shows the time series of the temperature profiles in the river. The bottom sensor experienced data loss during late August and was not recovered from then on. A significant difference in temperature across the water column develops due to surface heating from insolation. A stratification index was calculated as the standard deviation of the temperatures across the profile (Figure 30).

Figure 29. Time series of water temperature profiles during initial characterization.

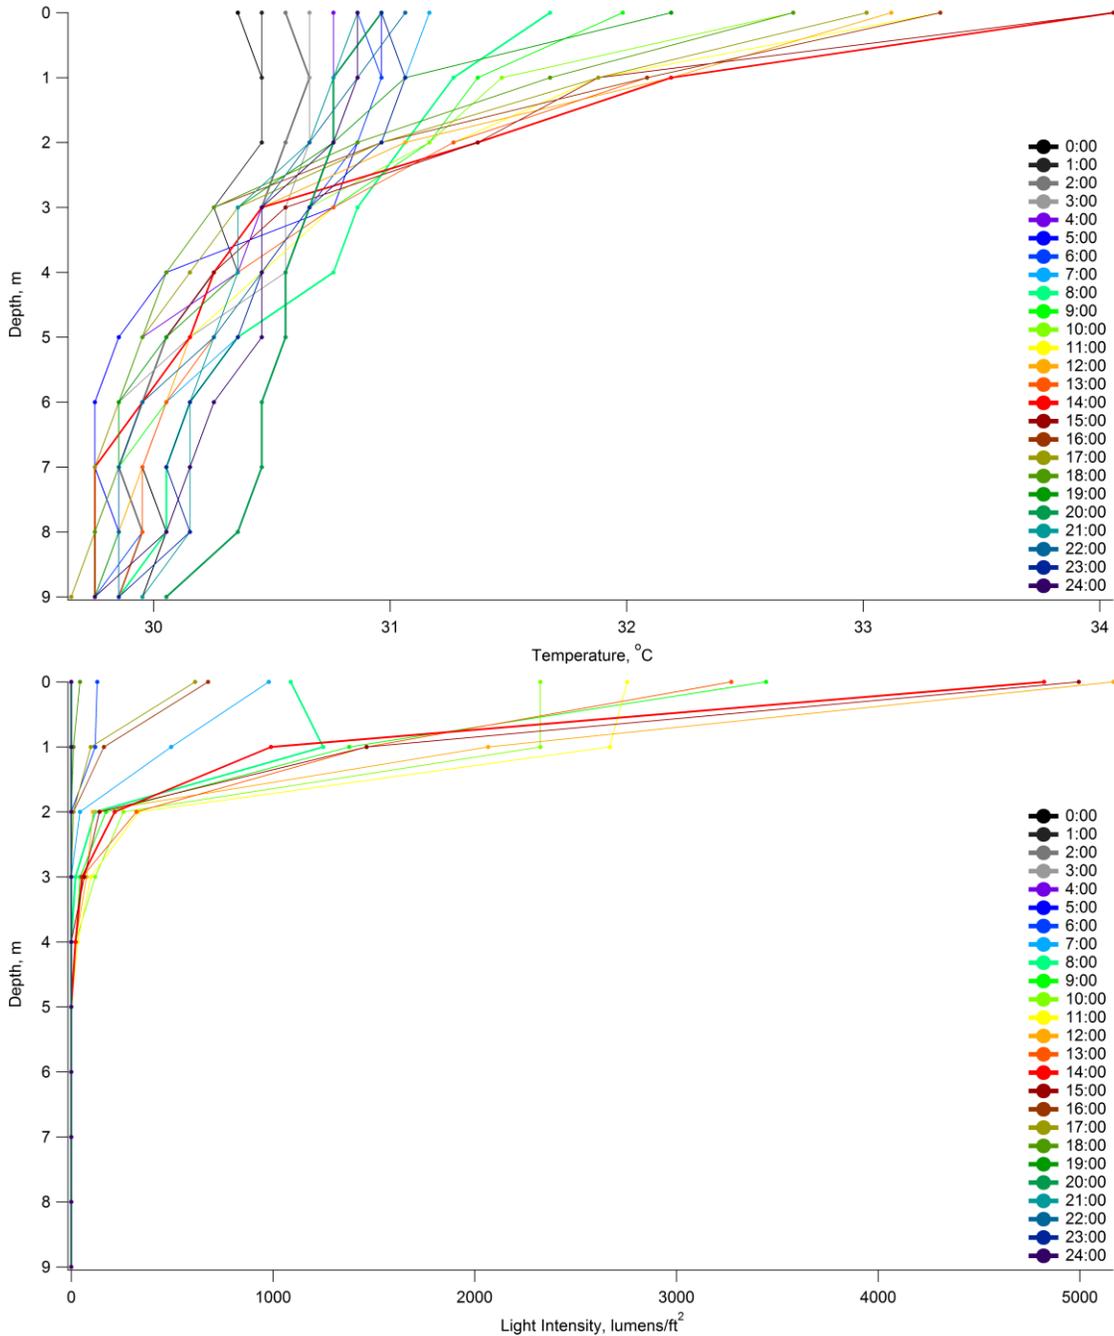
At peak stratification the temperature difference from surface to depth was over 4 degrees Celsius (see Figure 31 top), This level of deviation in temperature is significant with the thermocline forming at 2-3m. The light intensity was also measure along this profile. Figure 31 (bottom) shows that the light attenuates quickly past 2m.

Figure 31. Overlain temperature (top) and light intensity (bottom) profiles during peak stratification.

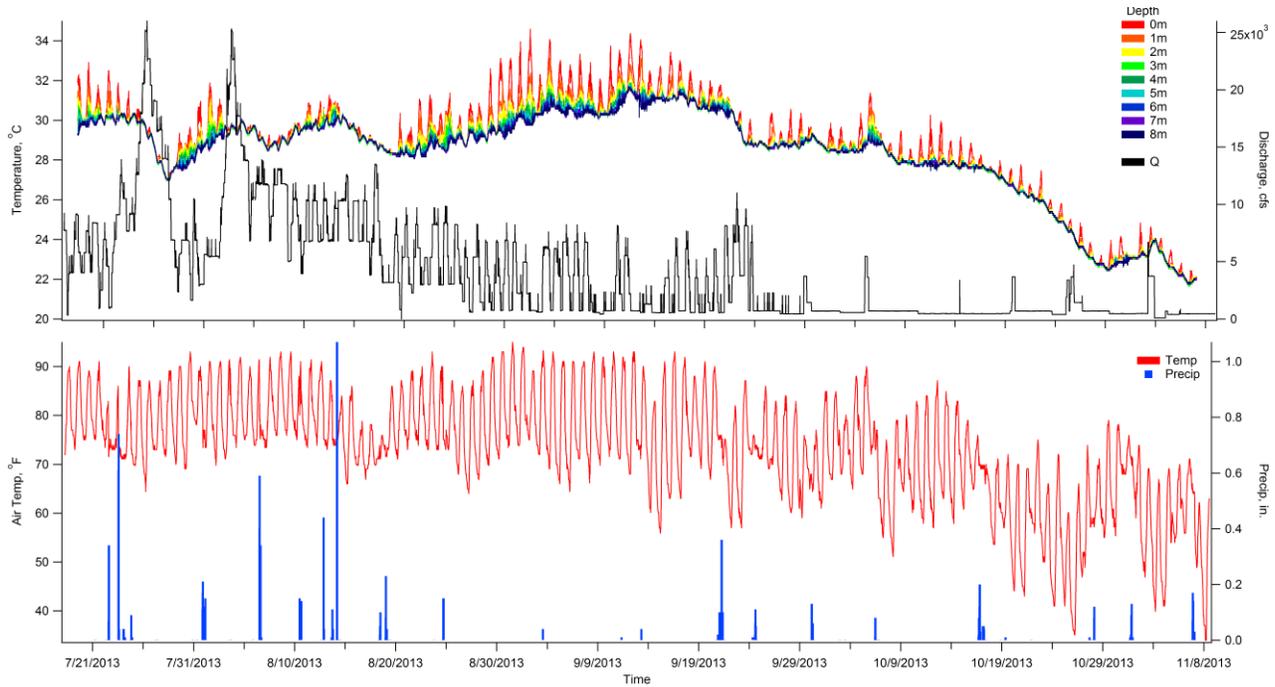
The stratification that follows strong insolation is negatively correlated with discharge. Figure 32 shows the river temperature profile time series with discharge, air temperature and precipitation. High discharge pulses are the result of the lock and dam releases due to river management. The stratification is also negatively correlated with precipitation. Figure 33 shows the daily averaged values of stratification, discharge, and air temperature to highlight these correlations.

Figure 32. Time series of water temperature profile with discharge (top) and air temperature with precipitation (bottom) during initial characterization.

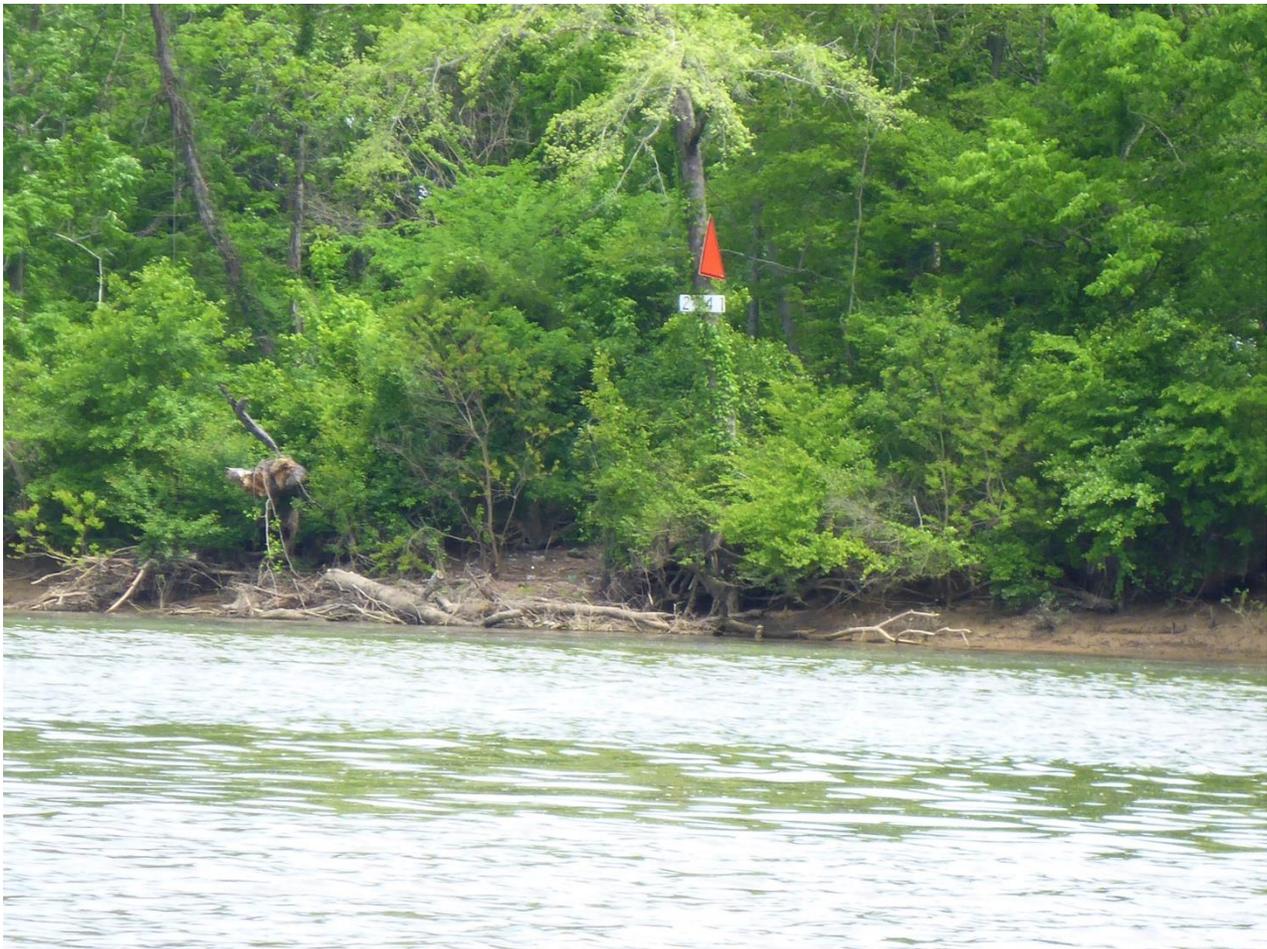
Morphology Type	S1	S2
RB* angle	145	NA
LB* angle	120	NA
Maximum water height	15m	NA
Bankfull width	130m	NA
Substrate composition	Sand, silt, clay	NA

Figure 43. Banks are typically shallow approaching the water along the reach.

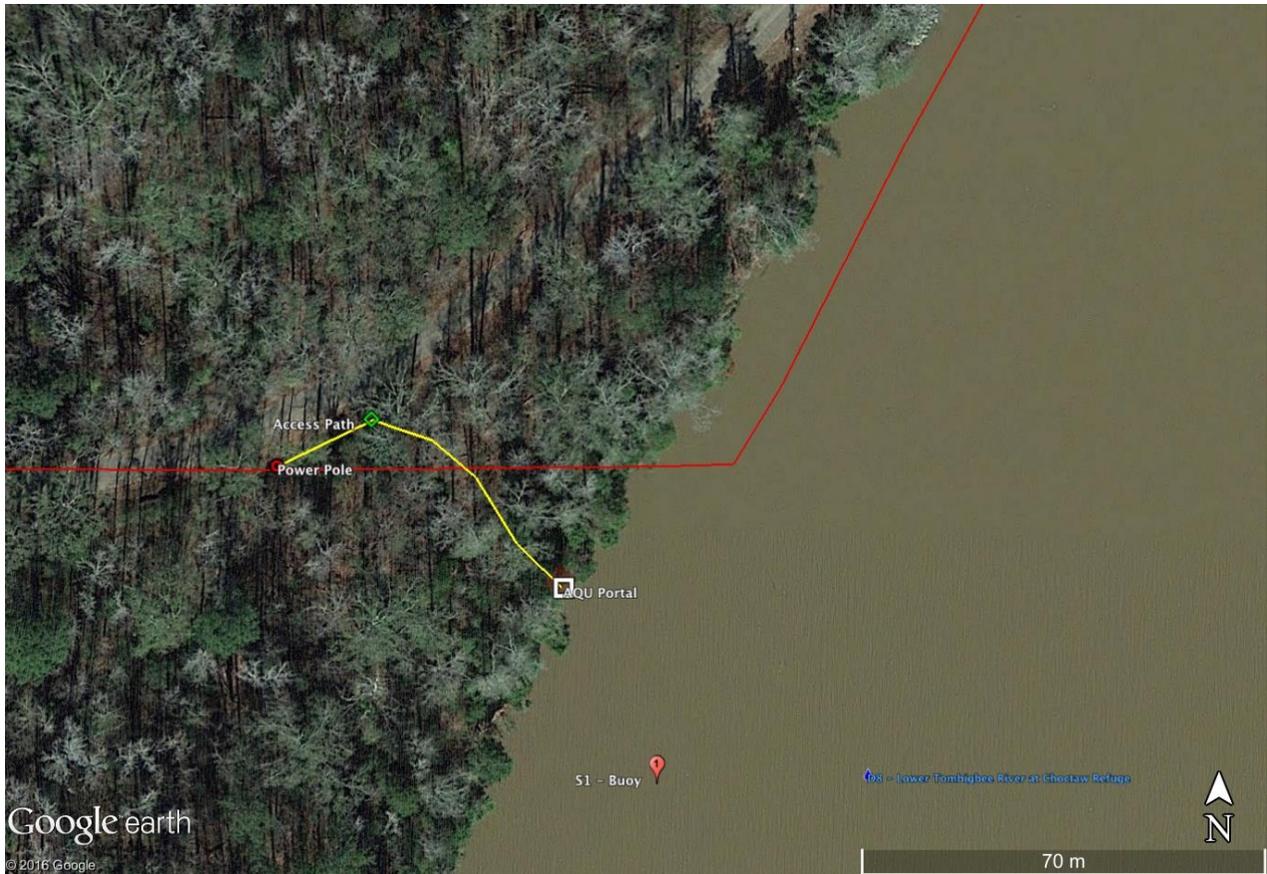
Figure 36 Map showing the location of power pole, the Aquatic and Auxiliary Portal for D08 Lower Tombigbee River, the clearing required (red box) and the conduit run (yellow).

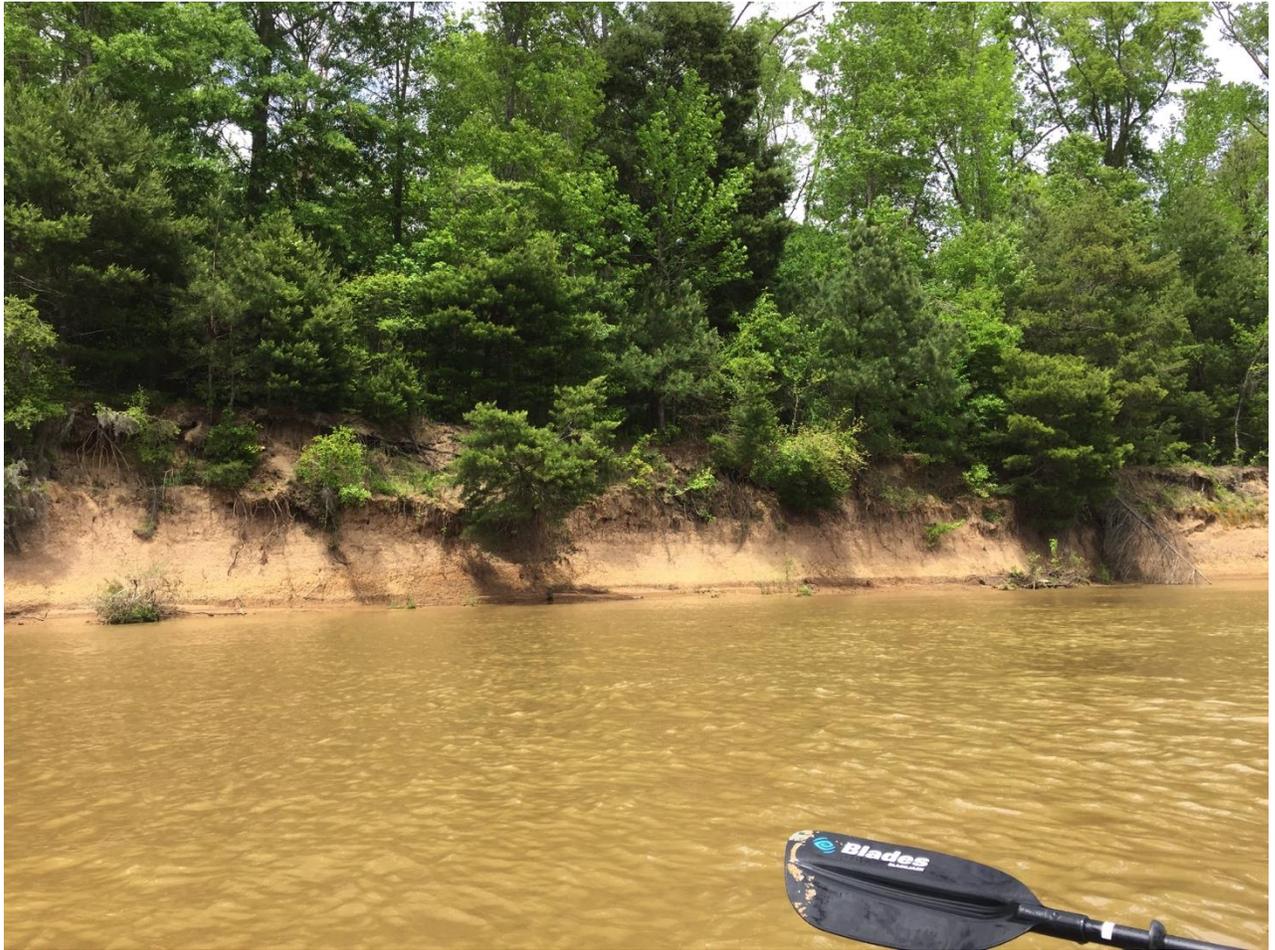
Morphology Type	S1	S2
RB* angle	90 (undercut)	NA
LB* angle	110	NA
Maximum water height	20m	NA
Bankfull width	270m	NA
Substrate composition	Sand, silt	NA

Figure 47 Substrate in D08 Lower Tombigbee River are mostly sand and silt.

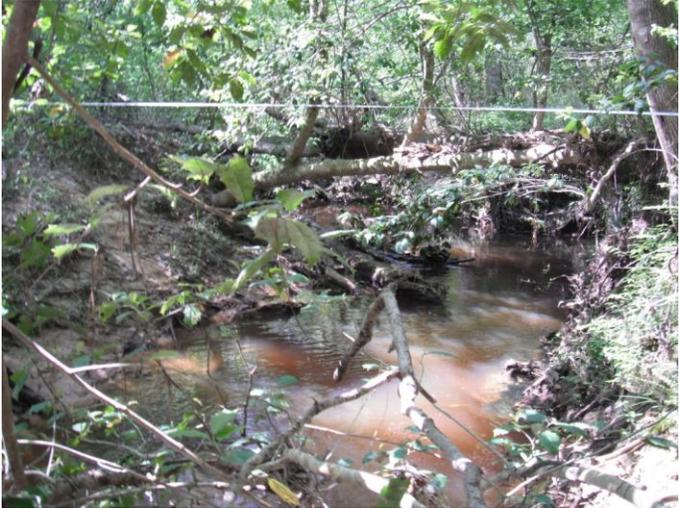
Figure 62 The Mayfield Creek (STR) channel features an abundance of vegetation and woody debris snags. Disturbance to these structures during construction and maintenance should be minimized. Shown here is the S1 sensor location.

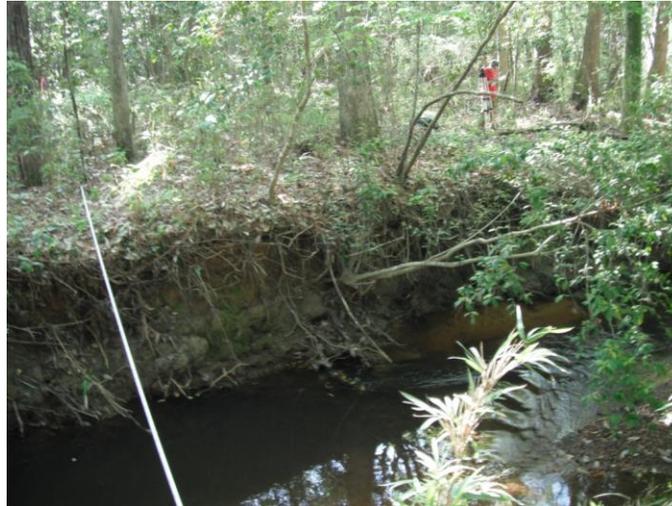
Figure 63 Steep banks ~2 m tall will likely require the installation of a small ladder or stairway to facilitate access to sensors.
