Domain 11 Aquatic Instrument System (AIS) Site Characterization Report

<i>Title:</i> Domain 11 AIS Site Characterization Report	<i>Author:</i> C. Bohall	<i>Date:</i> 04/28/2016
<i>NEON Doc. #:</i> NEON.DOC.002416		<i>Revision:</i> B

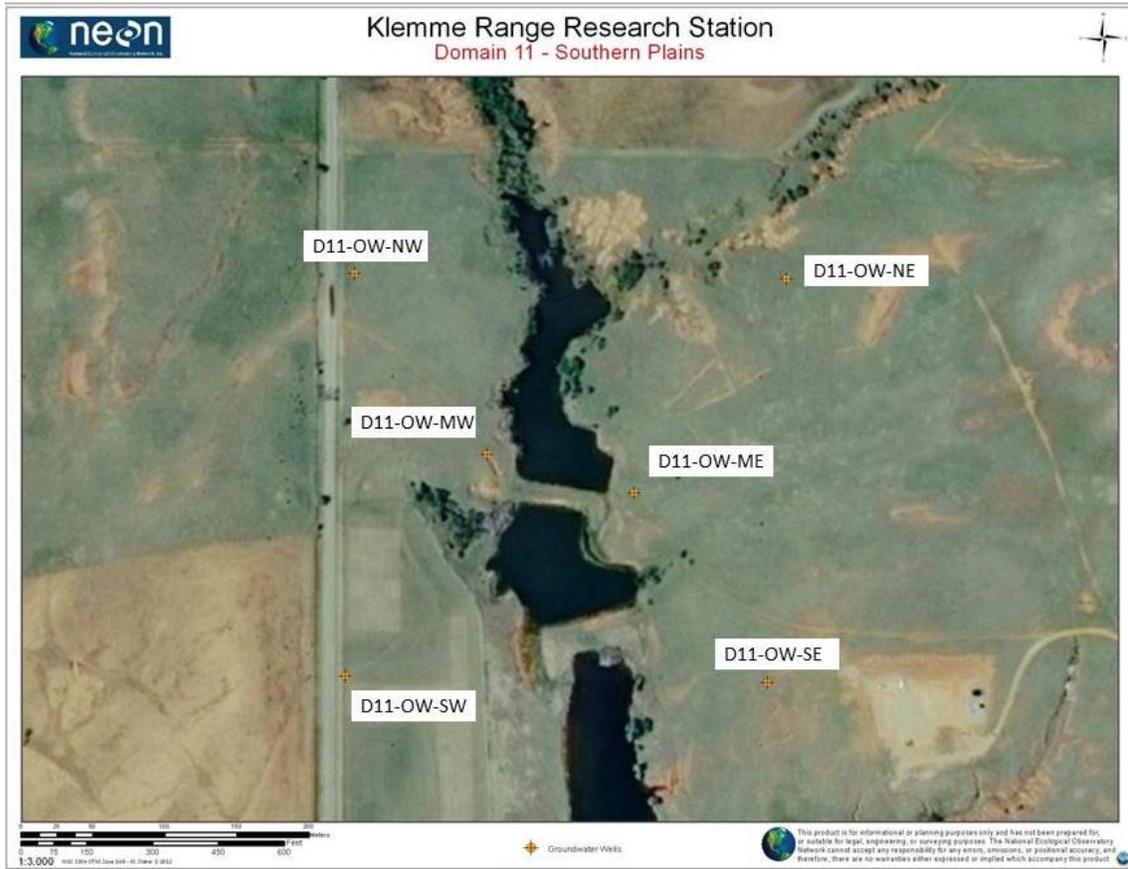
The exact location of wells may vary during the drilling process due to the presence of a dense consolidated layer located several feet below the ground surface. Outcroppings of this layer were observed during the visit. The ranch manager also mentioned this layer with relation to water wells he had drilled at his residential property located approximately ¼-mile from the site. Thus, actual locations of wells and the path of the drill rig will vary slightly from the plan if the augers are not able to penetrate this layer in a specific area.

Figure 49 Initial Groundwater Well Locations Based on EMS kmz File at Domain 11 South Pond Klemme.

The AQU team prefers a steel casing with a non-cement pad and will apply for a waiver for each well. However, EHS should prepare the landowner for this State regulation and the real possibility that cement will need to be used.

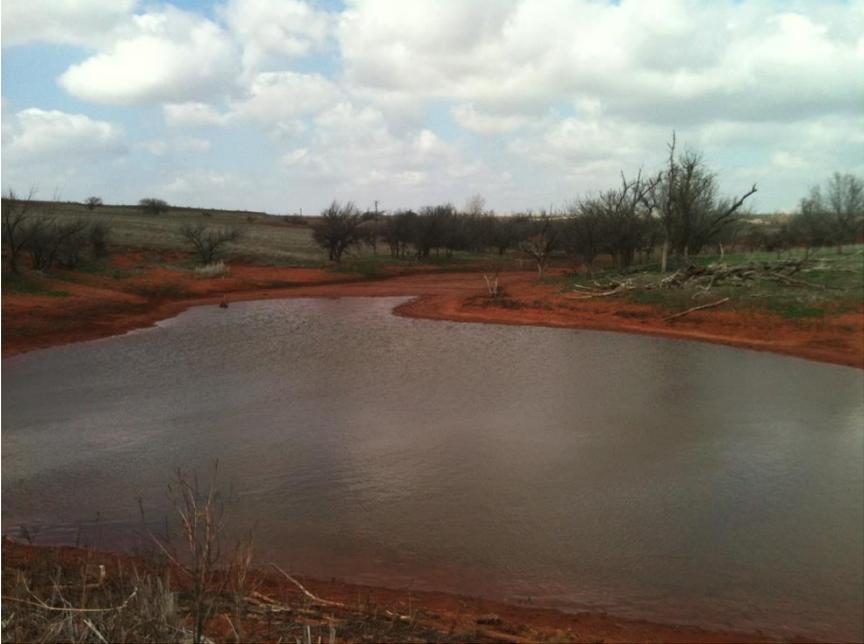
The majority of the higher riparian vegetation (oaks and willows) at North Pond has been removed. A few trees remain near the high water mark (bankful) on the upstream end of the pond. Ground cover consists of shrubs, bushes and forbs that cover 70-90% of the area. The bank edges of the berm consist primarily of cattails near the high water mark and a presence of Indian grass. Sparse presence of macrophytes was noted, with a few algal species identified near the shore edges (*Nitella*, an alga in the Order Charales – Stephanie Parker Pers. Comm.).

Figure 50 The riparian ground cover at Domain 11 South Pond Klemme.

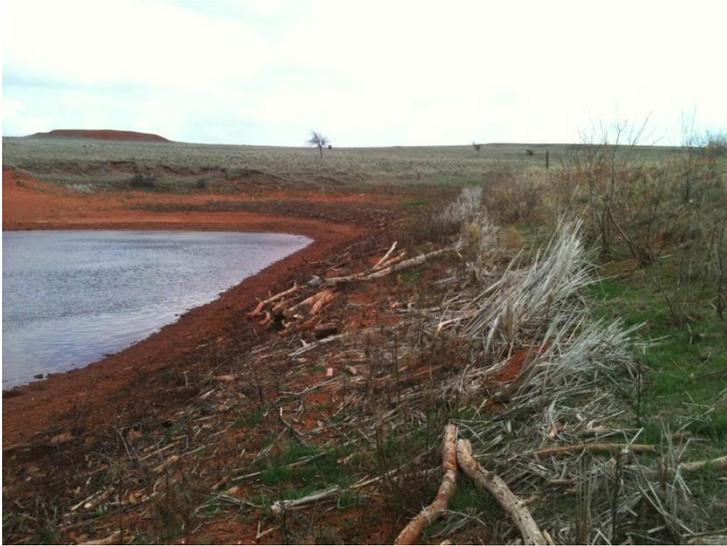
During 2012 site visits, AQU observed the following bank conditions at S1 and S2:

Morphology Type	S1	S2**
RB* angle	172.2	165.2
LB* angle	170.5	
Maximum water height	3.8	
Bankful width	70.1	
Substrate composition	Silty clay

Figure 52 Typical bank structure in Domain 11 South Pond Klemme.

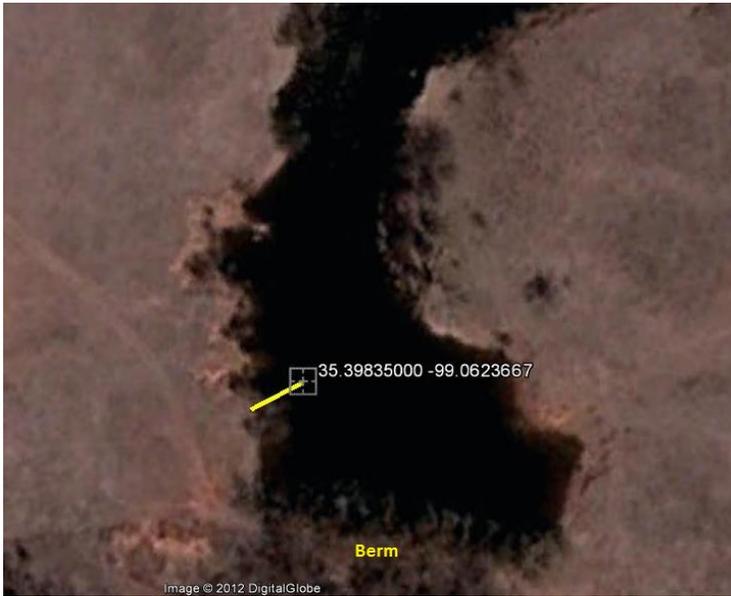
Figure 54 Proposed floating platform location for profiling system in Domain 11 South Pond Klemme. The length of the proposed platform would be approximately 13 m. Due to the steeper slope at the berm and the longer distance to the deepest section of the pond (30 m), a side access from the West is being proposed.

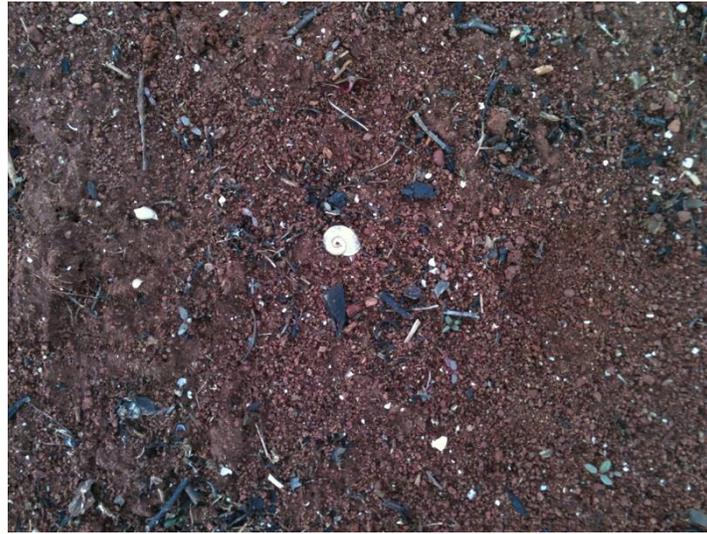
Figure 57 Example of more gravelly nature of the substrate on the berm banks. A large quantity of other dry vegetation and shells were also observed.

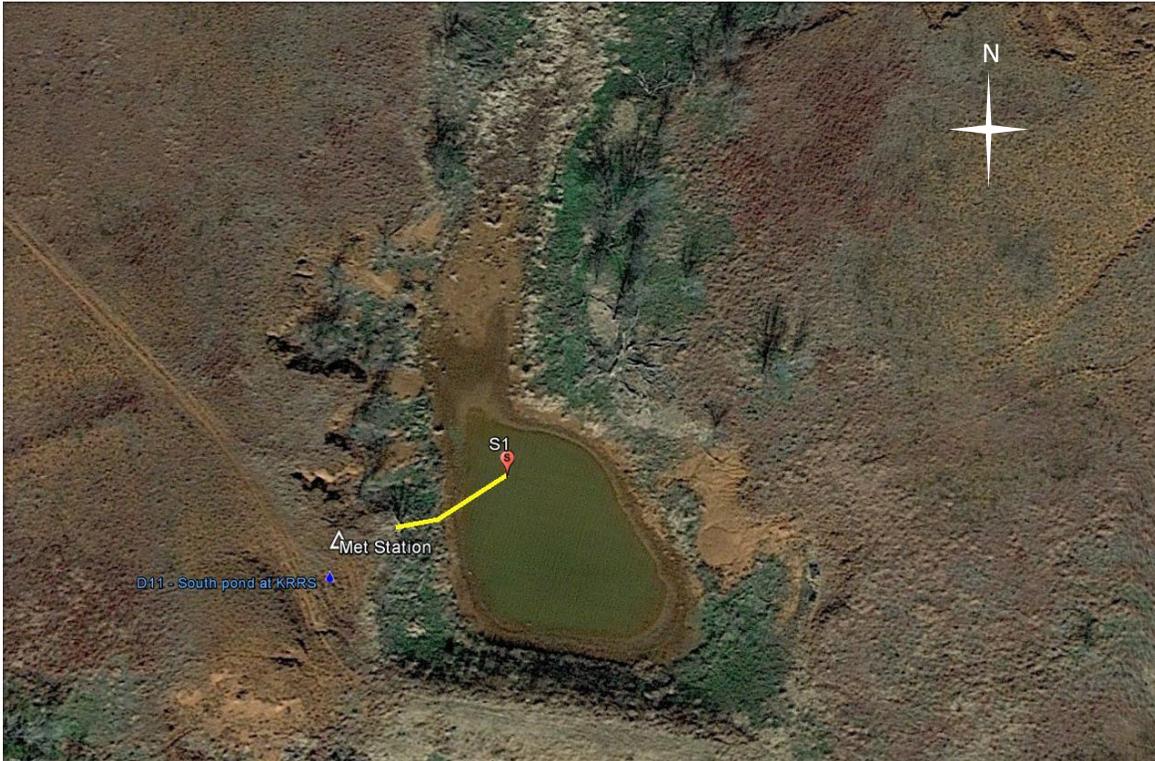
Figure 58 Approximate location of required footpath (shown in yellow) for Domain 11 South Pond Klemme.

- Steeper slope angles near the pond mean there is a potential restriction for access to the pond (particularly at low water level) during construction.
- The high degree of erodibility of the soils of the area, limit the weight and type of equipment that may be able to safely and non-destructively access the site.
- Parking is possible at the site, however, continuous access to the site will cause rutting and potential erosion of the soils. The walking distance between the parking area and sampling reaches is approximately 350 meters.
- Movement through or along the channel on foot will prove difficult or impossible due to deep pools, extensive riparian vegetation, fine-grained sediment composition, and poor water clarity.

Temporary access using removable non-permanent platforms to access locations of S1 and S2, particularly during low water level conditions to reduce erosion and impact on the site.
