D18 Aquatic Instrument System (AIS) Site Characterization Report

<i>Title:</i> D18 AIS Site Characterization Report	<i>Author:</i> S. Parker	<i>Date:</i> 02/09/2015
<i>NEON Doc. #:</i> NEON.DOC.001671		<i>Revision:</i> A

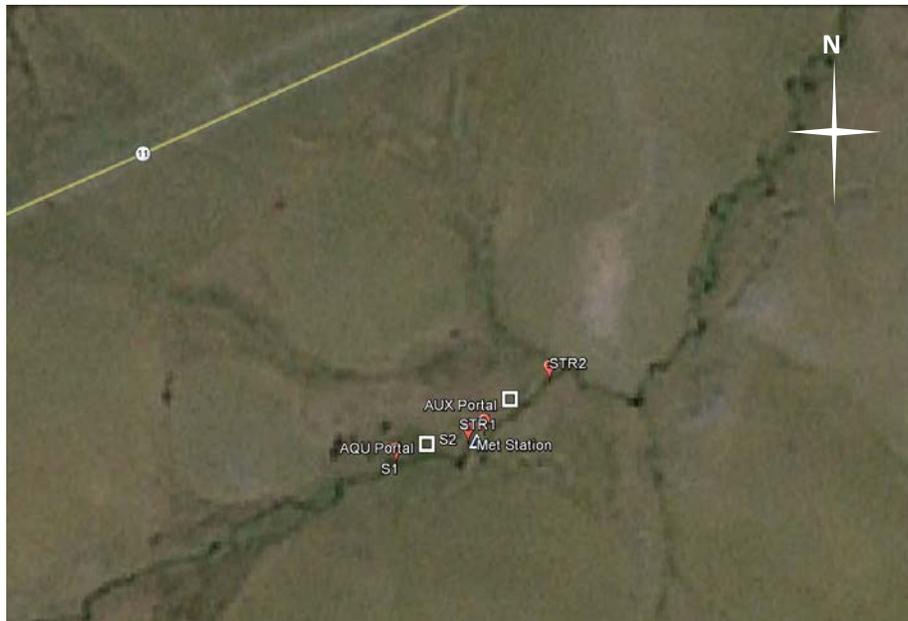
This site is expected to be an alternate power (solar) site. The initial estimated location for the Aquatic Auxiliary Portal is:

Figure 1. A Google-Earth-Derived Image of Aquatic and Auxiliary Portal locations for D18 Oksrukuyik Creek

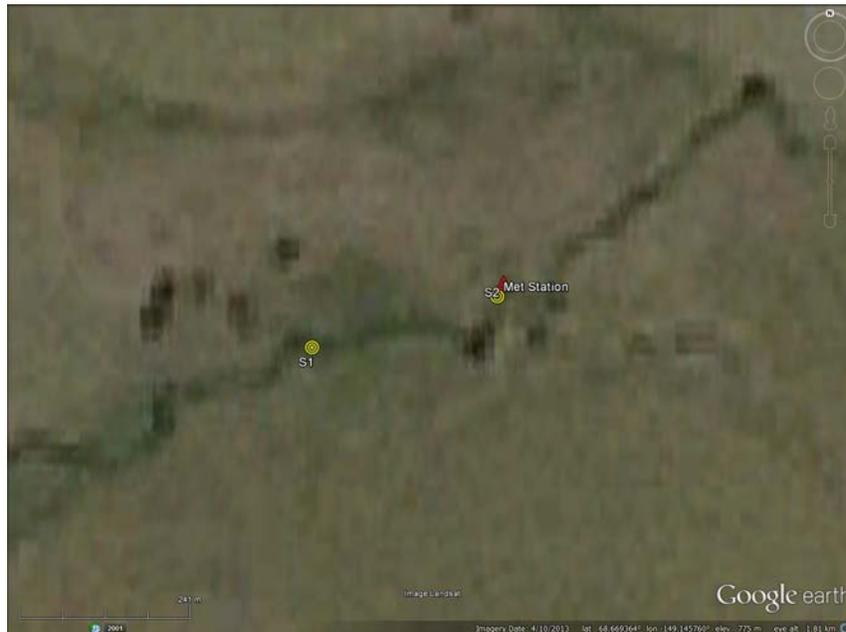
The discharge sensor should be located at S2.

Figure 2. Kmz File of D18 Oksrukuyik Creek Denoting Locations of S1, S2, and Met Station.

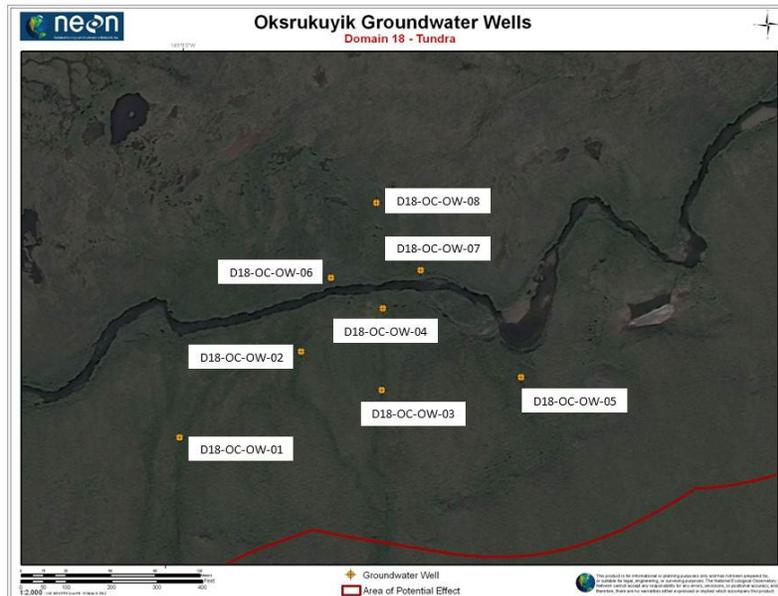
The groundwater observation wells network at the site (Figure 8, Table 05) will consist of 8 wells installed using a powered hand-auger. Topography at the site is fairly flat to the north of the stream and has a gentle hillslope to the south of the stream. The wells will be installed at varying positions around the stream focusing on water tracks that enter the stream. The maximum anticipated drilling depth will be 5 feet below ground surface. Wells will be drilled so that the base of the well interfaces with the permafrost layer. Wells will also be designed so that the depth of the well can be increased with minimal disturbance should arctic thawing continue to reduce permafrost.

Figure 7. Initial Groundwater Well Locations Based on EMS kmz File at D18 Oksrukuyik Creek

The AQU team prefers a steel casing with a non-cement pad and will apply for a waiver for each well. However, EHS should prepare the landowner for this State regulation and the real possibility that cement will need to be used.

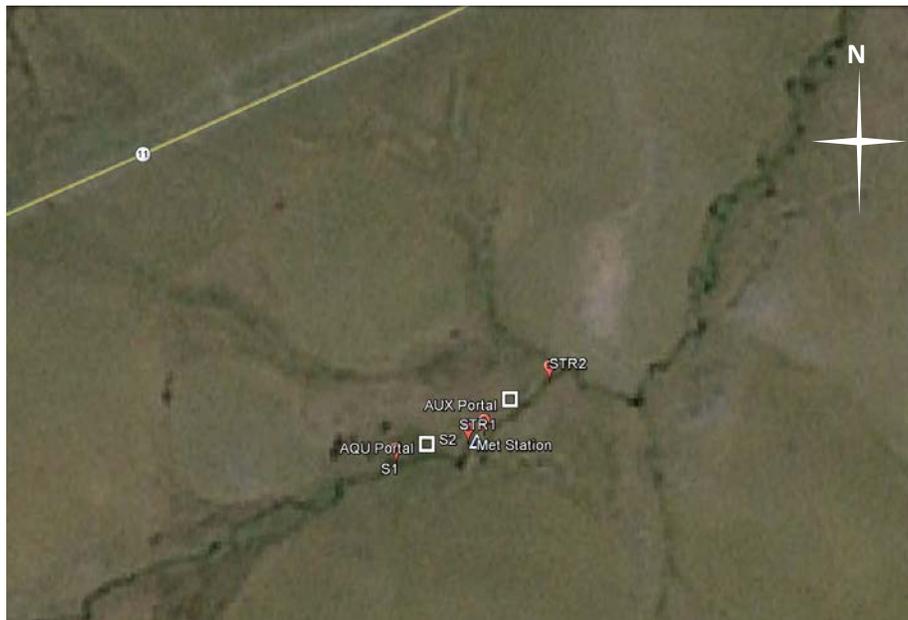
Figure 14. A Google-Earth-Derived Image of Aquatic and Auxiliary Portal locations for D18 Oksrukuyik Creek (STREON)

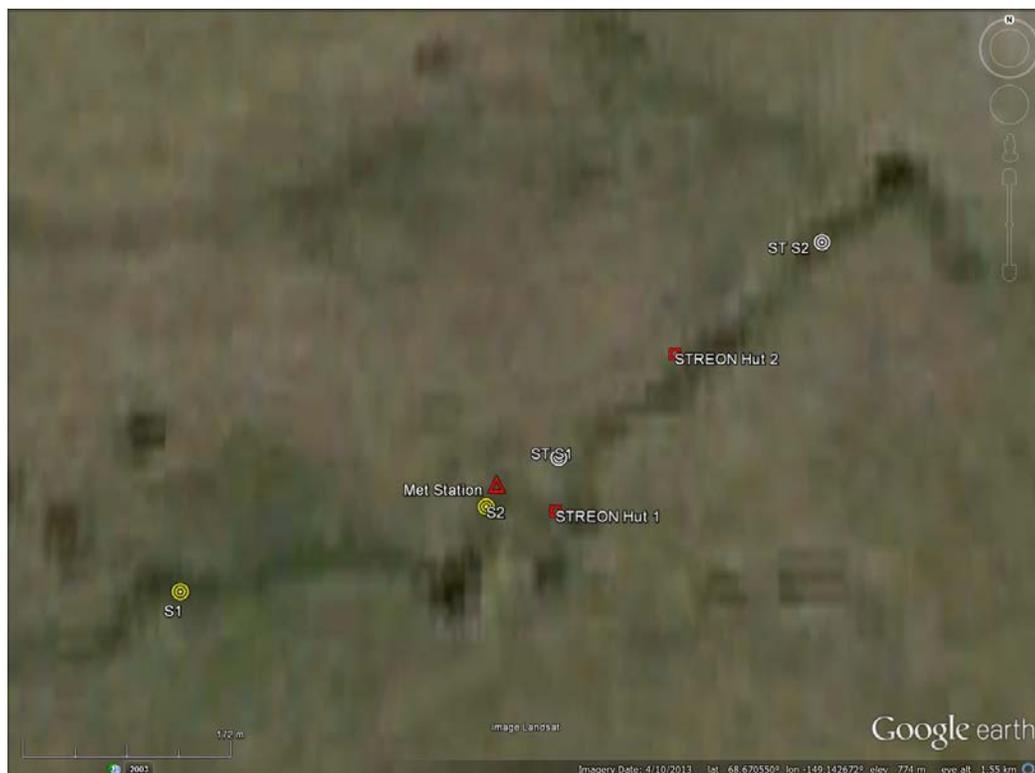
Figure 15. Kmz File of D18 Oksrukuyik Creek (STREON) Denoting Locations of ST S1, ST S2, and TREON Hut

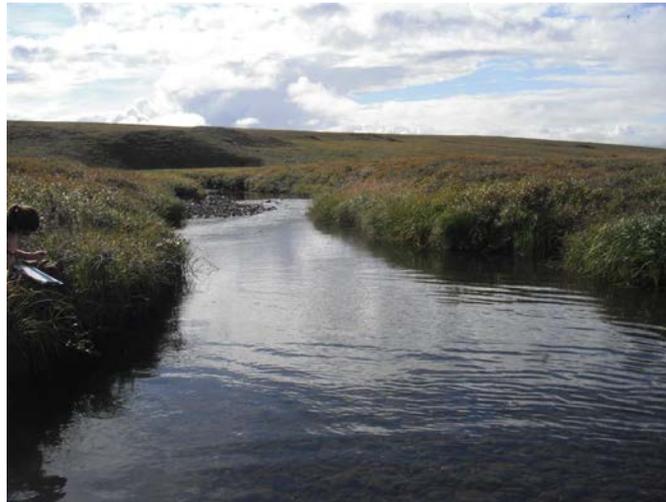
Figure 16. Photo of STREON S1 location at D18 Oksrukuyik Creek (STREON)

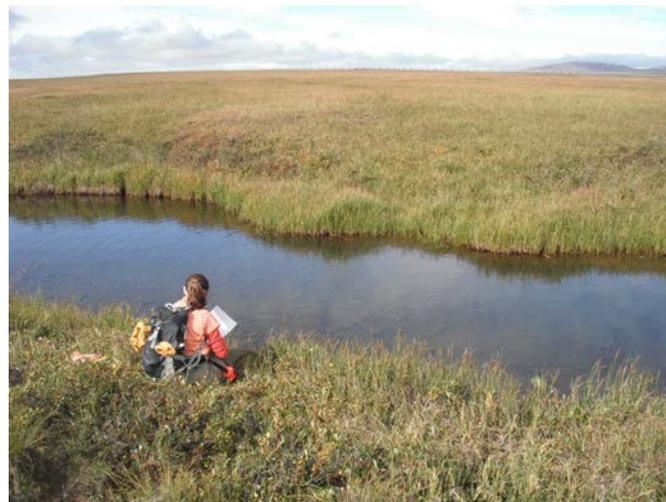
Figure 17. Photo of STREON S2 location at D18 Oksrukuyik Creek (STREON)

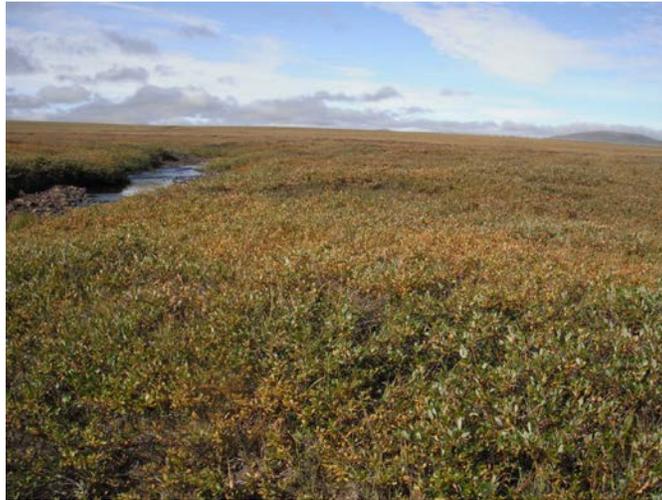
Figure 18. Photo of STREON Hut location at D18 Oksrukuyik Creek (STREON)

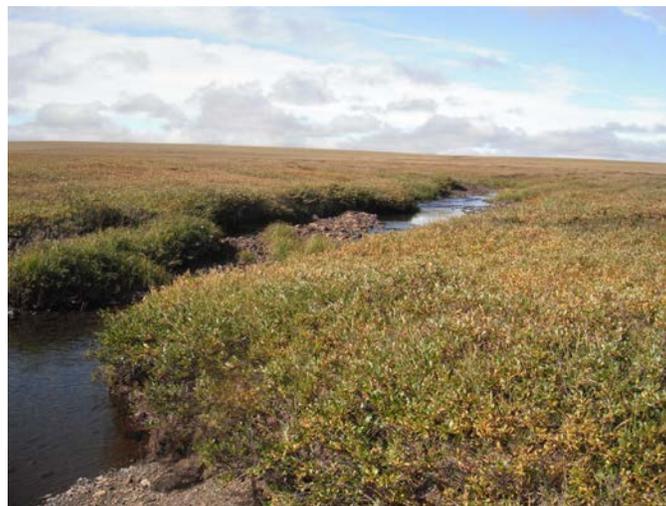
Figure 19. Photo of STREON dripper location at Oks Creek

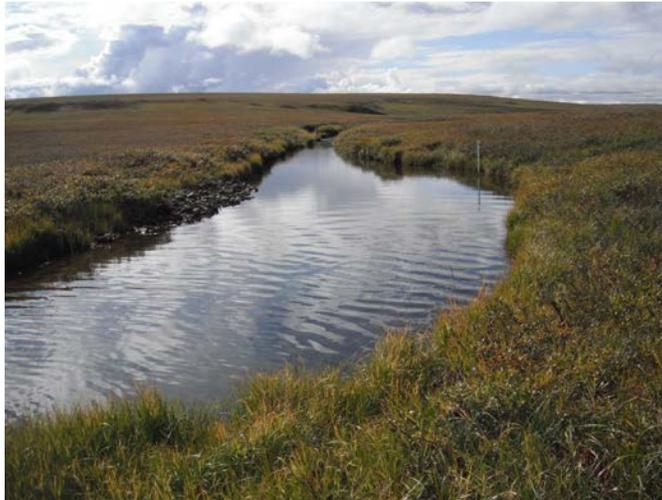
During 2010-2011 site visits, the following plant density and type were observed by the AQU team: Oks Creek flows through a tundra ecosystem. Riparian vegetation consists of willows, dwarf birch, and some sedges. There is no overhanging vegetation along the AQU reach.

Figure 20. The riparian canopy at D18 Oksrukuyik Creek (STREON) (STREON)

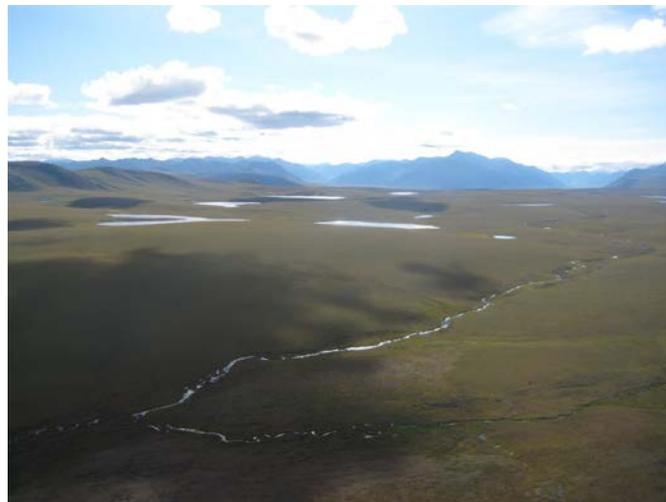
Figure 27. Looking southeast (upstream): Oks Creek upstream of the STREON study reach, showing lakes in the headwaters.

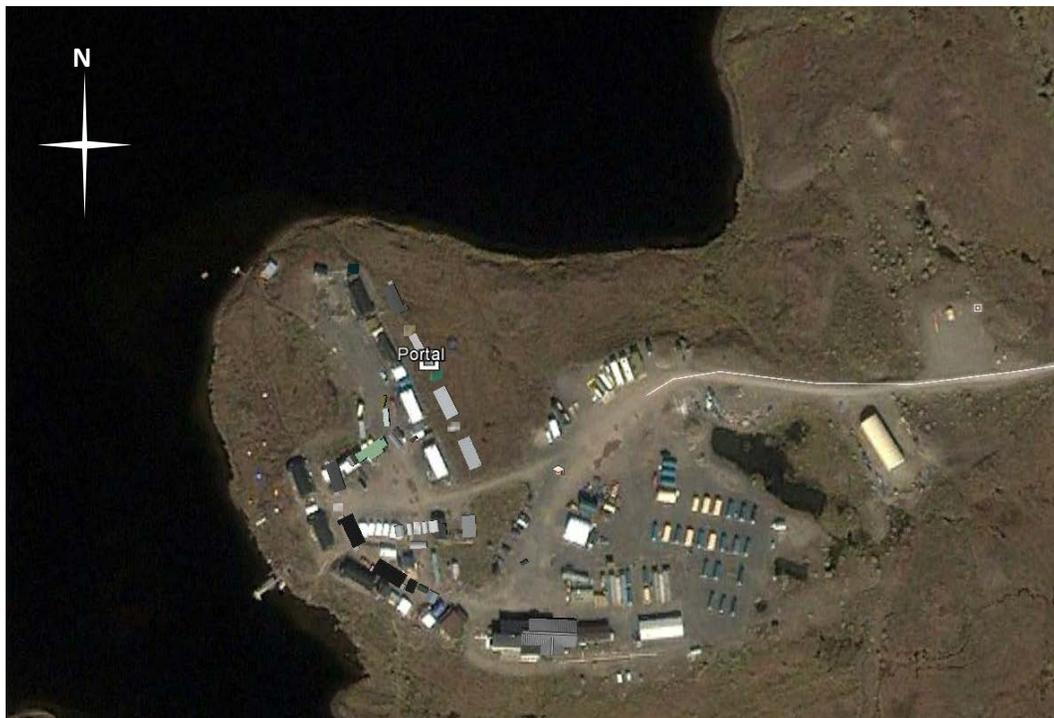
The initial estimated location for the Aquatic Auxiliary Portal (Table 14) and Aquatic Portal (Table 15) are co-located and illustrated in Figure 29. The portals are co-located. FCC is managing construction of a new research lab in which the portal will be located.

Figure 29. A Google-Earth-Derived Image of Aquatic Portal for D18 Toolik Lake

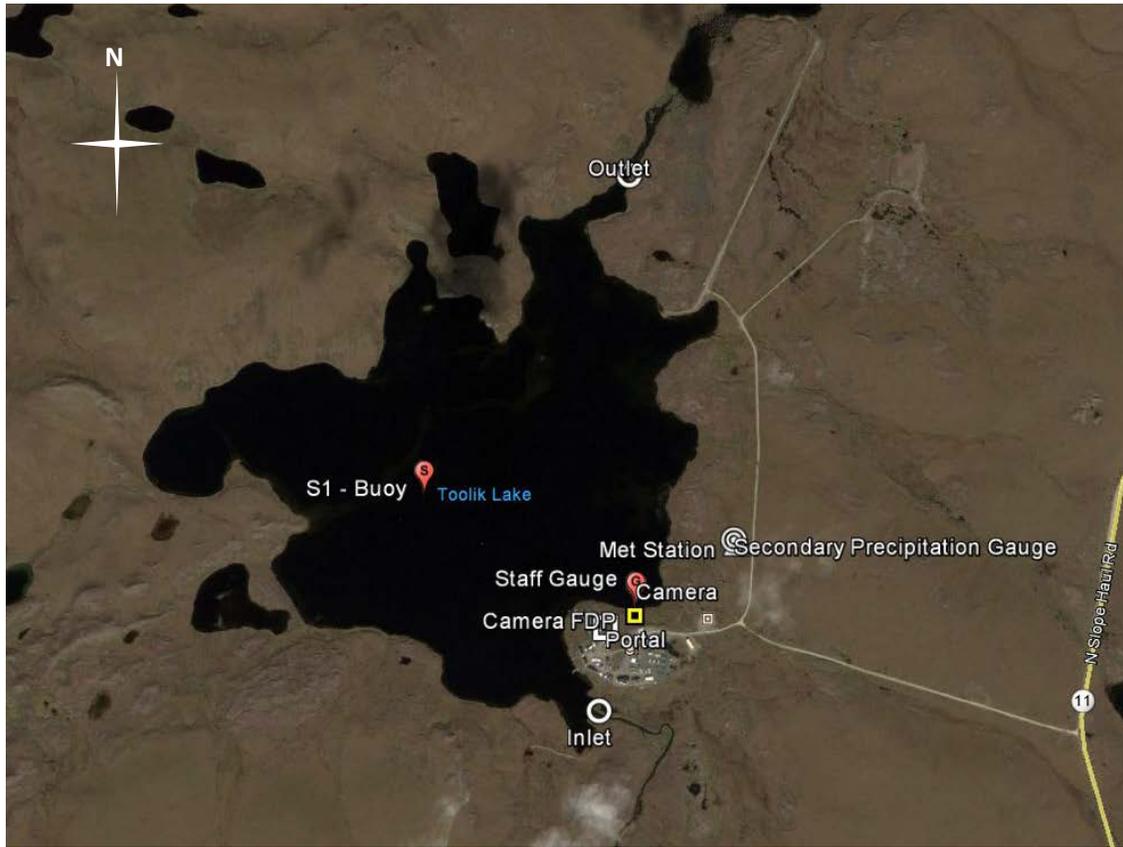
Figure 30. Google earth image of D18 Toolik Lake denoting locations of S1, Met station and Secondary Precipitation Gauge. Locations of Inlet, Outlet, staff gauge and camera and field device posts are also noted.

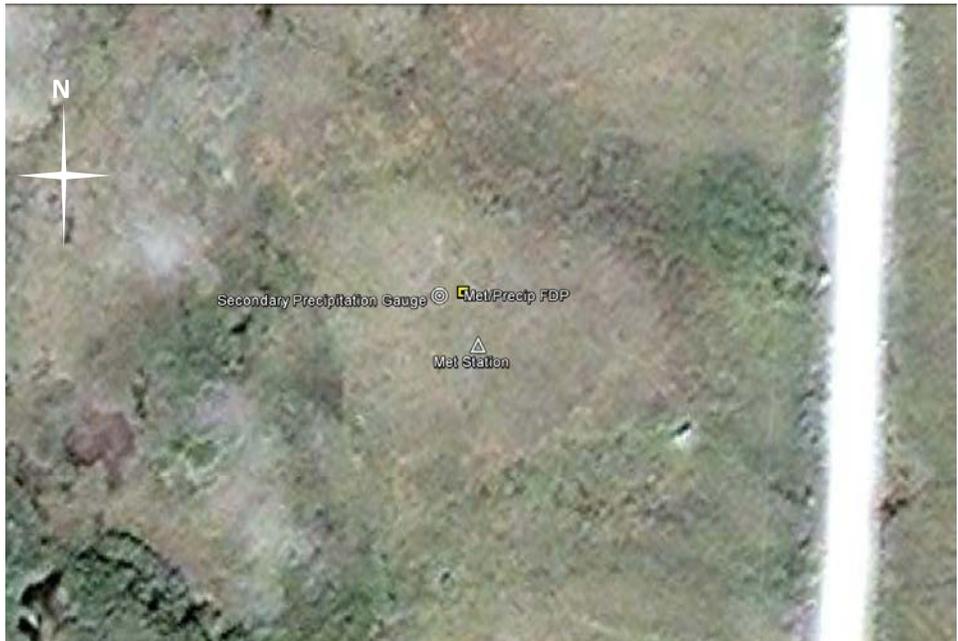
Figure 31. Google Earth image of D18 Toolik Lake Met Station Location with Secondary Precipitation Gauge and Field Device Posts shown.

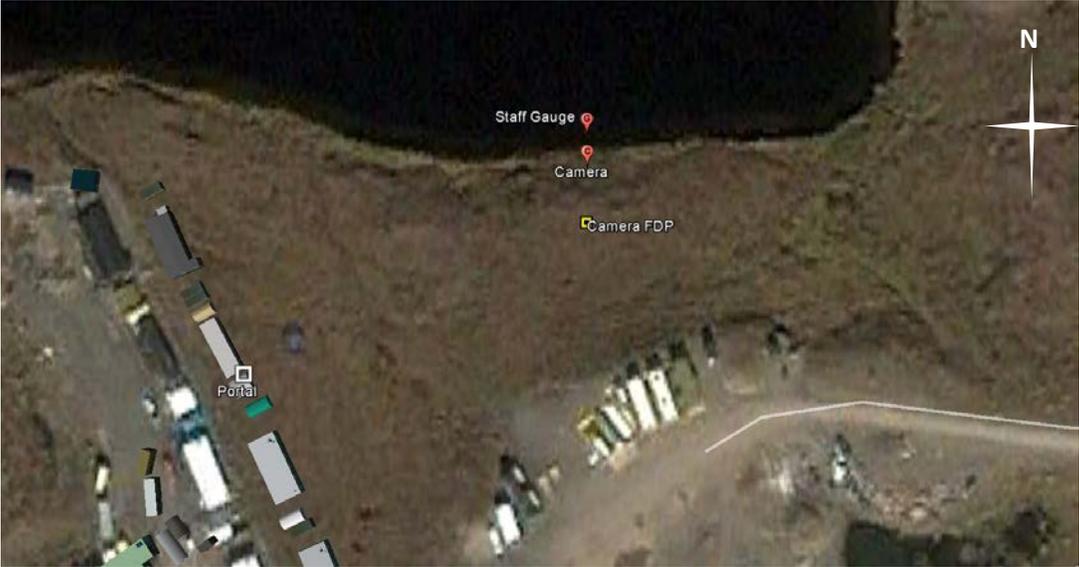
Figure 32. Google Earth image of D18 Toolik Lake Staff Gauge and Camera with associated Field Device Post.

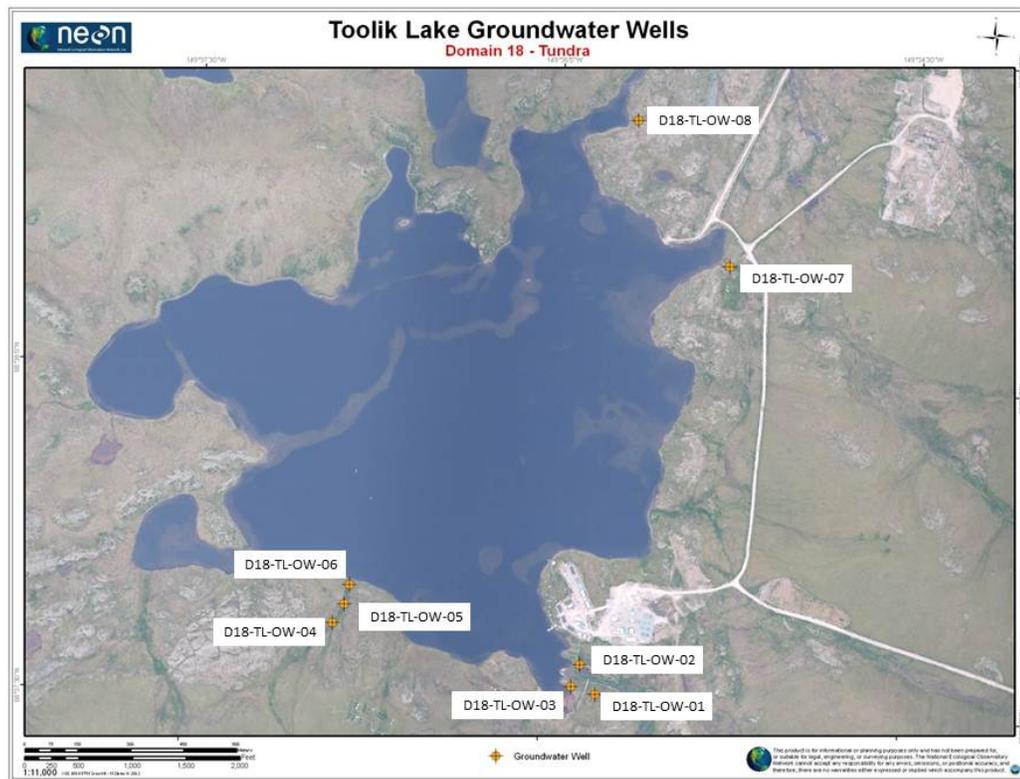
The groundwater observation wells network at the site (Figure 30, Table 18) will consist of 8 wells installed using a powered hand-auger. Topography at the site is dominated by rolling hills surrounding the lake. The wells will be installed at varying positions around the lake focusing on water tracks that enter the lake. The maximum anticipated drilling depth will be 5 feet below ground surface. Wells will be drilled so that the base of the well interfaces with the permafrost layer. Wells will also be designed so that the depth of the well can be increased with minimal disturbance should arctic thawing continue to reduce permafrost.

AQU prefers the surface completion of the wells to include an above-grade stick-up protective cover and be minimally invasive. However, the State of Alaska has several requirements for construction of groundwater monitoring wells that NEON will either need to meet or apply for a waiver. Chief among the State requirements are 1) an acceptable grout to fill the annular space such as neat cement, bentonite chips, or a bentonite / cement mixture; 2) surface seal of the well requires a poured concrete or cement slab poured around a steel outer casing with a locking cap; and 3) a licensed well driller is required to be onsite. No details are provided as to the thickness or size of the ground surface seal.

Figure 33. Initial Groundwater Well Locations Based on EMS kmz File at D18 Toolik Lake

The AQU team prefers a steel casing with a non-cement pad and will apply for a waiver for each well. However, EHS should prepare the landowner for this State regulation and the real possibility that cement will need to be used.

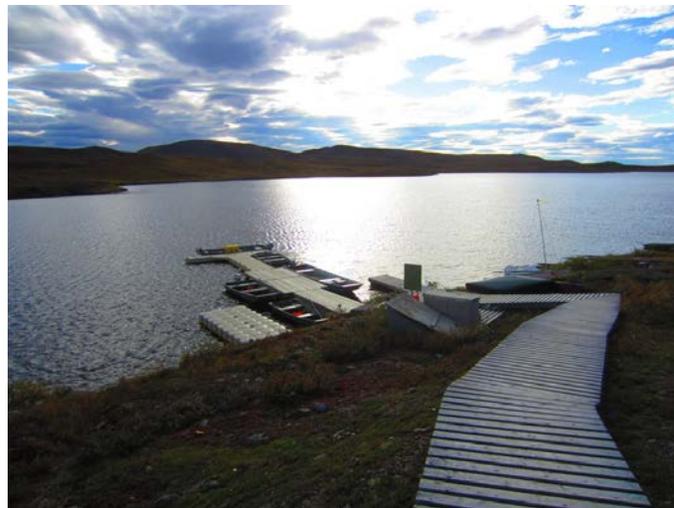
Figure 38. Docks maintained by Toolik Field Station are located on the southeast side of the lake next to the field station itself.

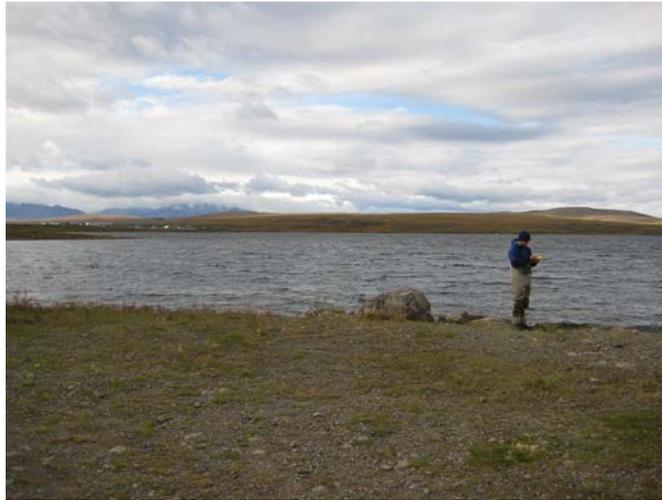
Figure 39. A boat launch is located on the north side of the lake off of a gravel access road. The field station is in the background of this photo.

A simple above grade boardwalk may need to be installed from the dirt road to the Outlet location at Toolik lake in order to minimize damage to local vegetation.
