DOMAIN 13 AQUATIC INSTRUMENT SYSTEM (AIS) SITE CHARACTERIZATION REPORT

AQU site characterization information presented in this document is for the **Domain 13** aquatic locations: **Como Creek** (core), **West St. Louis Creek** (relocatable). Issues and concerns for each site that need further review are also addressed in this document according to our best knowledge. Unless otherwise noted, the information contained herein takes precedence over the same information repeated elsewhere; thereby, this document contains the official change-controlled information pertinent to these sites.

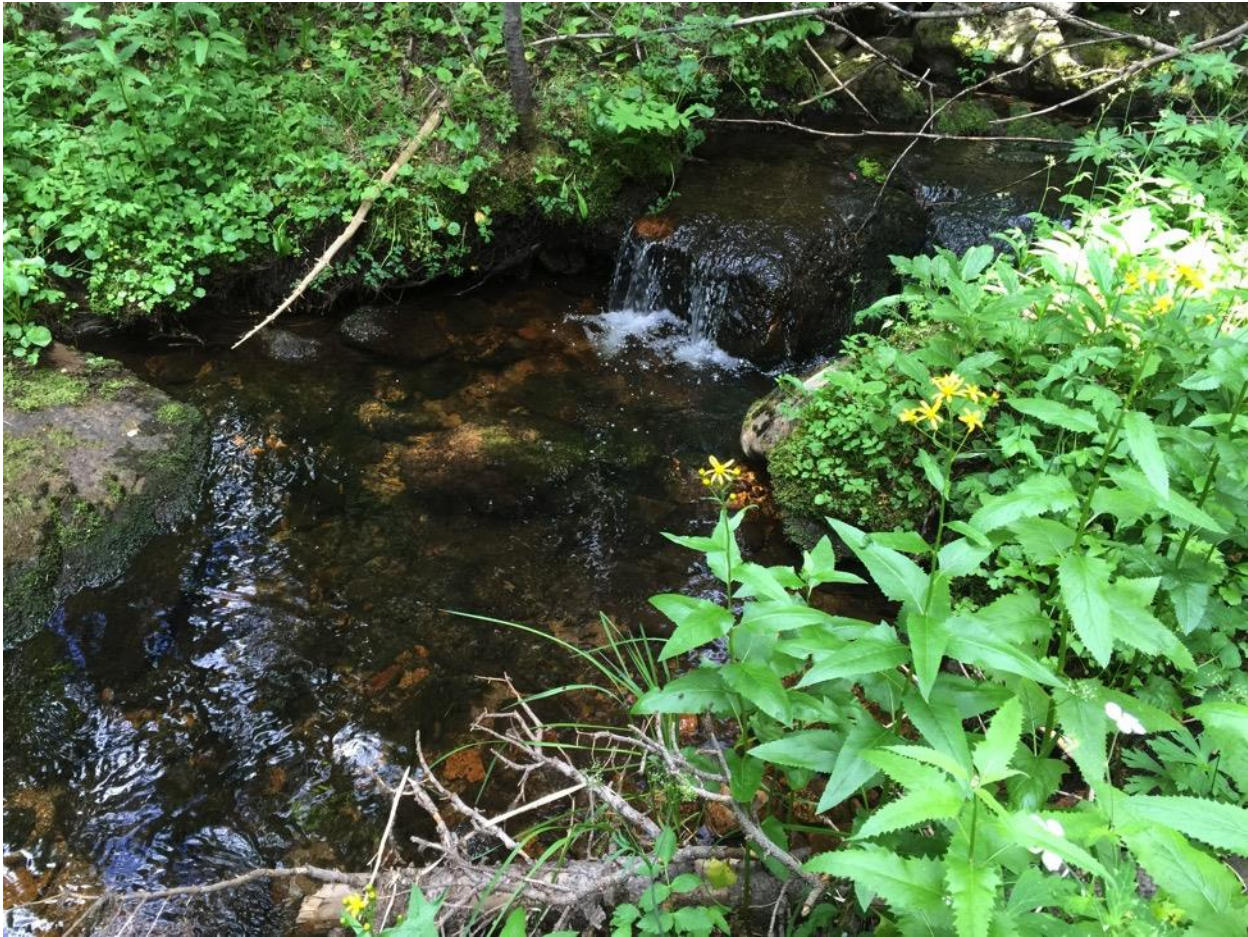
S1 is located just downstream some braiding in the stream.

Figure 3 Photo of S1 Location at Domain 13 Como Creek

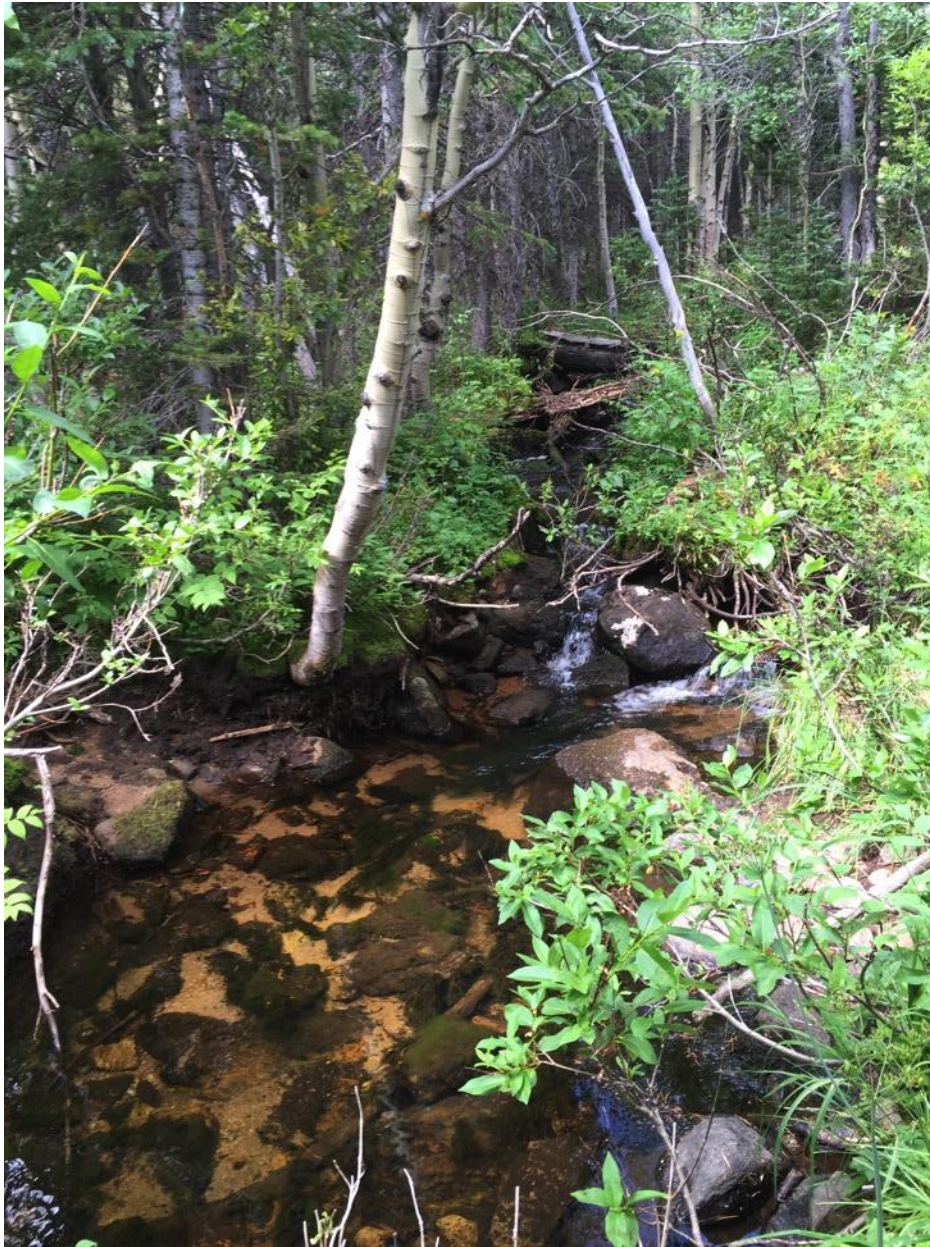
S2 occurs at a constricted channel within the stream, followed by a large flow-through pool.

Figure 4 Photo of S2 Location at Domain 13 Como Creek

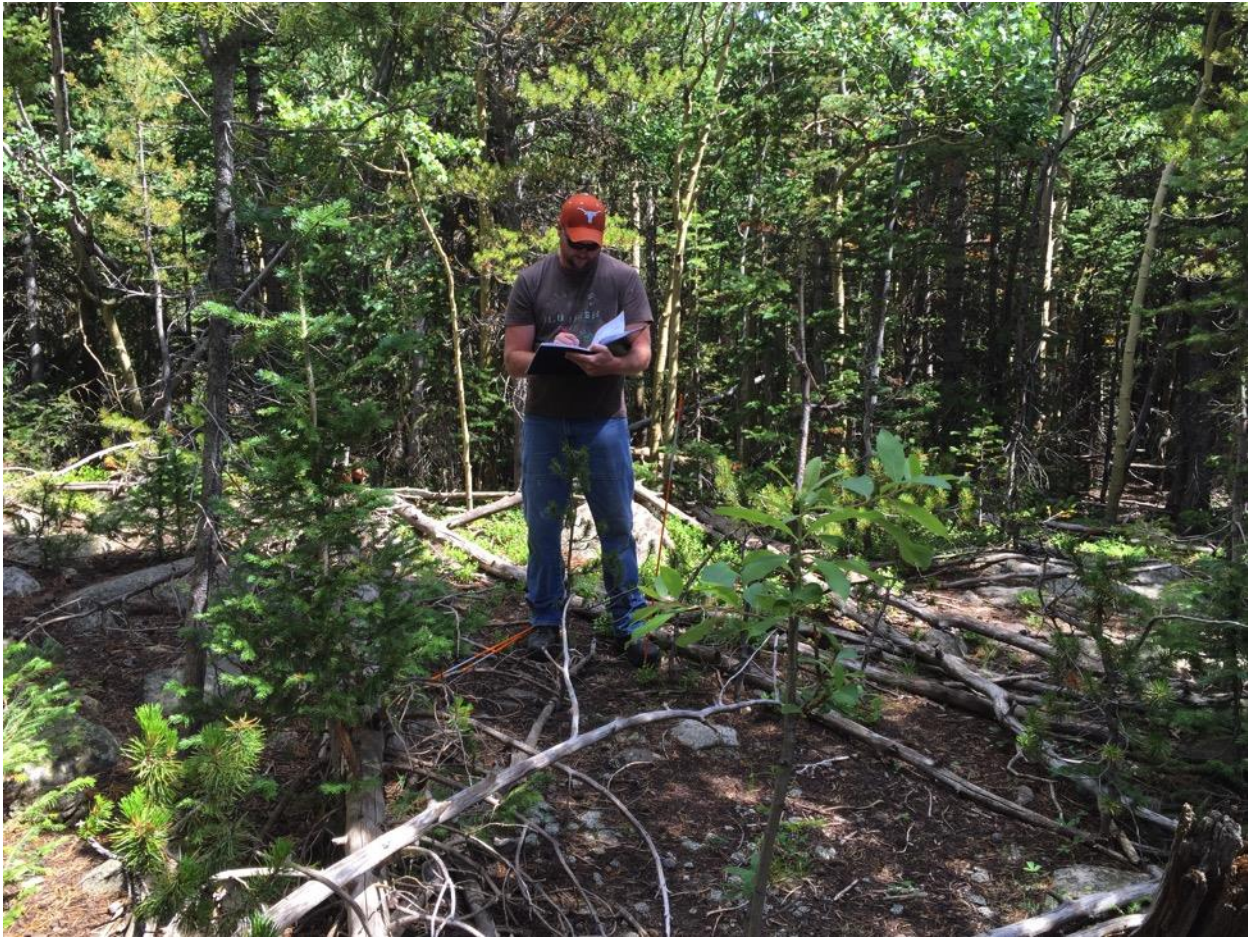
Figure 5 Photo of Micromet Station Location at Domain 13 Como Creek.

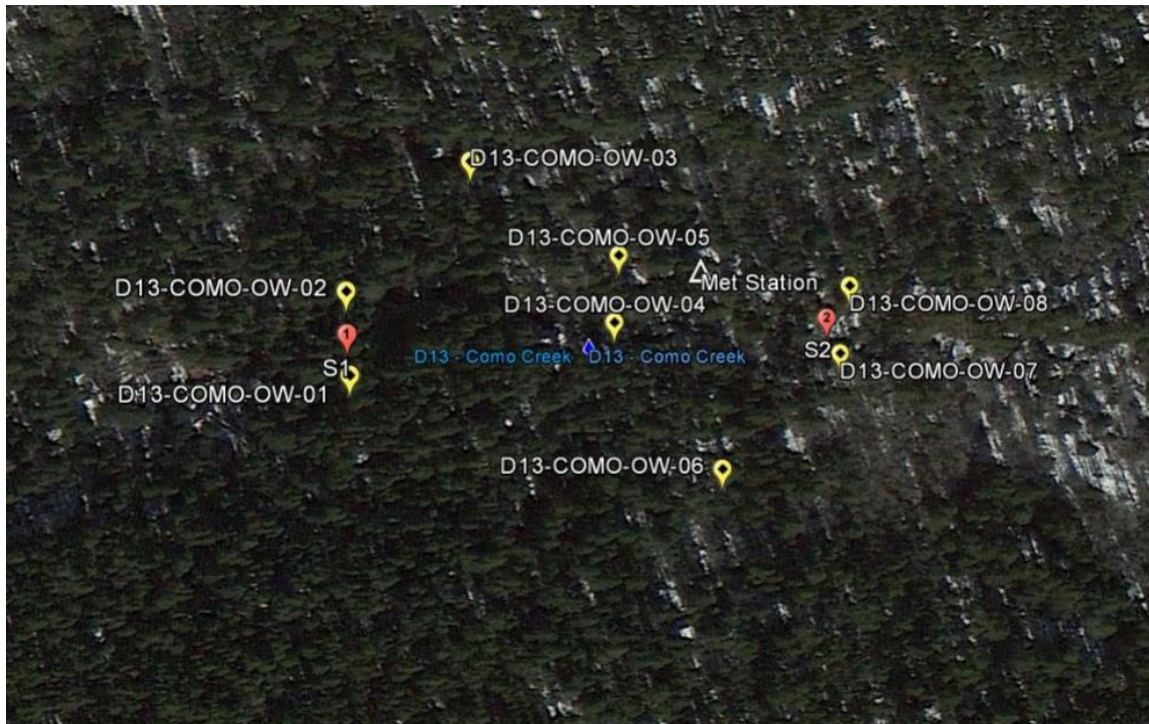
Figure 7 Initial Groundwater Well Locations Based on EMS kmz File at Domain 13 Como Creek

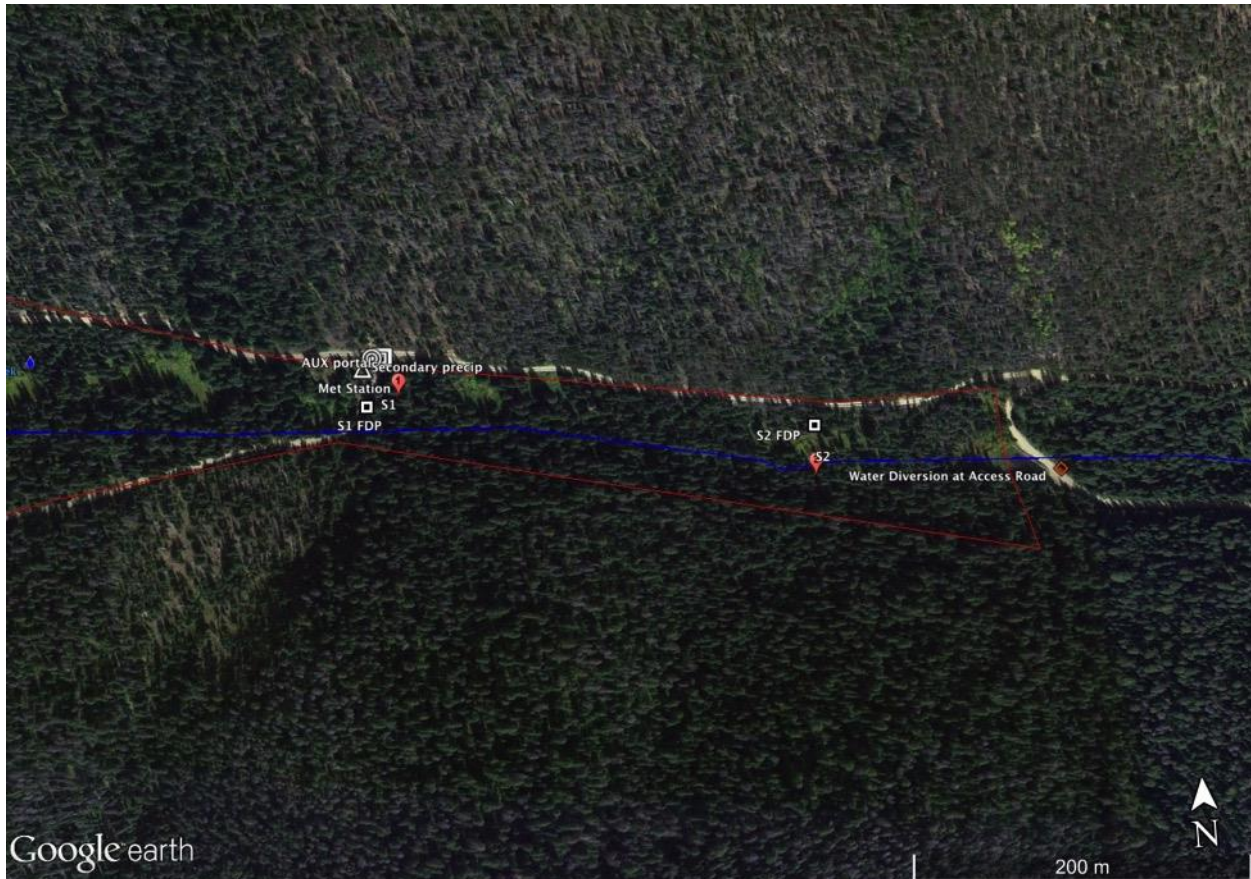
Figure 19 Kmz File of Domain 13 West St. Louis Creek Denoting Locations of S1, S2, and Micromet Station

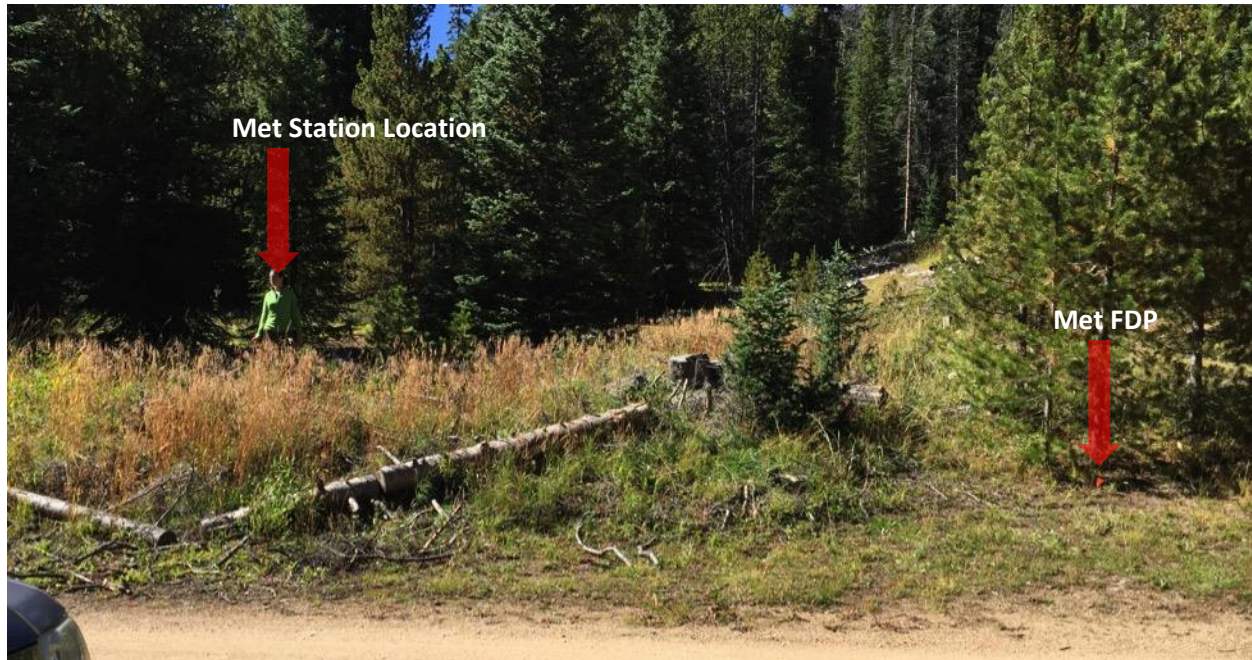
Figure 22 Photo of Micromet Station Location at Domain 13 West St. Louis Creek.

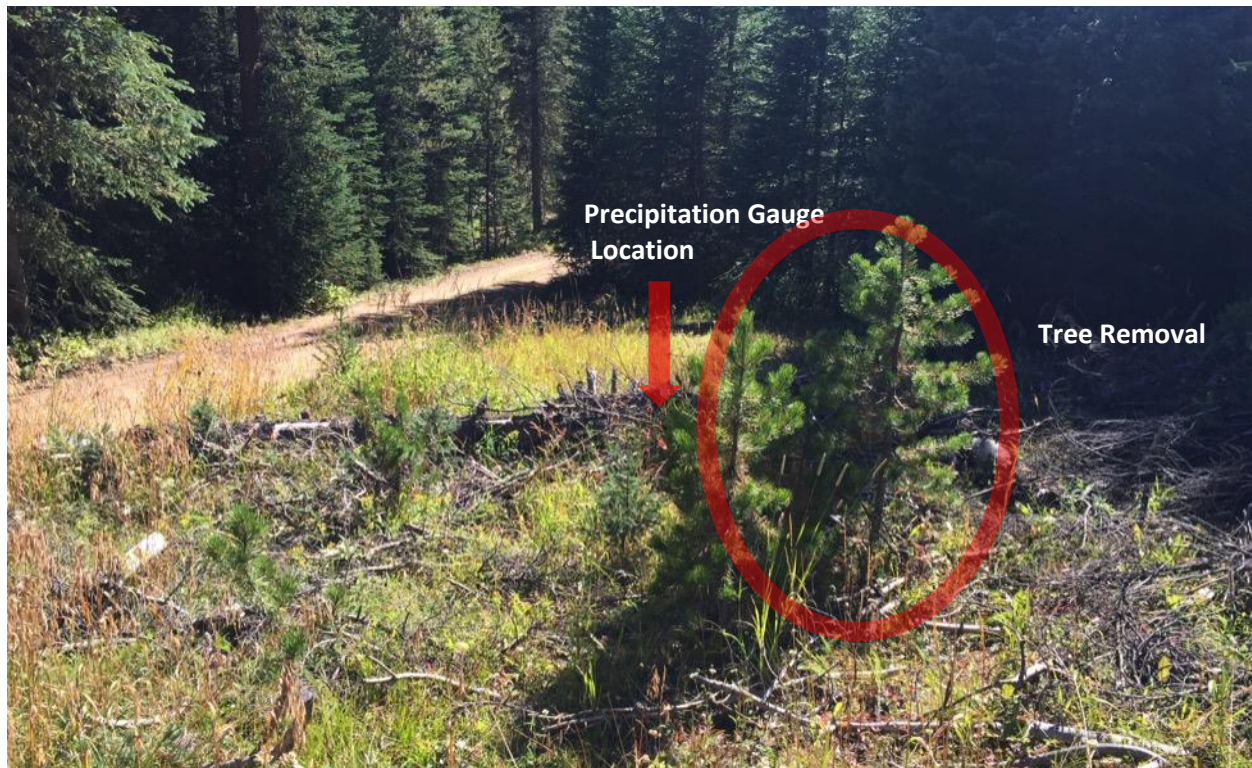
Figure 23. Photo of Secondary Precipitation Gauge (tipping bucket) Location at Domain 13 West St. Louis Creek.

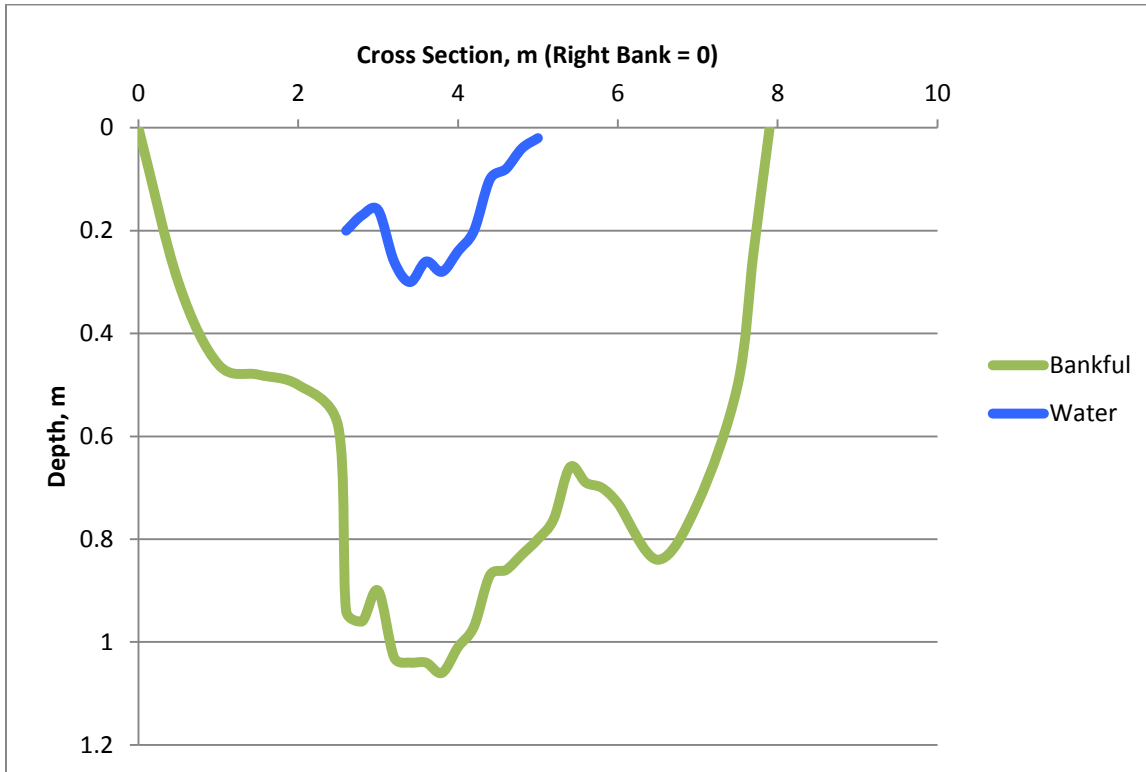
Figure 27. Graph of cross sectional survey at S1 pool.

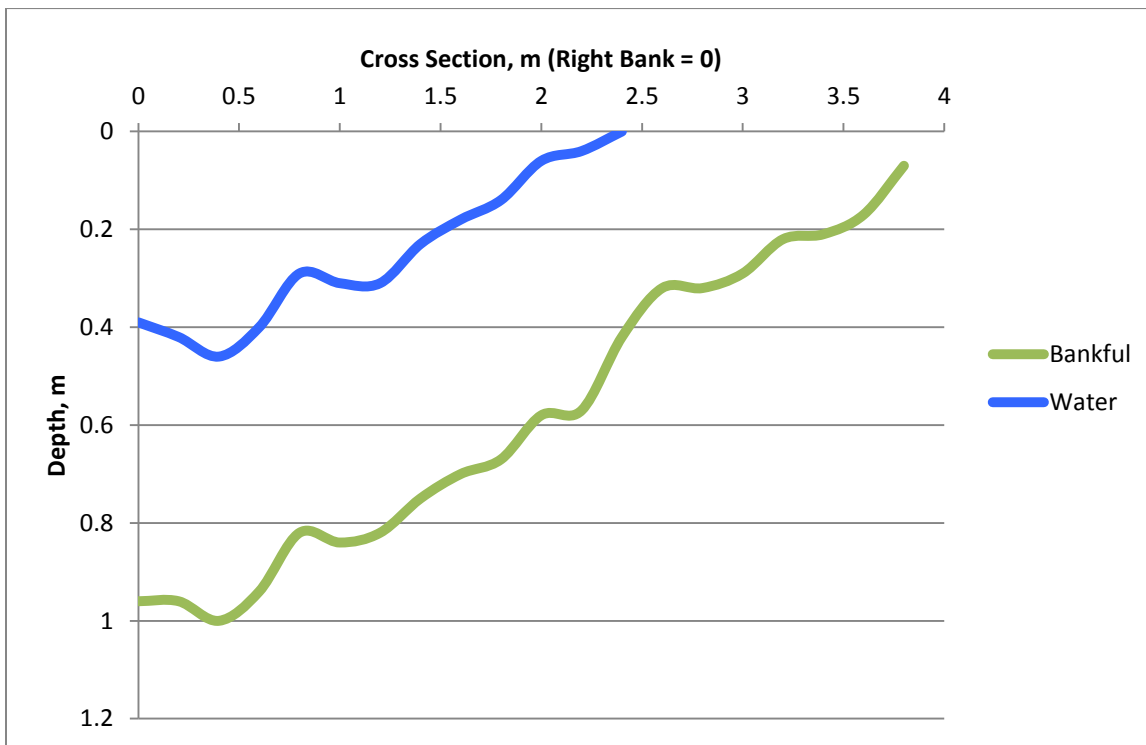
Figure 28. Graph of cross sectional survey at S2 pool.

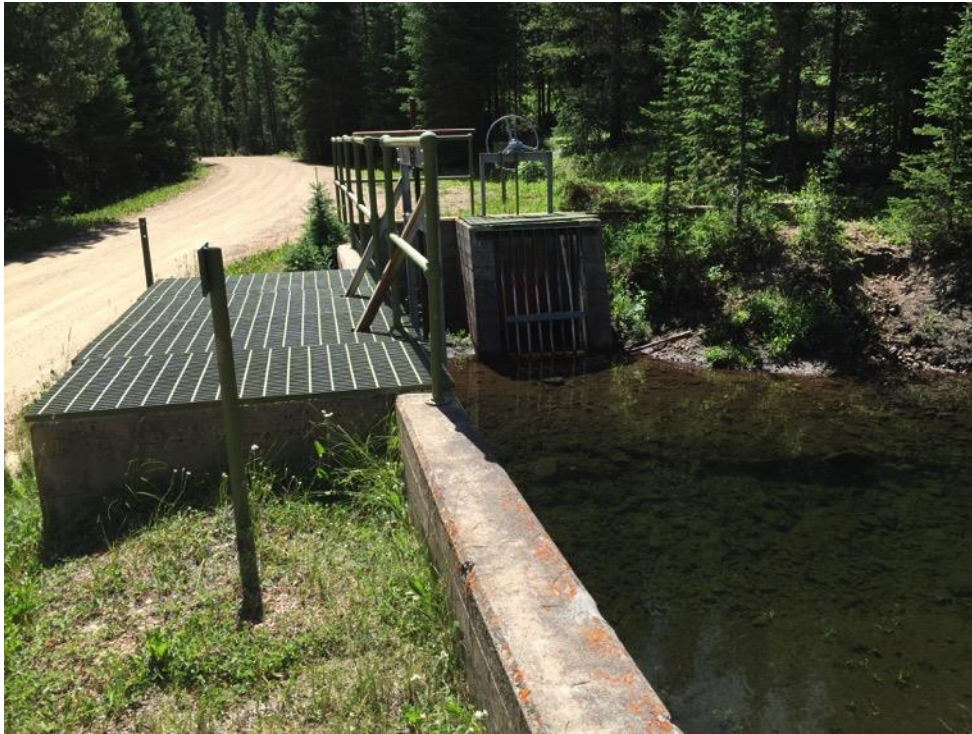
Figure 39. Picture of water diversion system installed on West St. Louis Creek downstream of the AQU reach at the access road.

There are a few notable features of the reach. Most notable of the watershed is the diversion that is installed just downstream of the AQU reach at the access road (see orange diamond on Figure 15). Figures 38 and 39 show the diversion and the resulting augmentation in flow downstream.

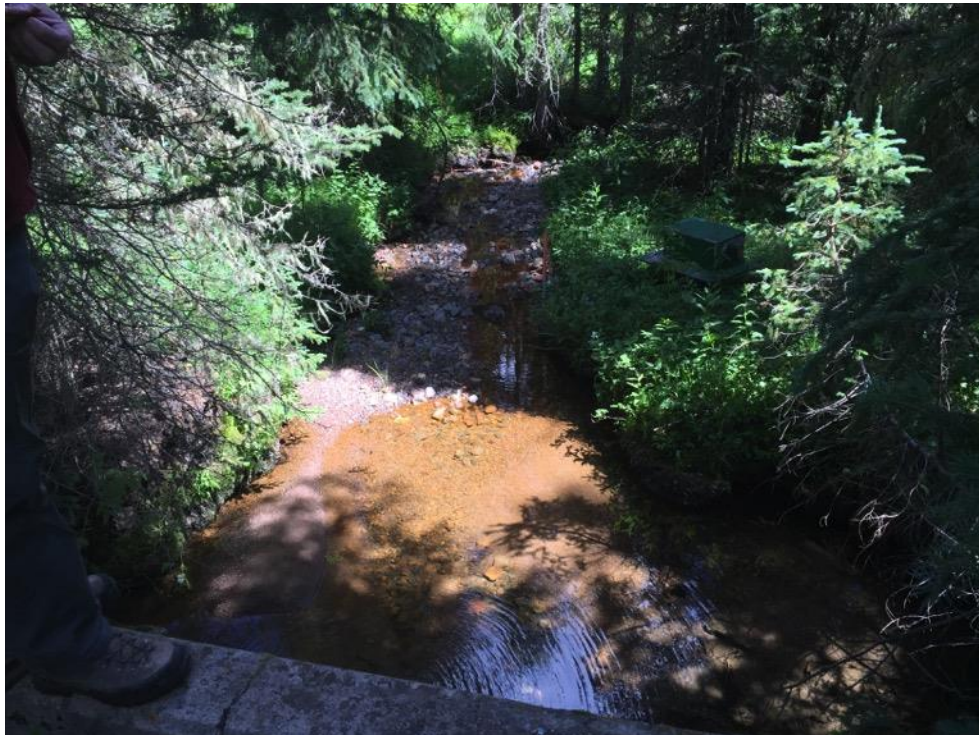
Figure 40. Picture of flow downstream of water diversion.

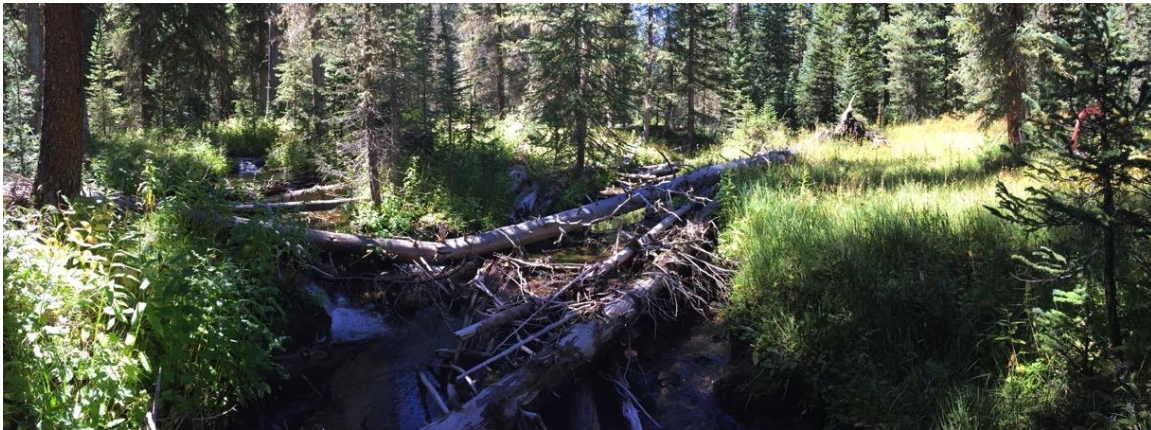
Figure 41. Picture of channel return at 750m (looking upstream).

There is a large section of high channelization between 750-900m. Figures 40 – 42 show examples of the braiding in the stream. The stream splits at 750m and then the two channels split more above 800m before returning to a single channel at 900m. The right channel (facing down stream) appears to be the primary channel with the bulk of the flow. However the flow is spread across up to 5 channels within this large swatch. In addition the meadow area along the left bank has very moist soils. It is assumed that surface water mixes across a broad unconstrained area between 750-900m.

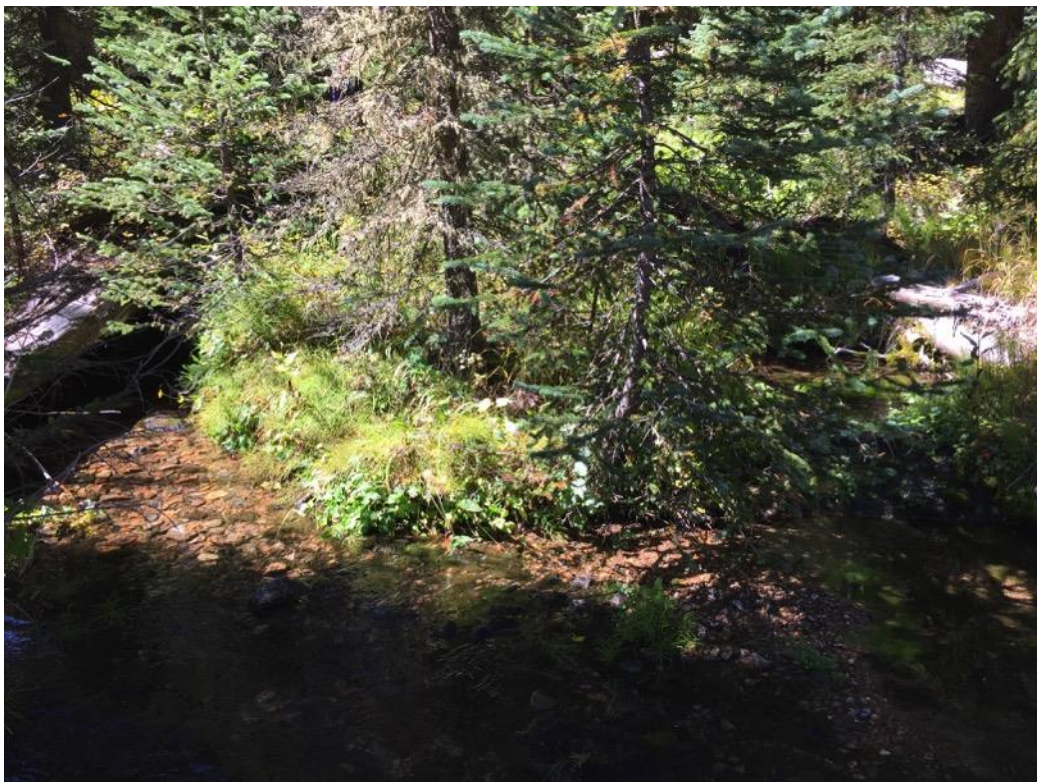
Figure 42. Picture of a splitting of the left channel at approximately 875m (looking upstream).

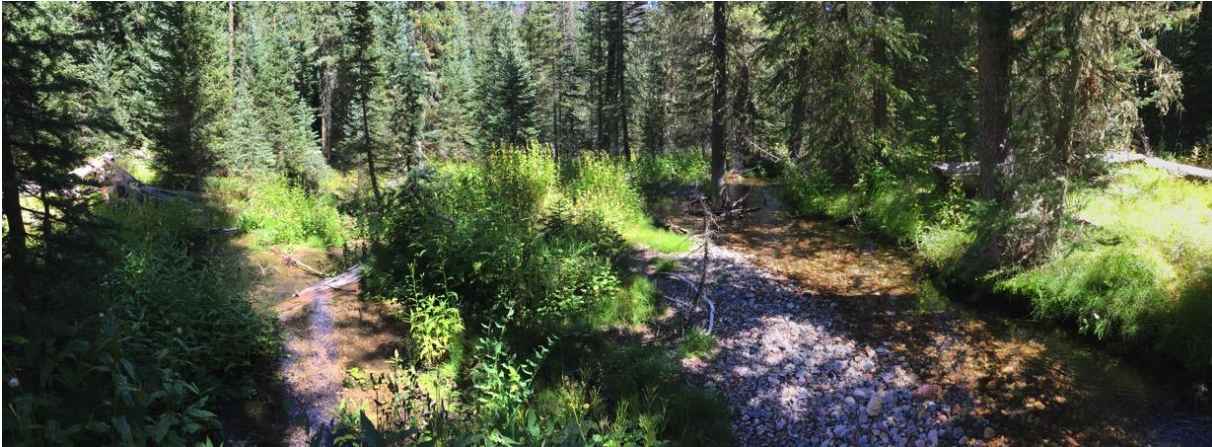
Figure 43. Picture of the initial channelization at 900m (looking downstream).

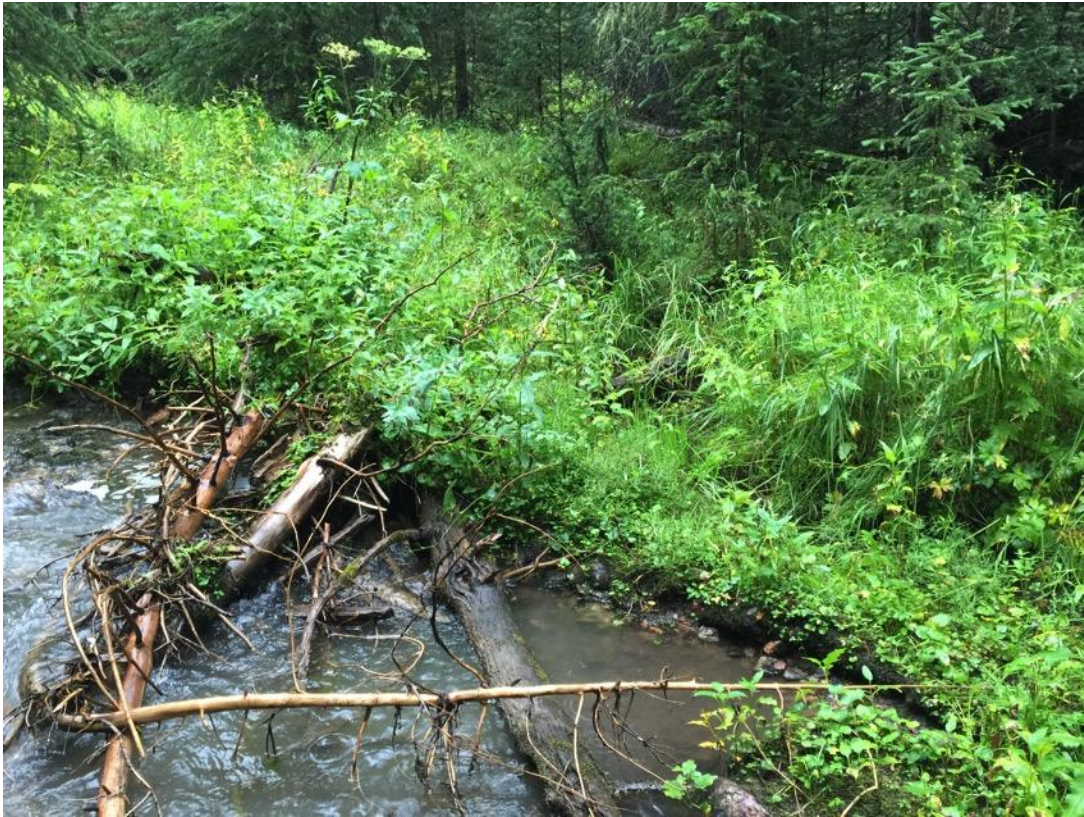
Figure 44. Picture of an example of the surface inputs from meadow areas along left bank of stream (taken at approximately 325m).

The surface flow appears to be significant within this watershed. There are a number of small surface inputs that are the result of high gradient topography surrounding the site and a relatively deep organic layer overlying seemingly shallow soils and rock. Meadow areas run intermittently along left bank of the reach. Many of these meadows contained saturated soils and surface water that also contain channels that deliver water to the stream.

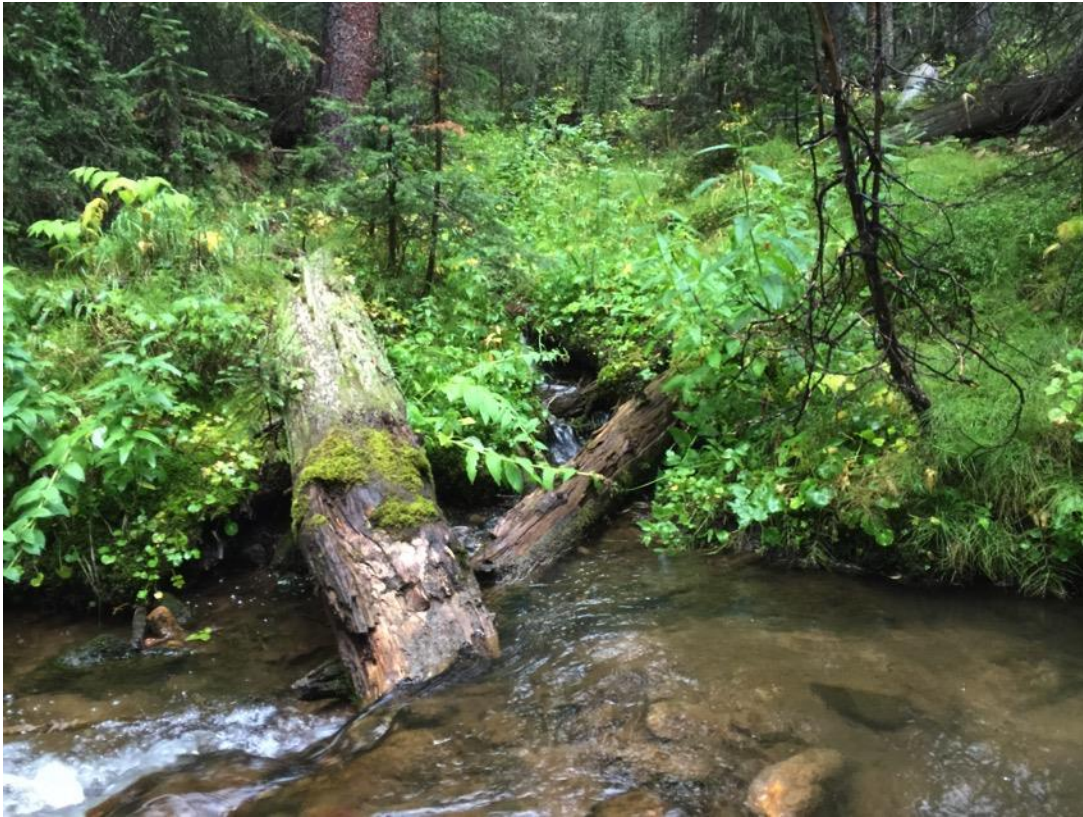
Figure 45. Picture of small tributary upstream of S1 located immediately downstream of the culvert.

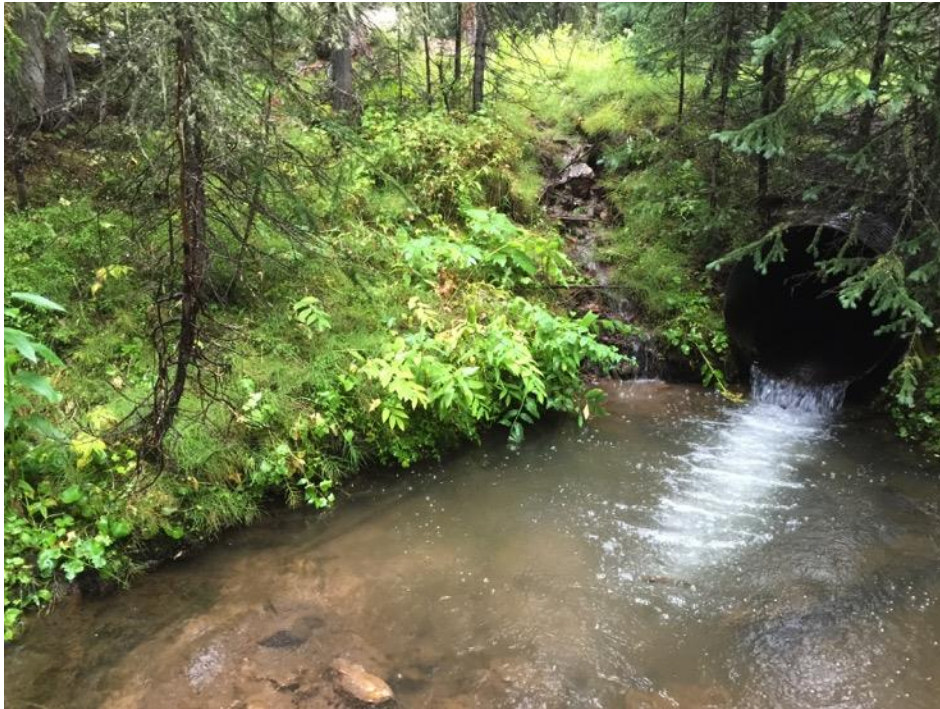
Figure 47. Picture of pool on downstream side of culvert where AQU reach passes the road to Byers Peak Trailhead.

The next road crossing is between the AQU sensor reach and the upper AOS reach. A culvert that is approximately 1m in diameter carries the stream under the road. Figures 46 – 47 show the downstream and upstream photos of the culvert respectively. This road is composed of dirt and gravel and is not salted through the winter. Recreational traffic to Byers Peak is constrained by limited parking and antipated to have minimal impact on the stream. The road to the Byers Peak trailhead is a one-way loop stating at the AQU Portal. This road passes the creek at the upper extent of the requested permissible area. A slightly smaller culvert passes under the road here where the creek becomes increasingly higher gradient and is no longer appropriate for AQU sampling. The road crossings in general are not considered to negatively impact AQU scientific data or sampling activities.

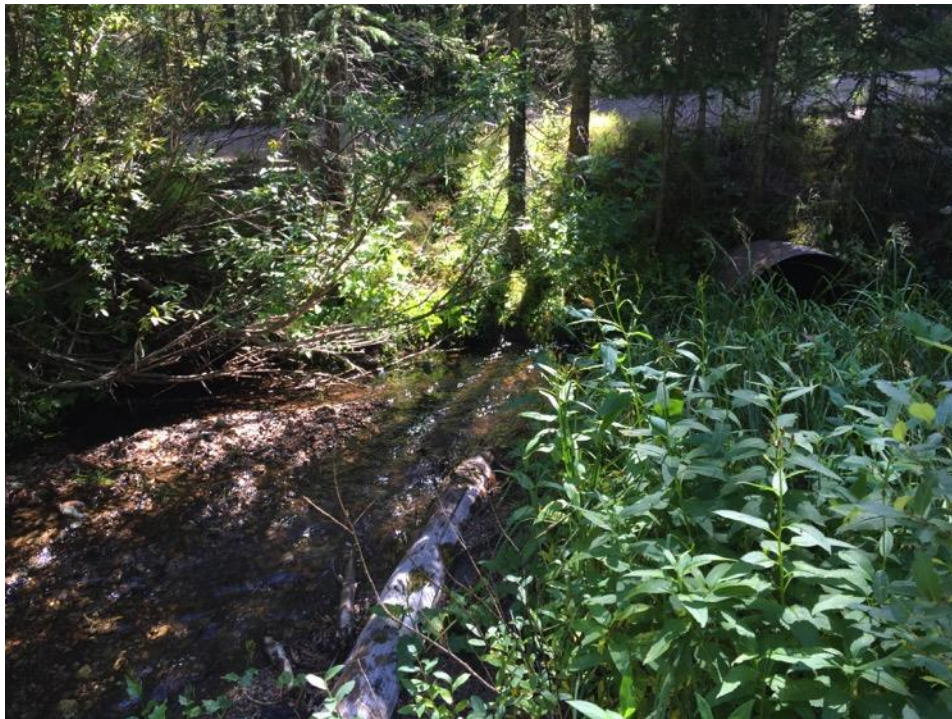
Figure 48. Picture of pool on upstream side of culvert where AQU reach passes the road to Byers Peak Trailhead.

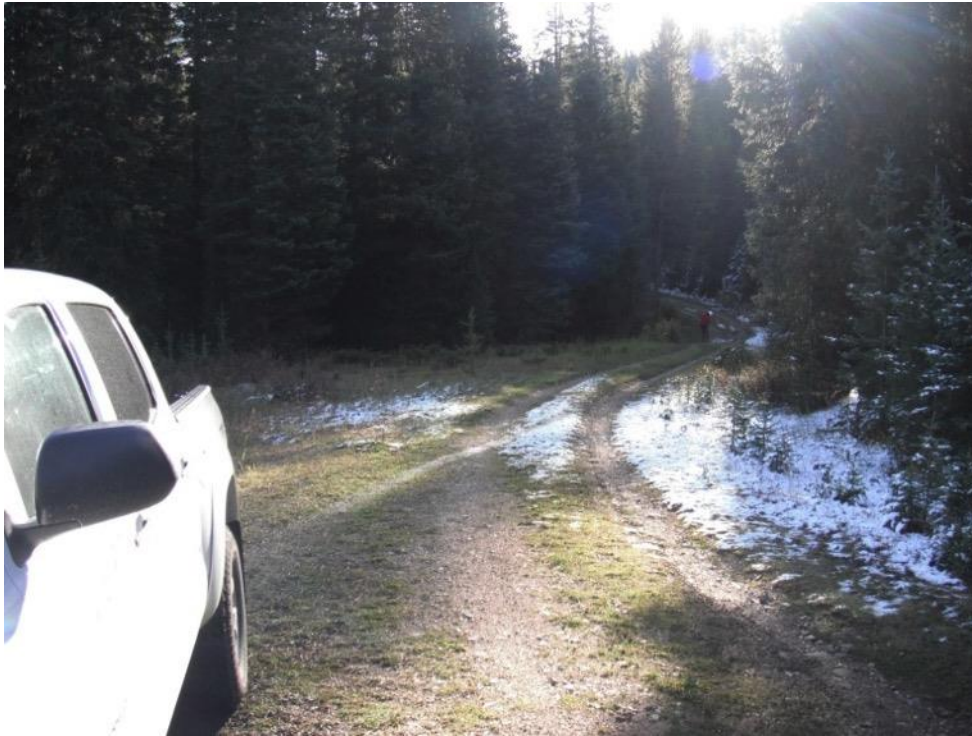
Figure 49 The gated road crosses the stream (via a culvert) upstream of the power drop where the person stands in this photo.
